## PRE-DEVELOPMENT REPORT & TREE INVENTORY

RE: 4790 Norwood Avenue, Sacramento, APN 237-0040-001, County of Sacramento jurisdiction, California

**NORWOOD AVE TOWNHOMES**

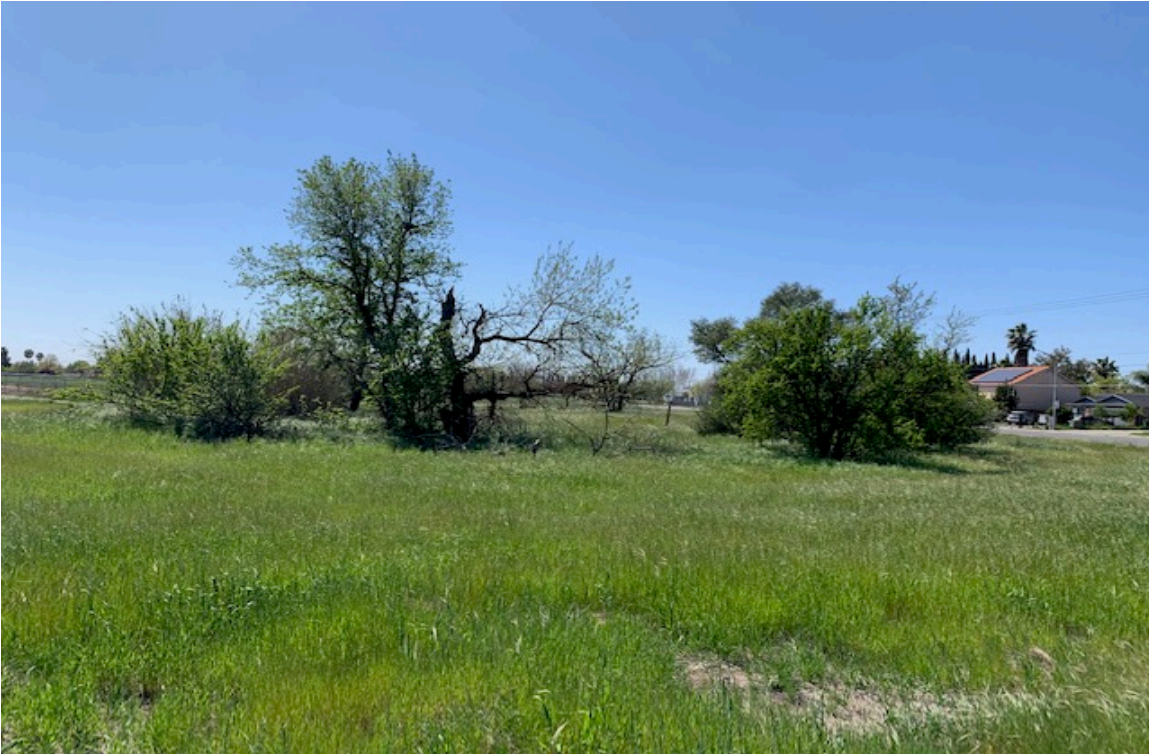
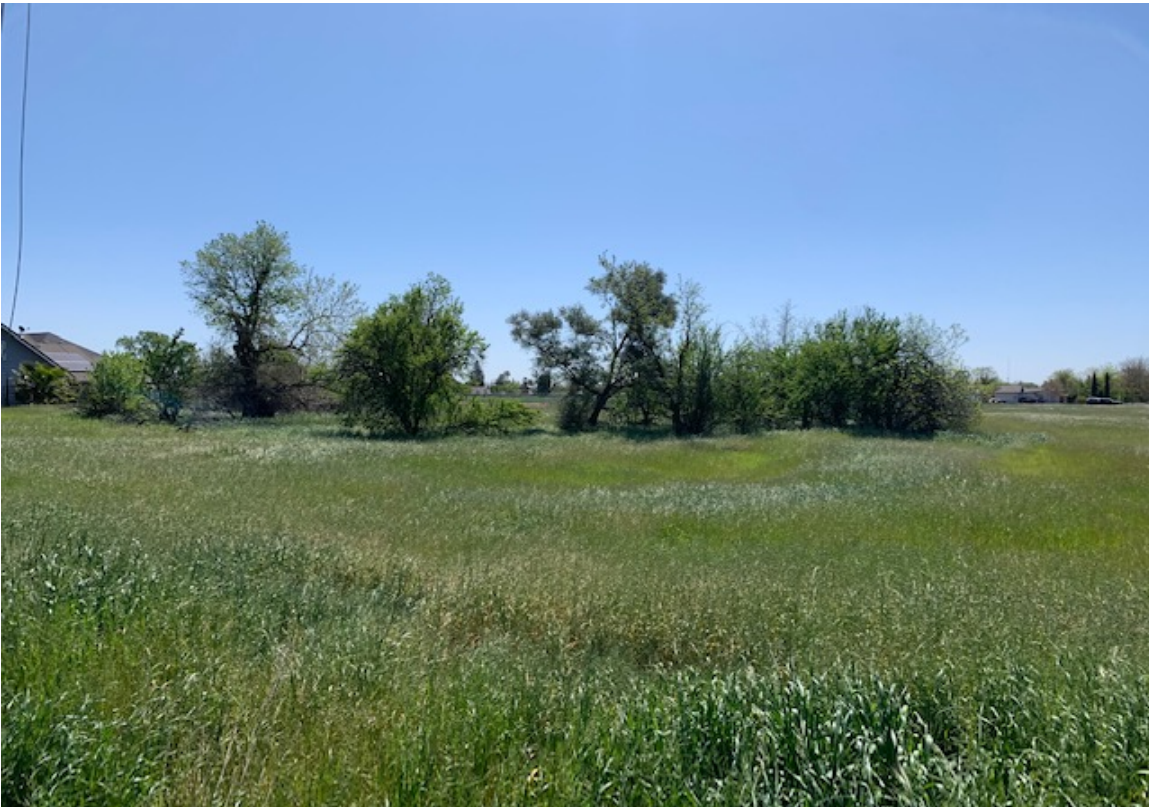
Top: View of trees facing north    Bottom: View of trees facing south.
