APPENDIX B
ARBORIST REPORT

PRELIMINARY ARBORIST REPORT & TREE INVENTORY

RE: 5330 Rio Linda Blvd., APN 226-0062-004-0000, 226-0062-011-0000, 226-0062-008-0000; City of Sacramento jurisdiction, California

ROBLA ESTATES

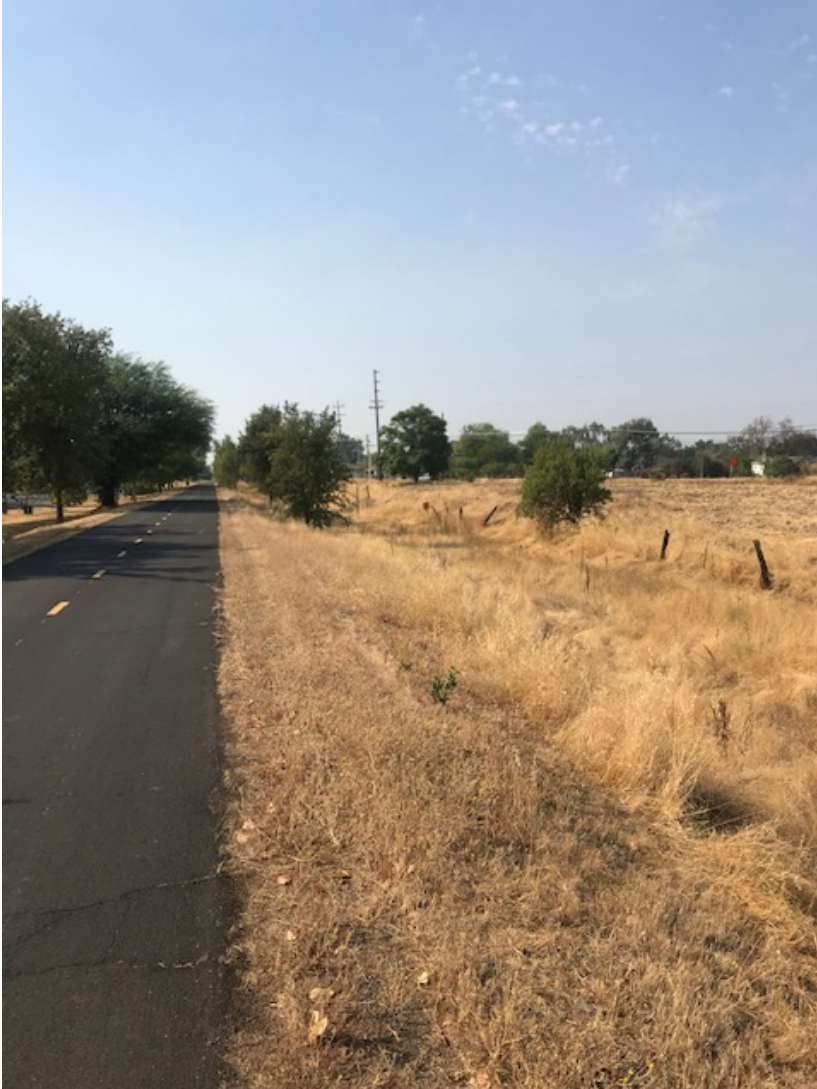
Photo 2, August 18, 2020. Looking south down the bike path

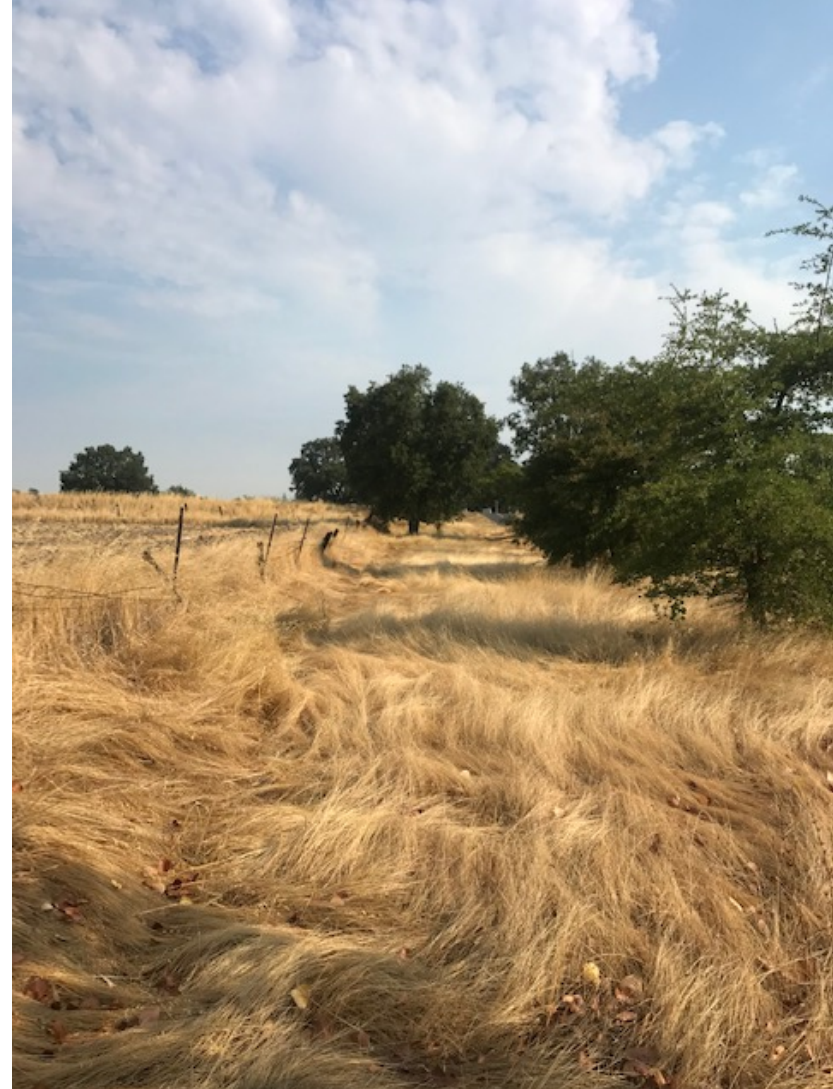
Photo 3, August 18, 2020. Looking north. Demonstrates Trees inside and outside the survey area
