Arborist Report for the Sacramento Commons Project Site, City of Sacramento, California

OCTOBER 15, 2014

Revised DECEMBER 22, 2014

**AERIAL INSPECTION AND RISK ASSESSMENT,
FIVE ELM TREES, SACRAMENTO COMMONS
SACRAMENTO, CALIFORNIA**

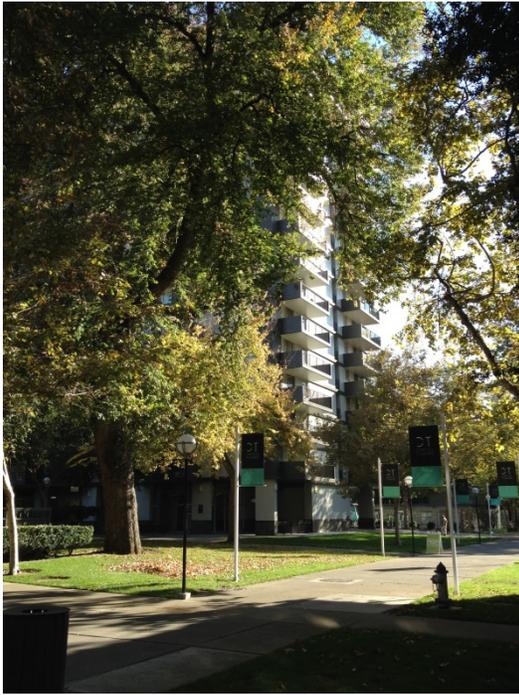
Photo 1: Heritage Tree #76 (American elm) in the central portion of the site.

- Implement Tree Associates (Appendix D) recommendations for Heritage Trees #66, 67, and 76 during site preparation and continue inspections every 2-3 years and after major storms.

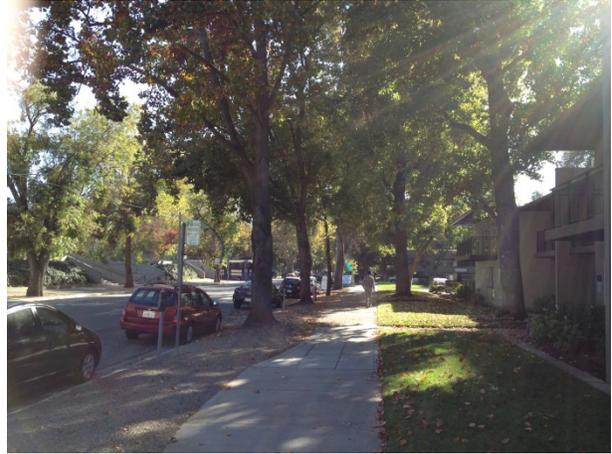
Photo 2: City Street Trees along the west side of 7th Street, including trees #46, 47, and 48.

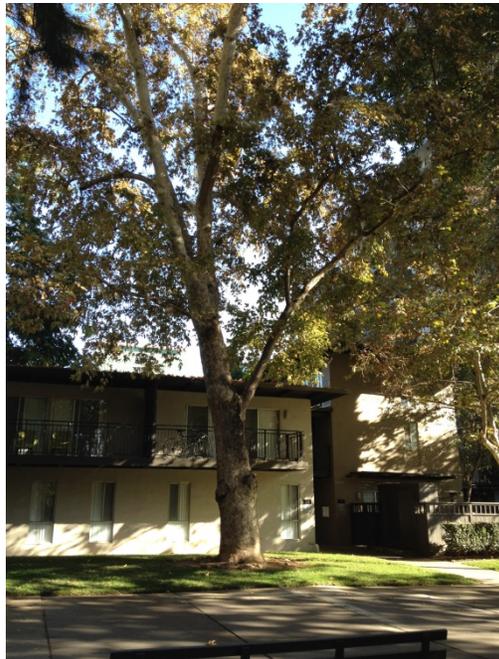
Photo 3: Heritage Tree #77 (California sycamore) in the northern portion of the project site.

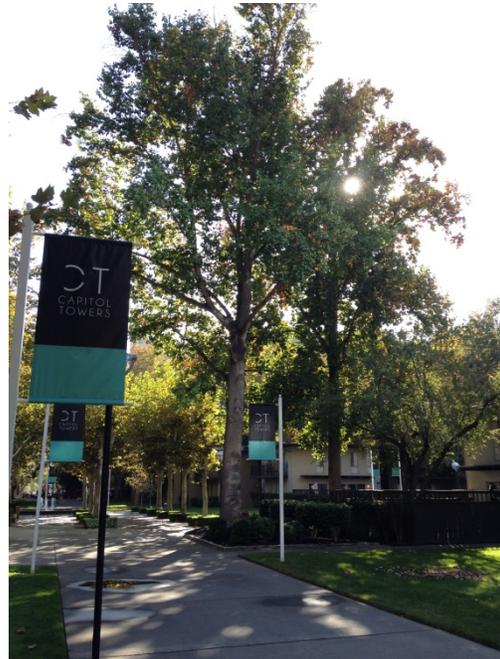
Photo 4: Heritage Tree #106 (Tulip Tree) in the central portion of the site, along the 6th Street corridor.

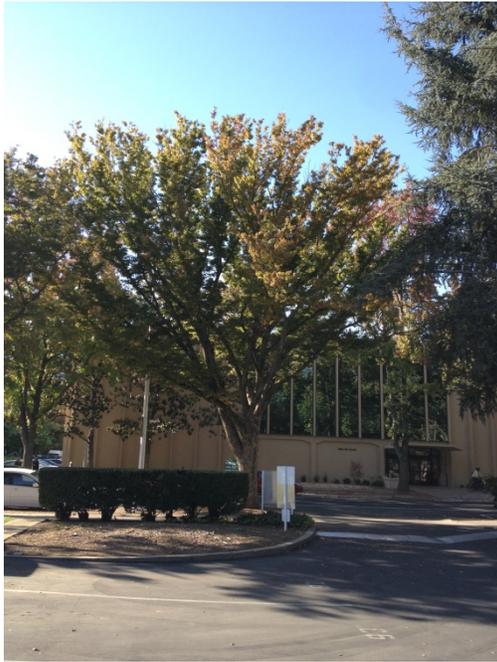
Photo 5: City Street Tree #20 (Zelkova) along the east side of 5th Street.

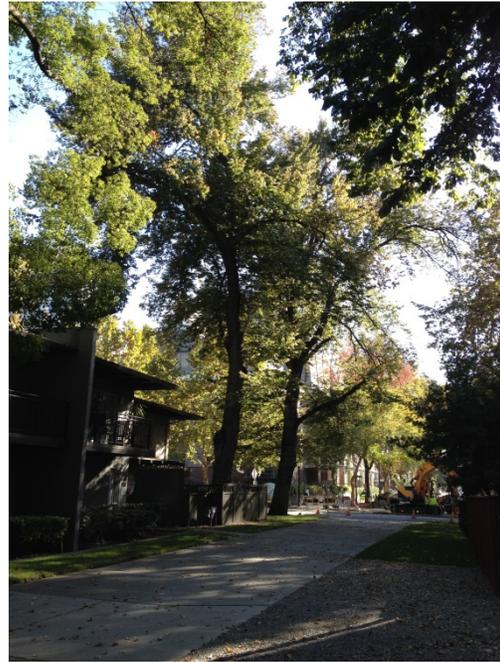
Photo 6: Two Heritage Trees (American elm trees, #66 and 67) in the southern portion of the project site.

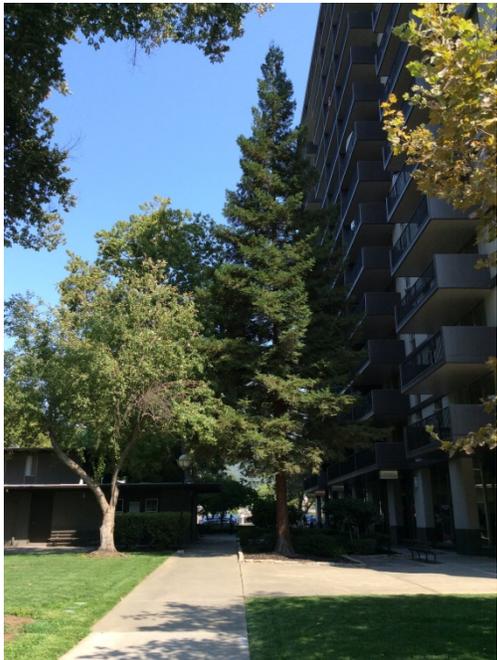
Photo 7: Non-Heritage Tree #237 (Coast redwood) in the central portion of the site.

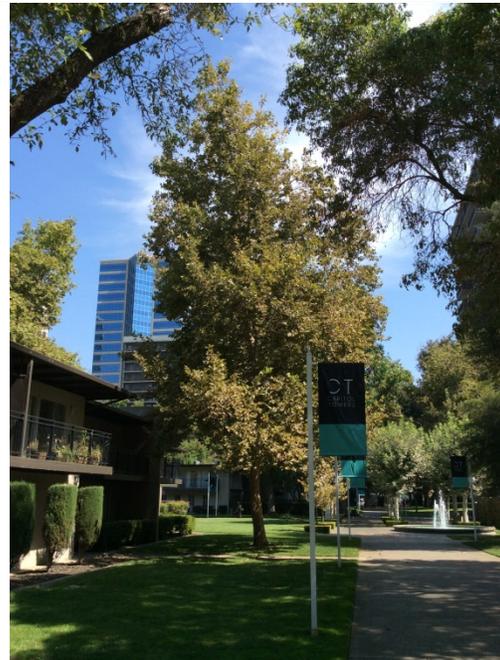
Photo 8: Non-Heritage Tree #315 (London plane tree) in the central portion of the site.

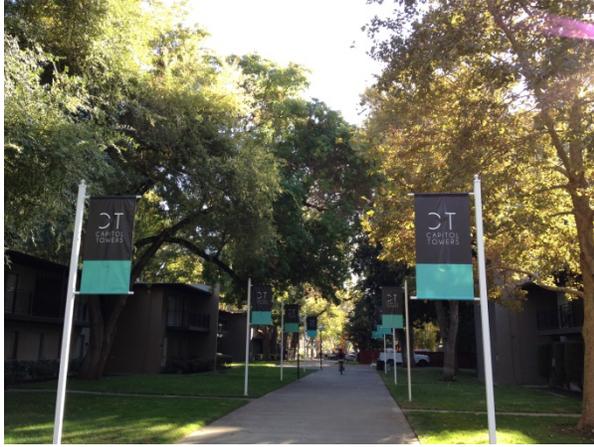
Photo 9: Heritage Trees #66, 67, and 69 and Non-Heritage Trees #68 and 164 in the southern portion of the site.

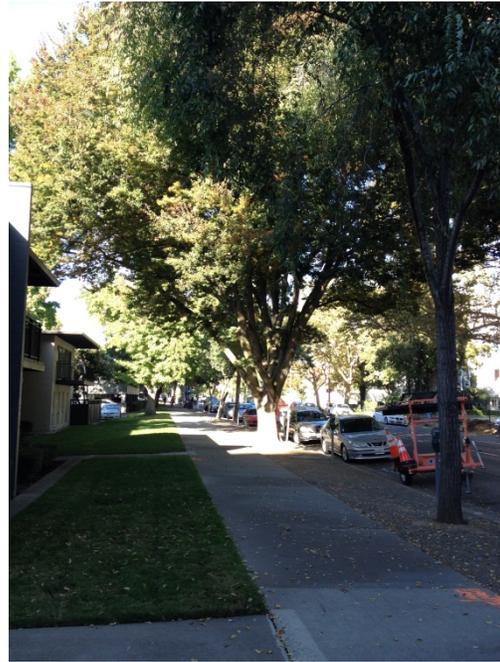
Photo 10: City Street Tree #55 along 7th Street.

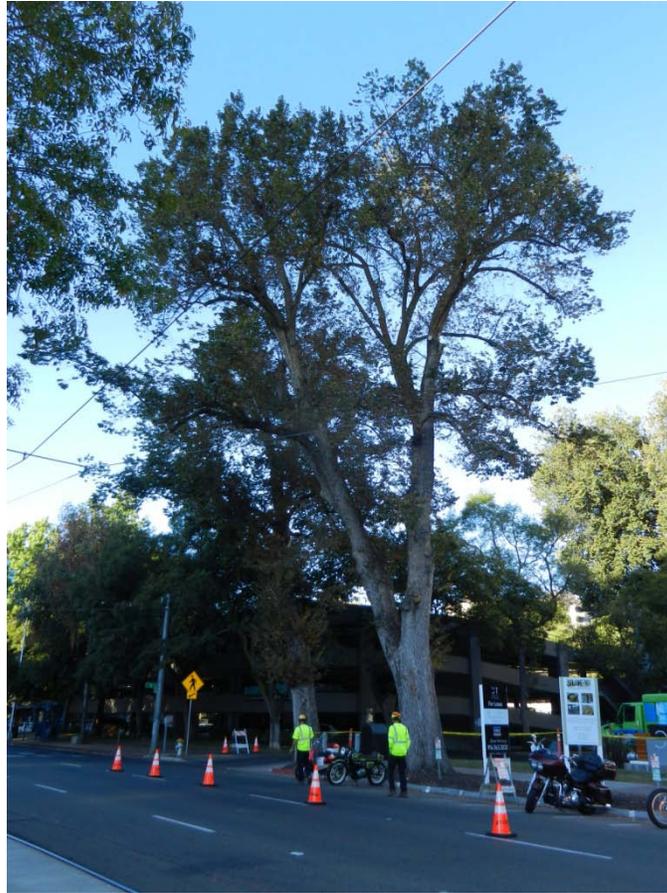
- Significant reduction cuts (to shorten limbs) have been made recently.
- Many old pruning cuts inspected with no or insignificant decay unless noted.
- A few breakouts in the upper canopy to 6" diameter are visible.

Figure 1. Looking southeast at Tree #49.

Following the above recommendations should reduce the likelihood of limb failure to possible.

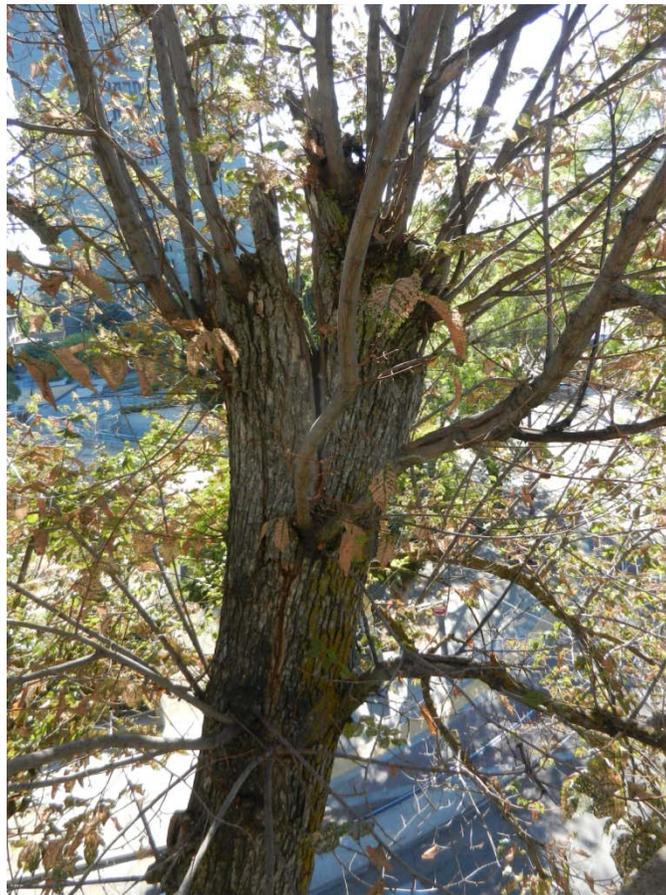
- South-facing codominant secondary trunk off southeast-facing trunk has previous breakout(s) near top with extensive decay (Figure 2).
- South-facing codominant secondary trunk on north-facing trunk with previous breakout and extensive decay where topped many years ago (Figure 3). As little as 2 inches of sound wood exists just below attachment point of up to 13-inch diameter limbs. Likelihood of limb failure is probable¹.

Figure 2. Breakout on south facing codominant secondary trunk on southeast facing trunk with extensive decay.

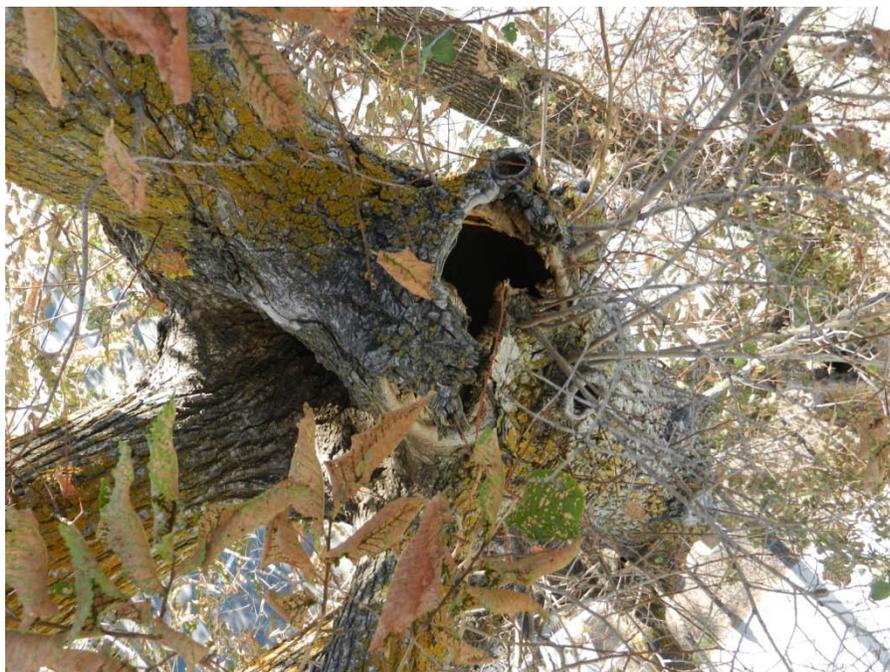
Figure 3. Looking down on south facing codominant secondary trunk on north-facing trunk. Note previous breakout, cavity and extensive decay.

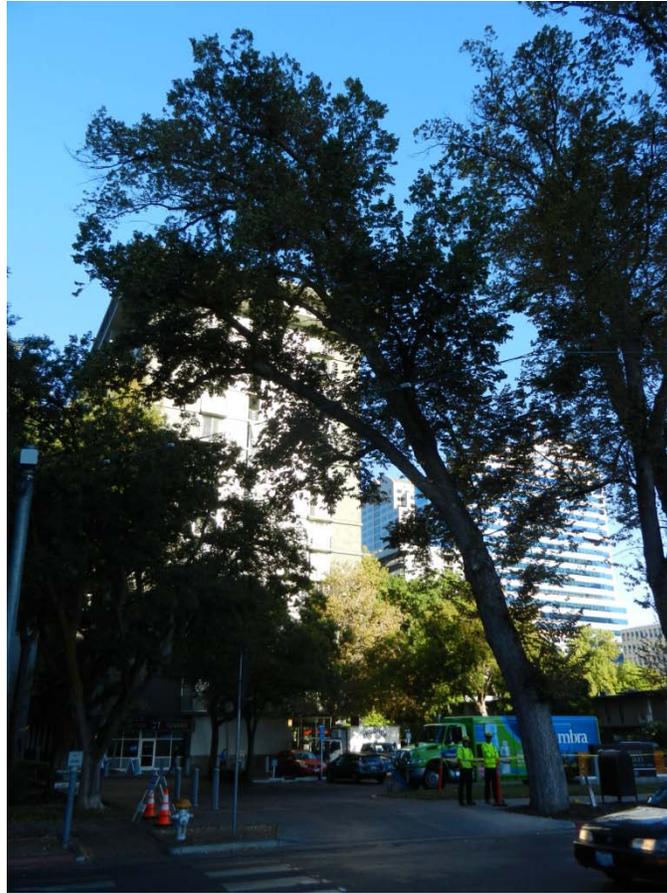
Figure 4. Looking westward at Tree #50.

Following the recommendations above should reduce the likelihood of limb failure to possible.

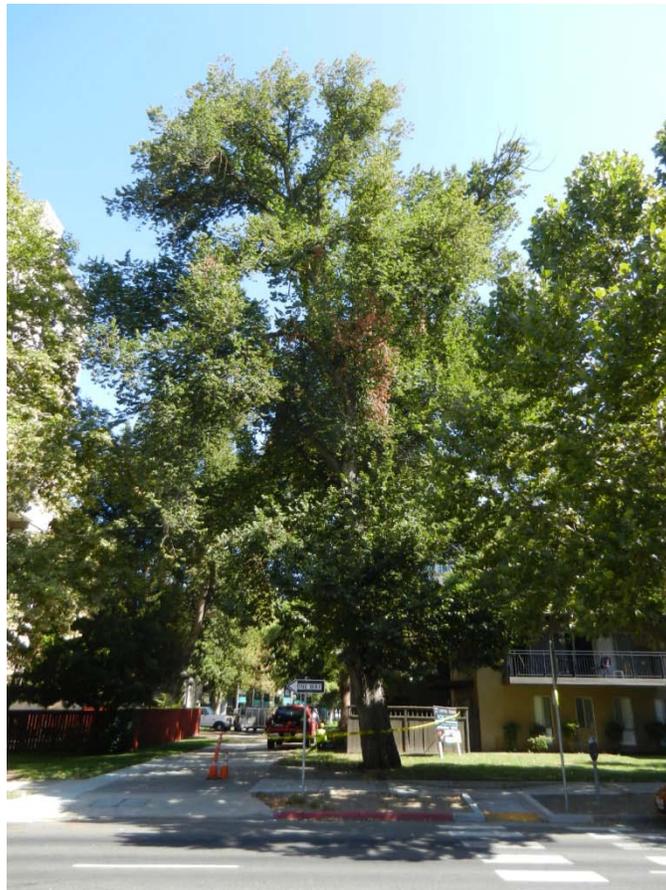
Figure 5. Looking northward at Tree #66.

- Remove dead and broken limbs.
- On north trunk, use reduction cuts to remove 30% of the foliage on trunk.
- On north facing codominant trunk, use reduction cuts to remove 30-50% of the foliage on primary limbs over apartments.
- Remove west facing primary limb at 15 feet.
- Remove west facing primary limb at 55 feet on south facing trunk.
- Use reduction cuts to remove the following percentage of foliage/buds on the limbs below:
 - Primary facing south attached at 30 feet on south trunk – 50%, up to 5” dia. cuts;
 - Primary facing southeast at 40 feet on south trunk – 25%;
 - Primary facing south at 60 feet on south trunk -20%.
- Repeat aerial inspection within two years or after major storms.

Following the recommendations above should reduce the likelihood of limb failure to possible.

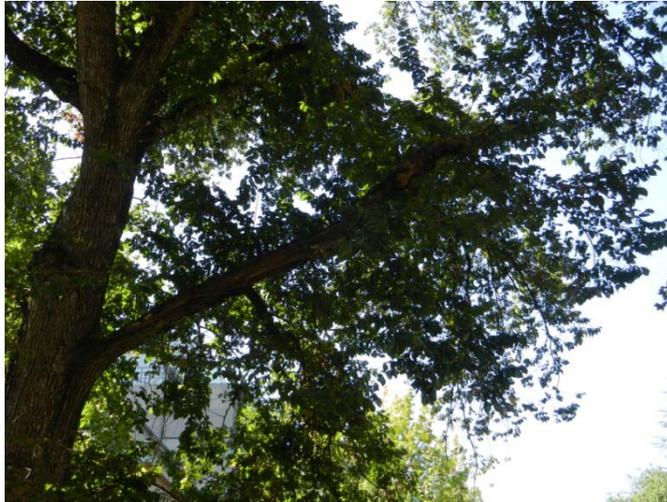
Figure 6. West facing primary limb at 15 feet with wound and decay on upper side of limb.

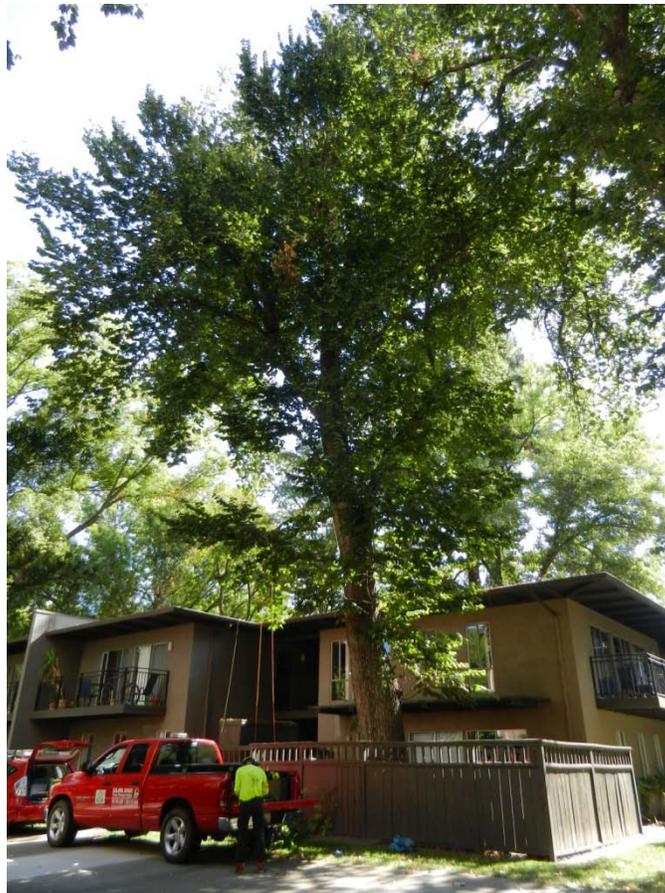
Figure 7. Looking northeast at Tree #67.

- Remove dead and broken limbs.
- Use reduction cuts to remove the following percentage of foliage/buds on the limbs below:
 - East facing primary attached at 40 feet – 30%;
 - Secondary attached at 45 feet on northeast facing primary attached at 35' – 15%;
 - Secondary off primary facing north attached at 35' – 15%.
- Re-inspect tree for pruning needs within three years or after major storms.

Following the recommendations above should reduce the likelihood of limb failure.

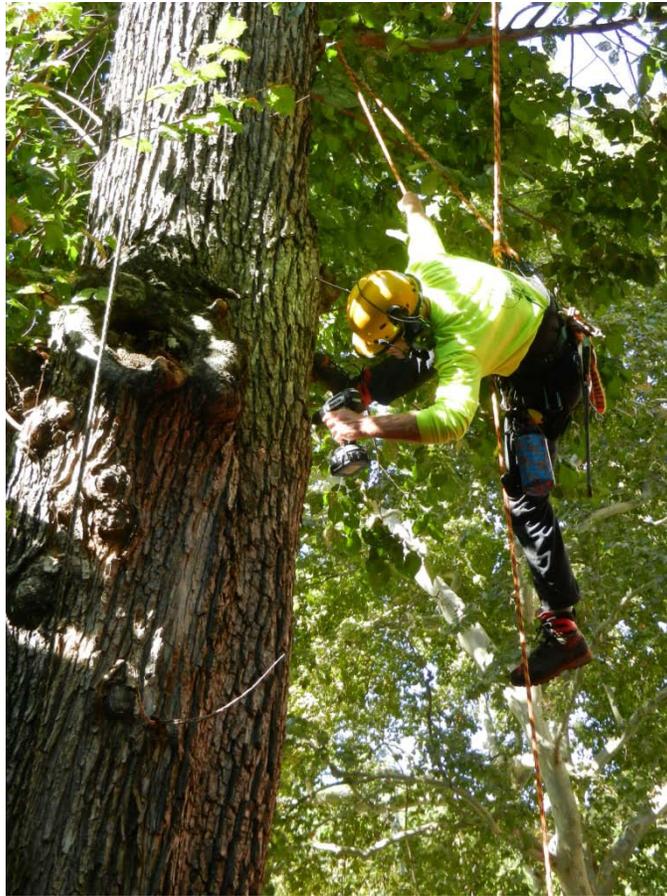
Figure 8. Rhett Richardson, Owner of Solano Shade Tree Preservation drilling to determine sound wood thickness near large wound with decay.

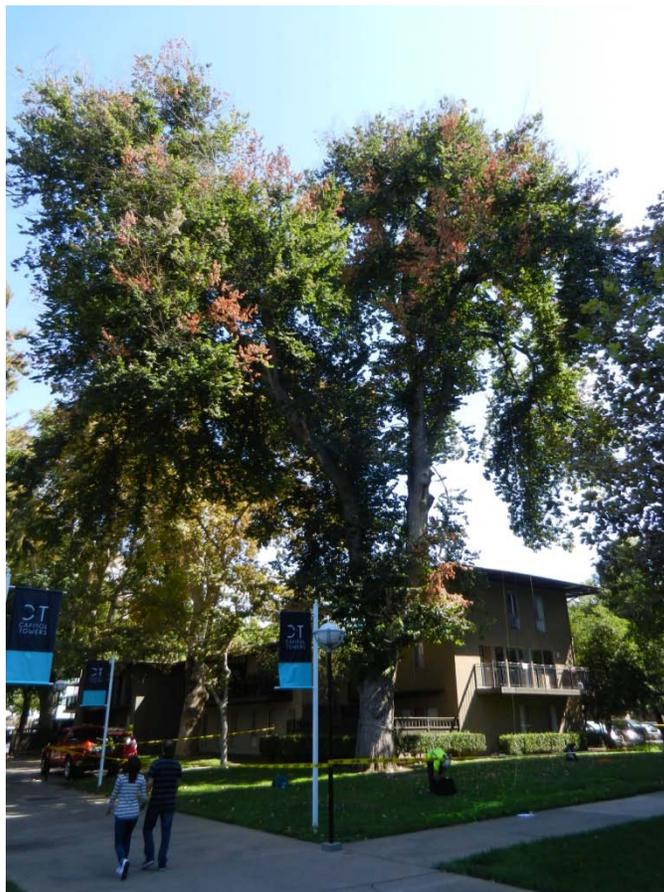
Figure 9. Looking northeast at Tree #76. Note wilted foliage caused by squirrel damage.

- Remove secondary limbs facing north attached at 65 feet on east-facing primary immediately.
- Shorten south-facing primary attached at 30 feet by 20 feet (heading cut).
- Use reduction cuts to remove the following percentage of foliage/buds on the limbs below:
 - East-facing primary attached at 35 feet – 30%, max 7" diameter cuts;
 - Northwest-facing primary attached at 15 feet – 30%, max 6" diameter cuts;
 - Secondary at 50 feet on east facing primary attached at 35 feet – 30%.
- Remove dead and broken limbs.
- Repeat aerial inspection within two years or after major storms.

Following the recommendations above should reduce the likelihood of limb failure to possible.

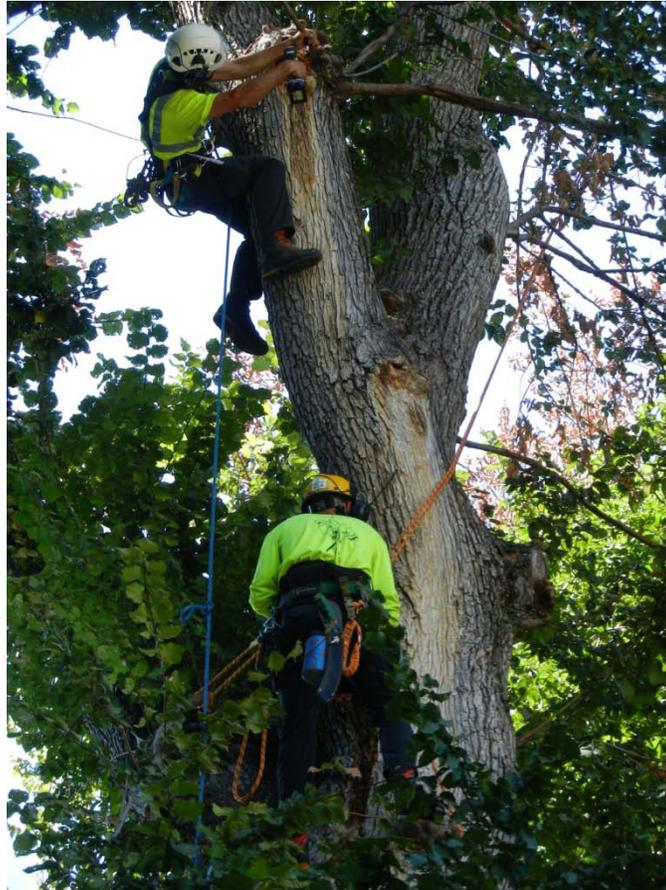
Figure 10. Justin and Rhett inspecting cavities with decay on Tree #76.

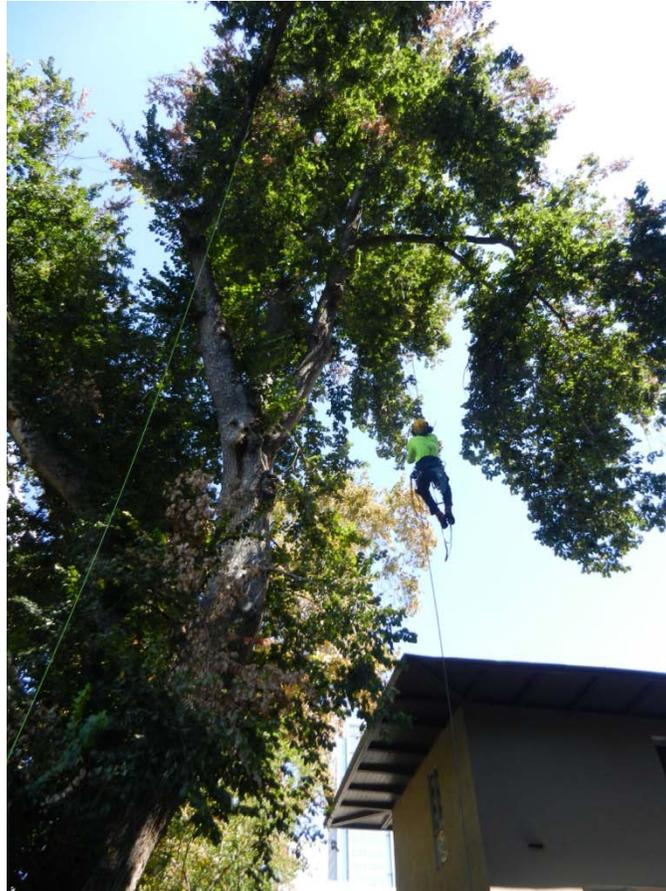
Figure 11. Secondary limbs hanging over apartments (above climber) are cracked and have an imminent likelihood of failure.
