# California Tree and Landscape Consulting, Inc.

October 23, 2024

## REVISED<sup>1</sup> PRE-DEVELOPMENT ARBORIST REPORT & TREE INVENTORY

**RE: Mary Ann’s Bakery, (APNs 003-0112-003, -004, -021, -018, -020 & -017); City of Sacramento Jurisdiction**

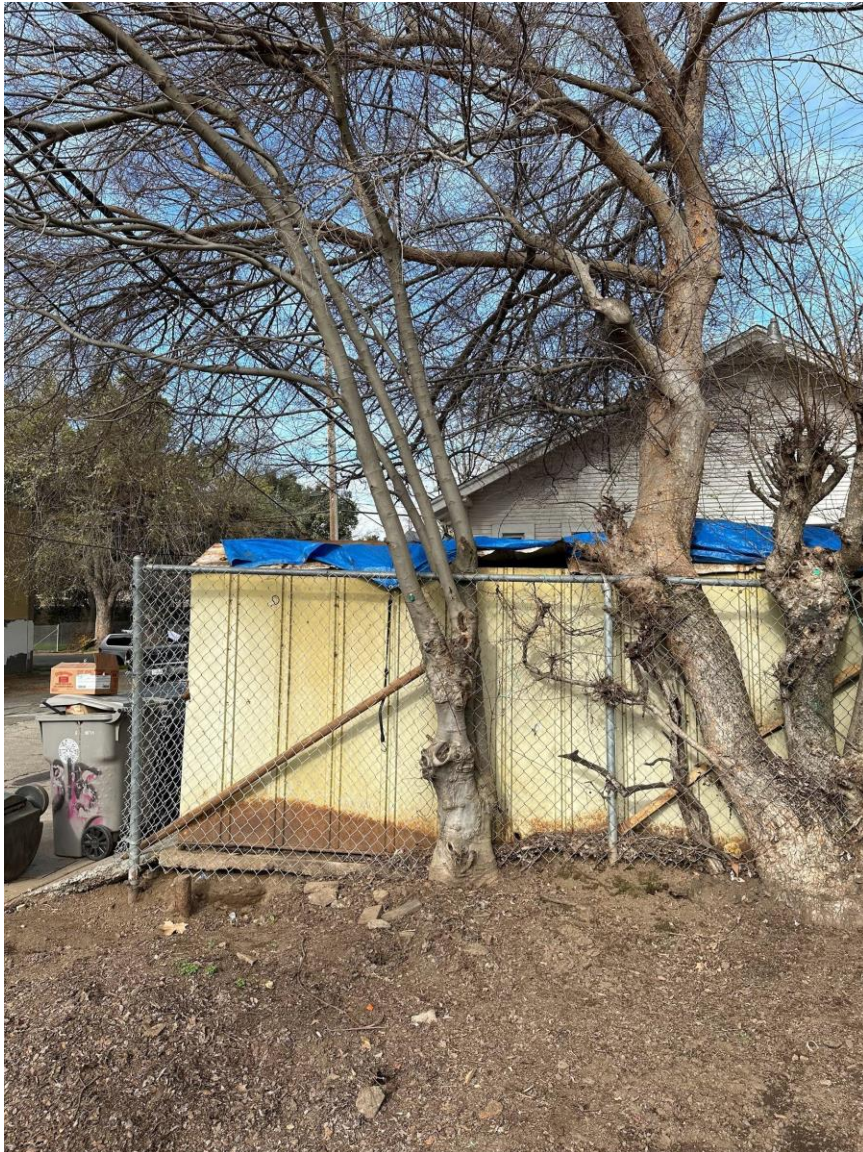
Photo #1, Shows Trees #8950 & #8951

8951		Yes		No	Chinese elm	<i>Ulmus parvifolia</i>	34	5,9,20,14	42	25	1-Extreme Structure or Health Problems	Growing through chain-link fence, forks, one to the 3 feet above grade, we attachments hissing wounds, where the stems have begun to engulf the top on the fence the largest stem bends at that	Proposed for removal	NA

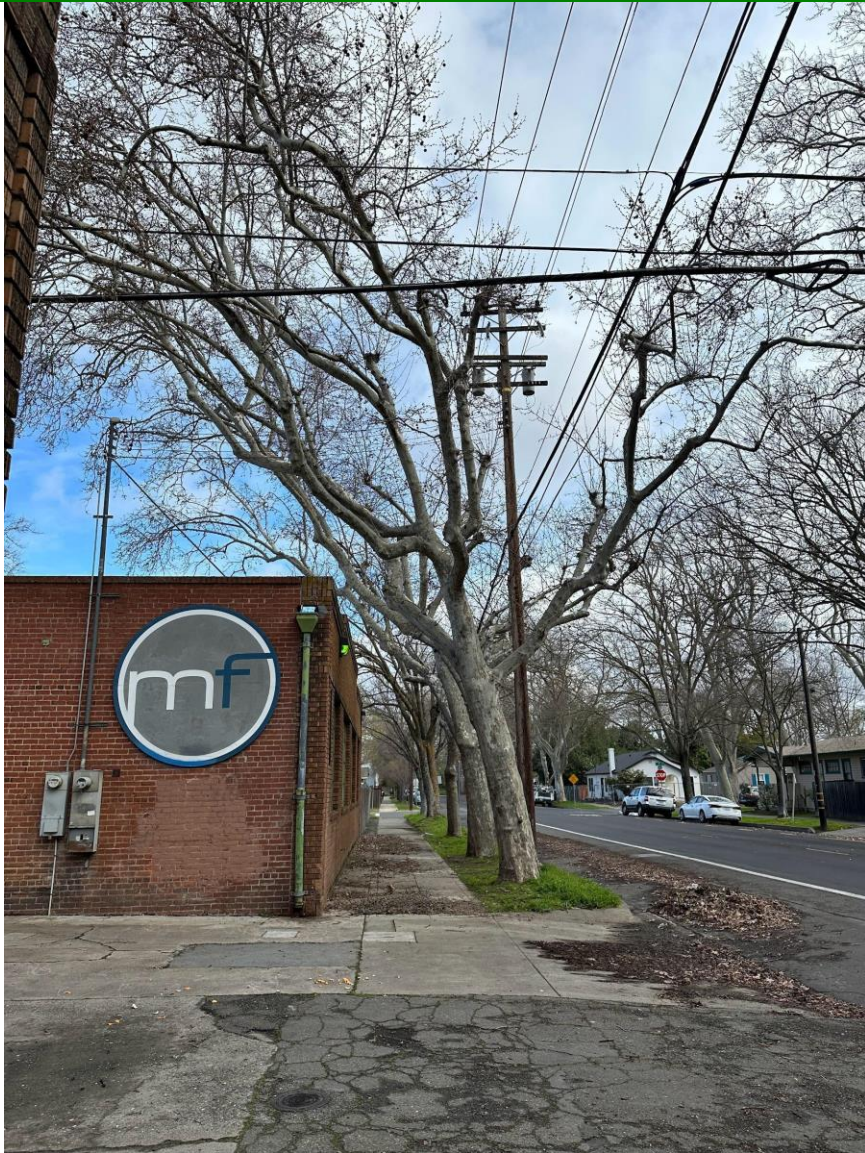
Photo #7, Shows Alhambra Blvd., view north from Chinatown Alley & Tree #59899 in front

59899		Yes	Yes	Yes	London plane tree	<i>Platanus × hispanica</i>					2- Major Structure or health problems	Topped for utility line clearance, above average amount of dead branches.	Retain	Remove branch or reduction prune - 1x16", 1x15", 1x14", 1x11", 1x8", NON Standard. ~40% of canopy.
59901		Yes	Yes	Yes	Chinese pistache	<i>Pistacia chinensis</i>	7			8	3-Minor Problems	Ivy covering root collar/lower trunk.	Retain	None
59902		Yes	Yes	Yes	London plane tree	<i>Platanus × hispanica</i>	14		54	10	2- Major Structure or	Topped for utility line clearance, above	Retain	Remove branch or

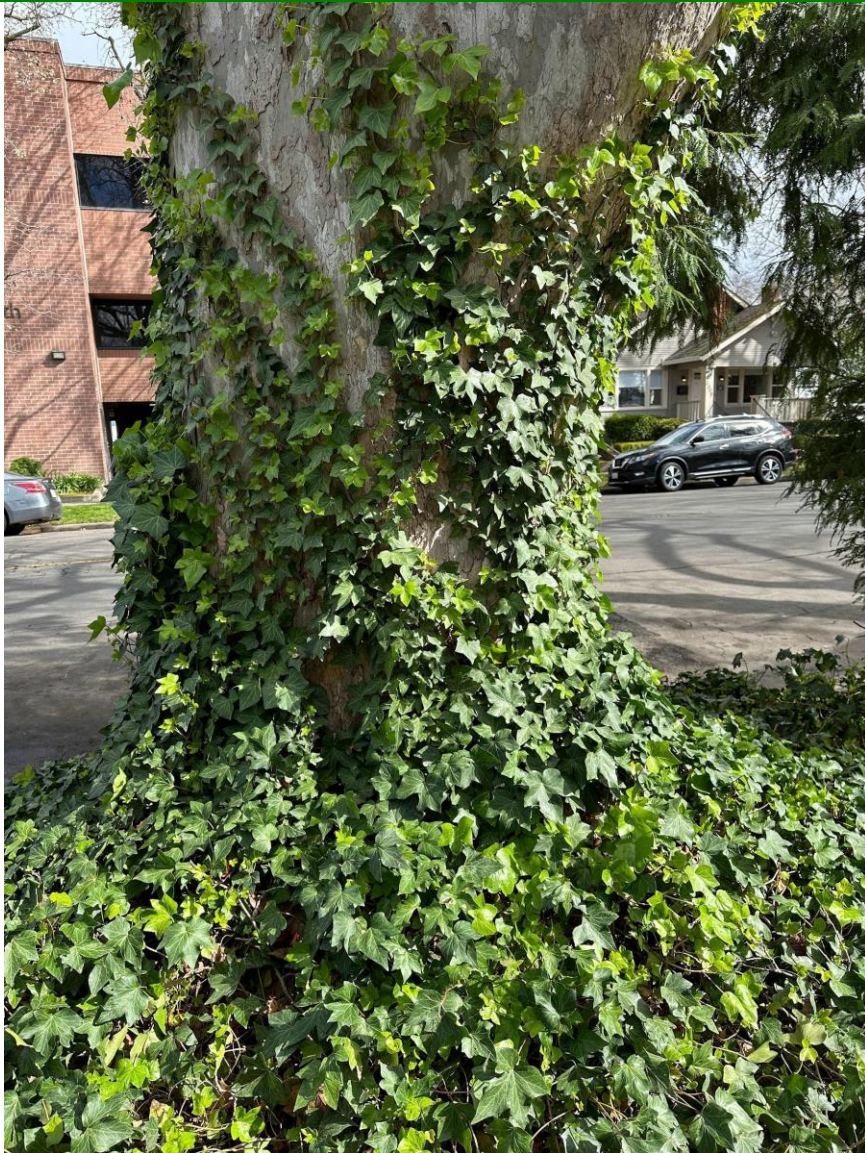
Photo #11, Shows Tree #59887 with typical ivy growth

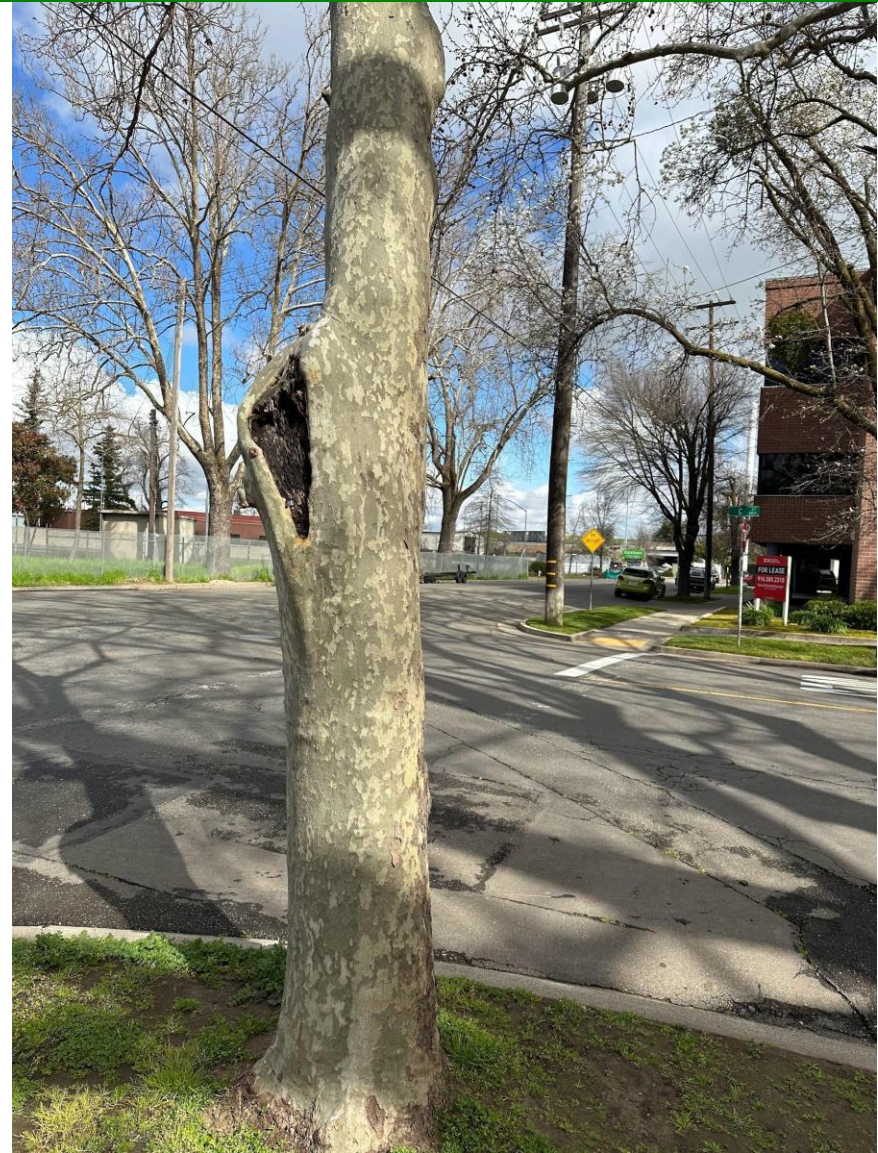
59886		Yes	Yes	Yes	London plane tree	<i>Platanus × hispanica</i>	18		54	21	2-Major Structure or health problems	Trunk wound south side 6' above grade with minor to moderate decay. One sided west.	Retain	Remove branch or reduction prune - 1x6", ~5% of canopy.
59887		Yes	Yes	Yes	London plane tree	<i>Platanus × hispanica</i>	42		54	35	3-Minor Problems	Root collar lower trunk covered in ivy	Retain	Remove branch or reduction prune - 1x28", 1x18", 1x12". ~35% to 45% of canopy.
59888		Yes	Yes	Yes	Coast redwood	<i>Sequoia sempervirens</i>	9		54	12	2-Major Structure or health problems	Stump sprout from within the stump.	Proposed for removal	NA

Photo #12, Shows Tree #59886 with cavity/decay

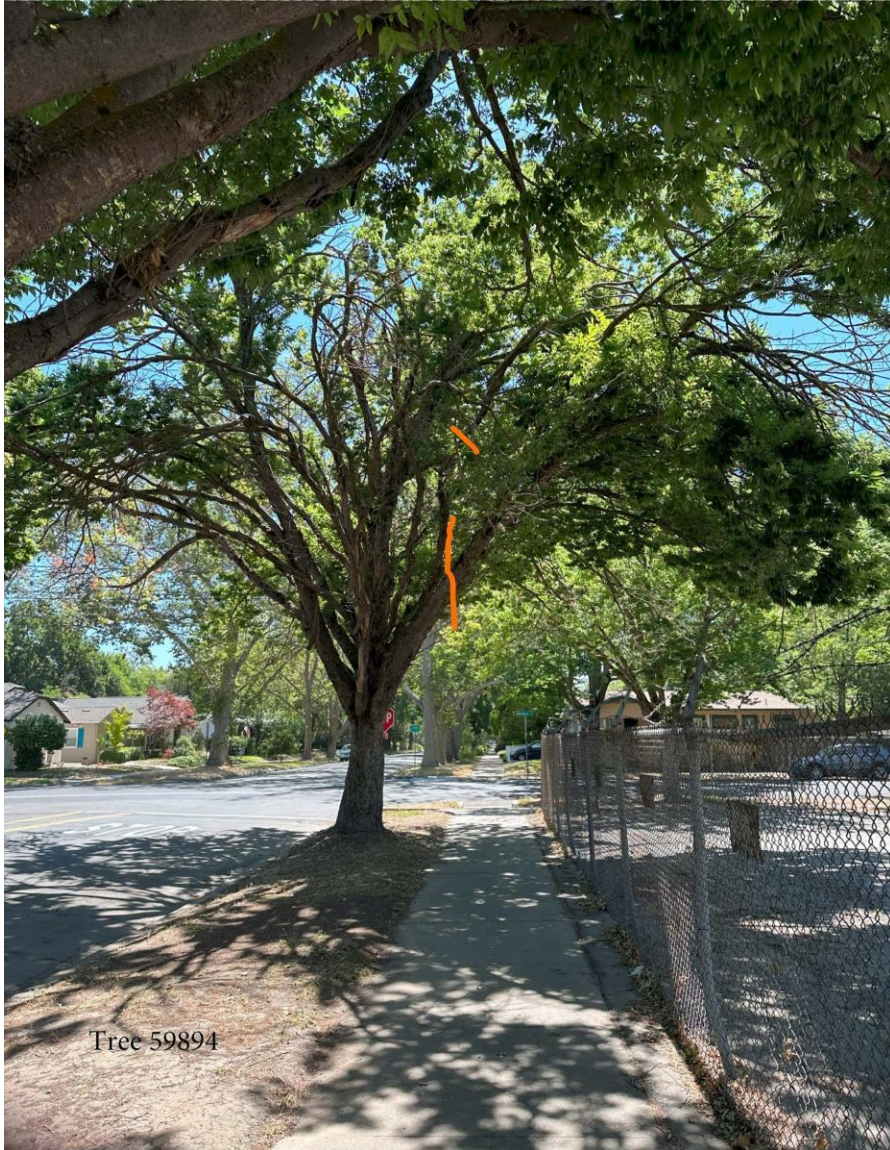
Photo #15, Shows Tree #59894, with pruning cuts

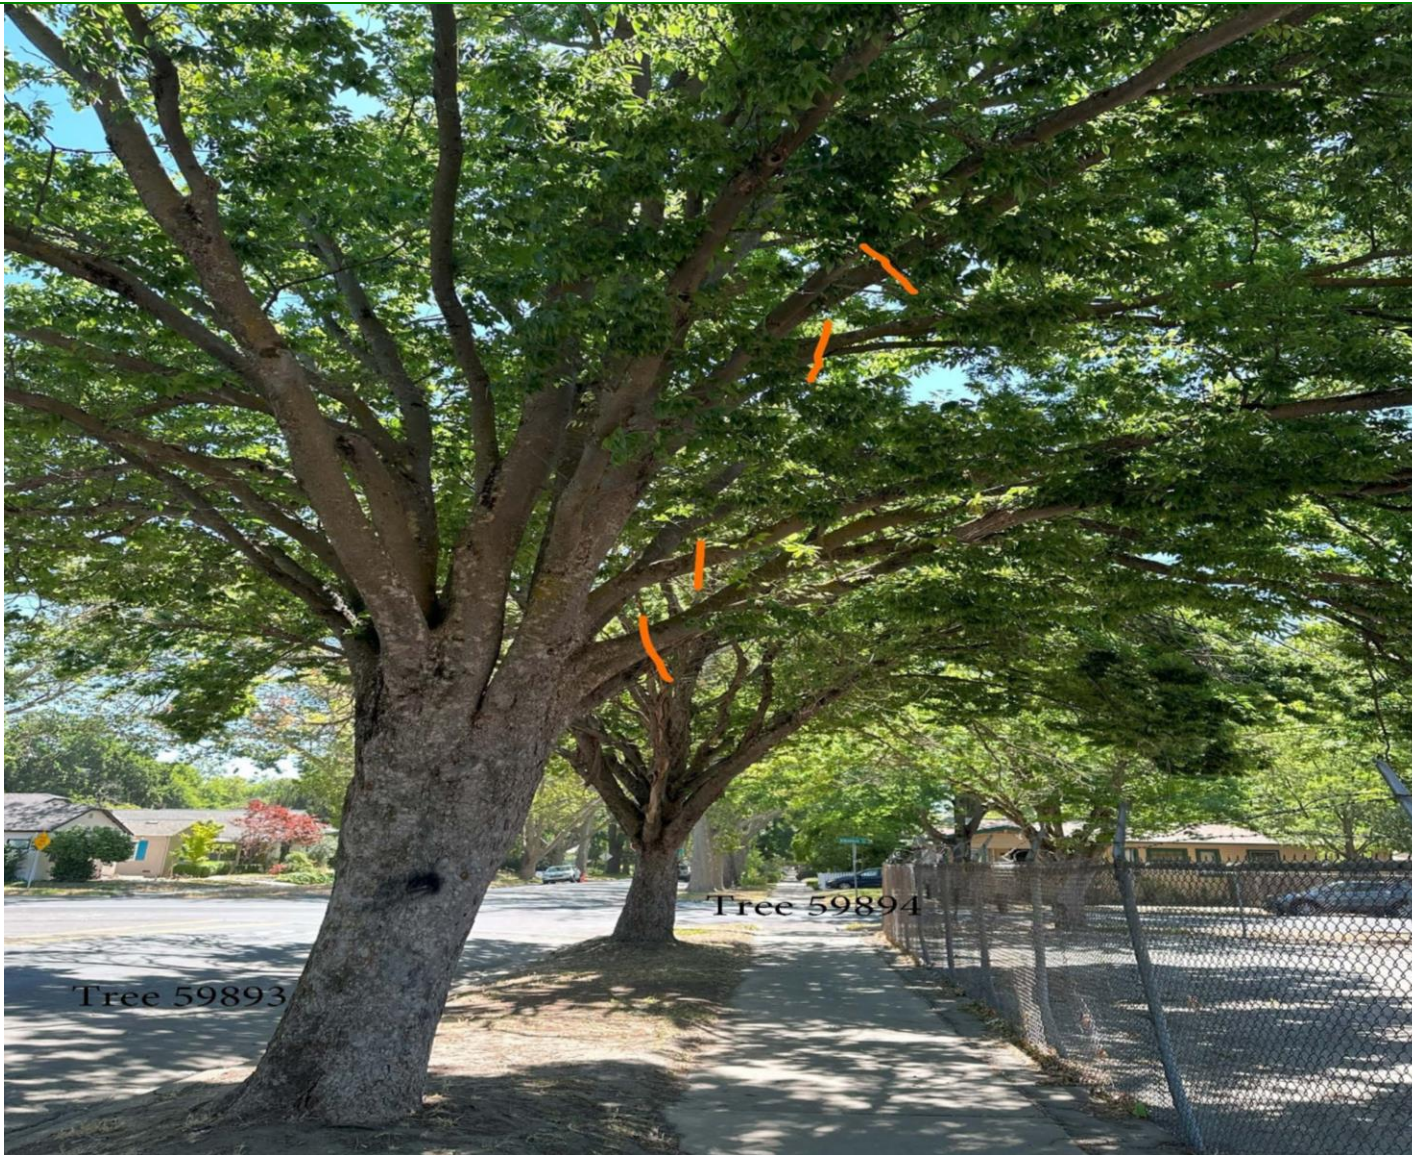
59893		Yes	Yes	Yes	Zelkova	<i>Zelkova serrata</i>	24		54	25	3-Minor Problems	Above average amount of dead branches.	Retain	Remove branch or reduction prune - 6x4" to 6". ~20% of canopy.
59894		Yes	Yes	Yes	Zelkova	<i>Zelkova serrata</i>	35		54	29	3-Minor Problems	Above average amount of dead branches.	Retain	Remove branch or reduction prune - 1x12", 3x4". ~20% of canopy.
59895		Yes	Yes	Yes	Zelkova	<i>Zelkova serrata</i>	21		36	20	2-Major Structure or	Weak attachments, above average	Retain	Remove branch or

Photo #16, Shows Trees #59893 (left) & #59894 (right), with pruning cuts

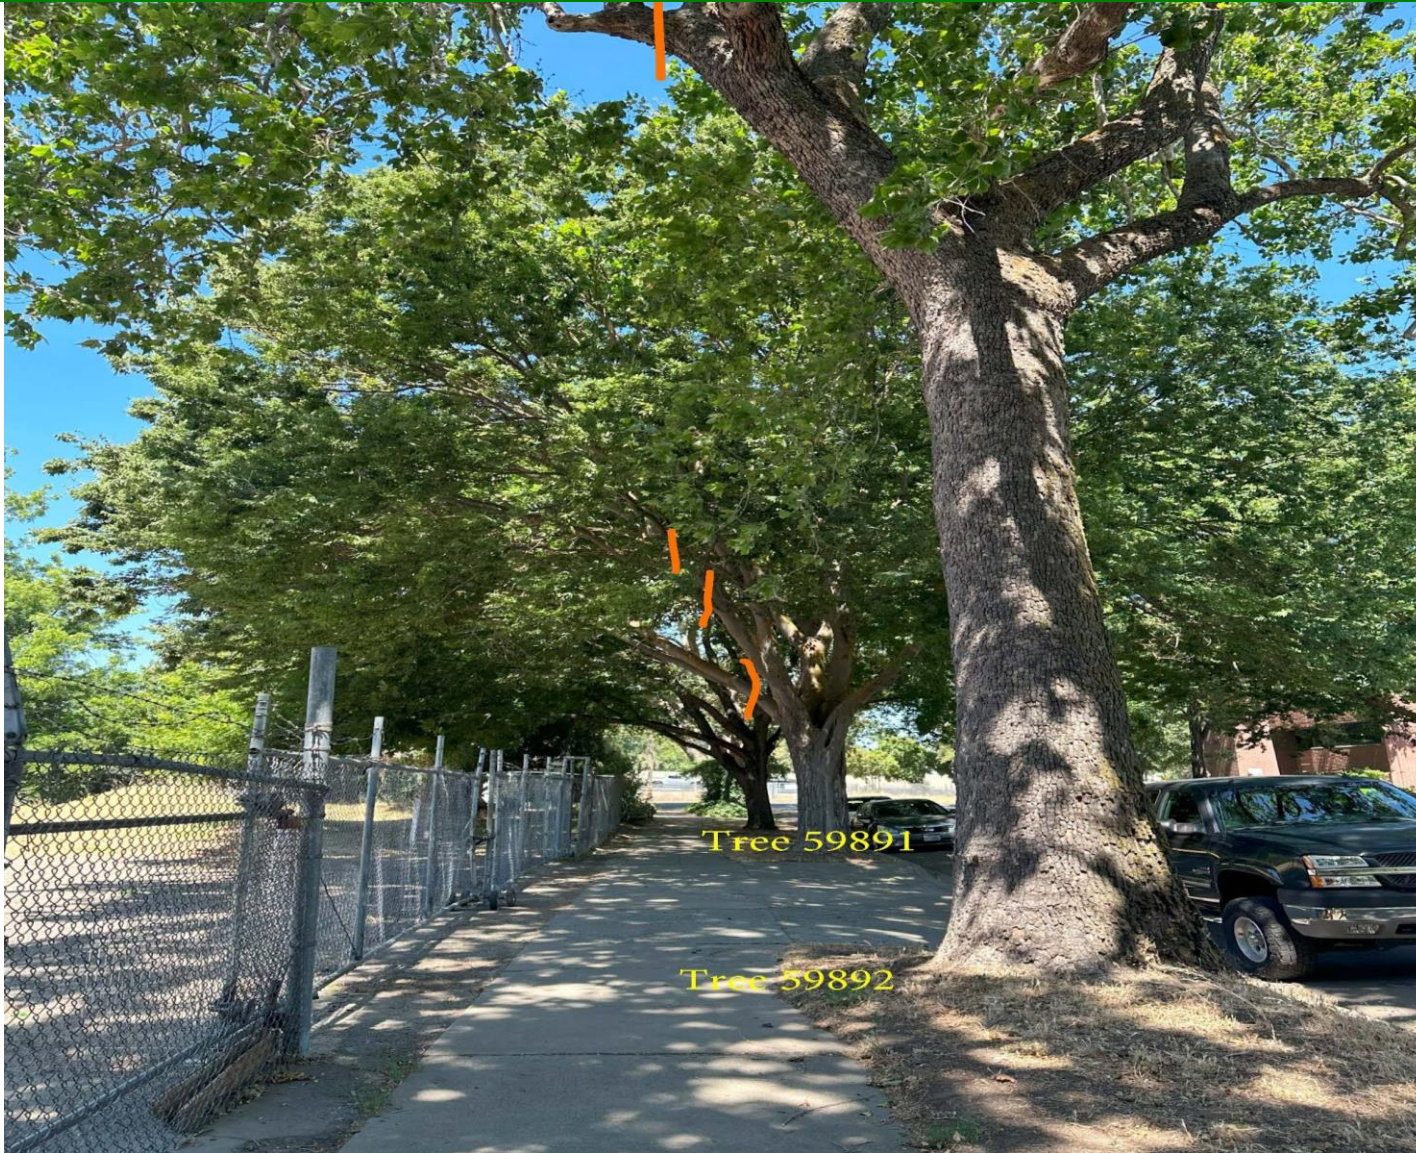
Photo #17, Shows Trees #59891 (back) & #59892 (front), with pruning cuts

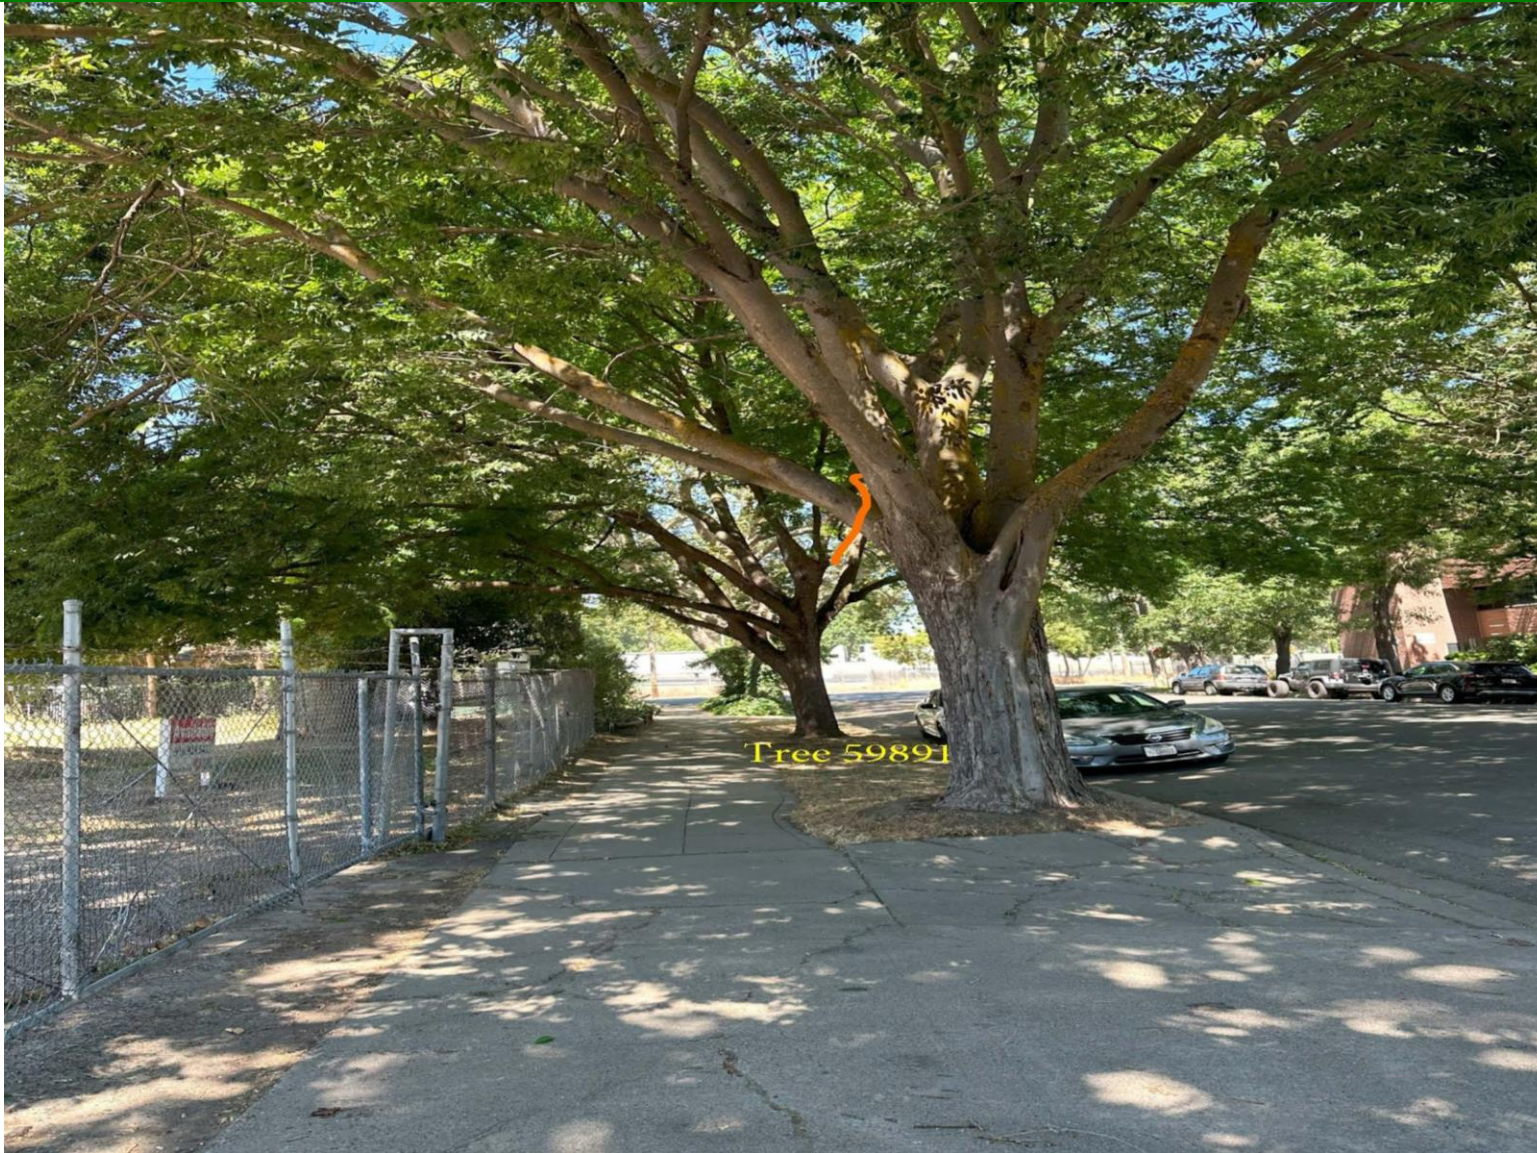
Photo #18, Shows Tree #59891, with pruning cuts

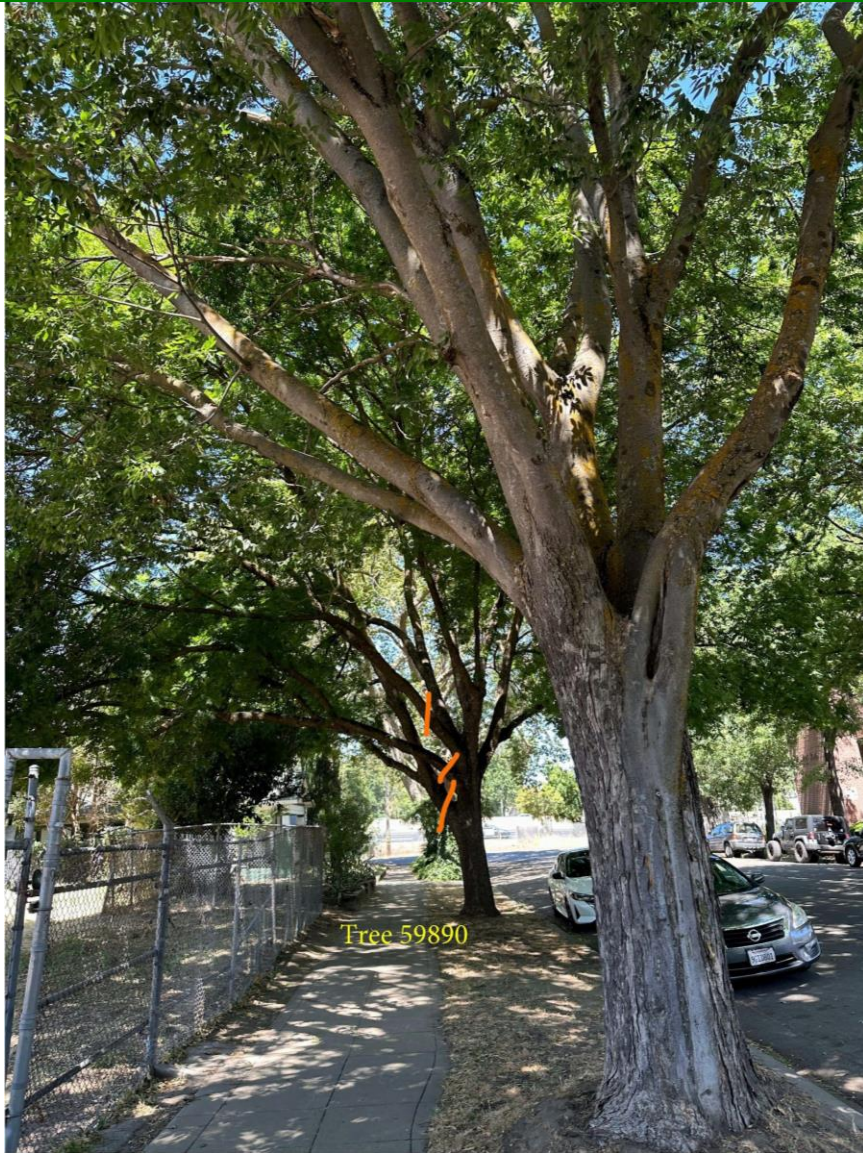
Photo #19, Shows Tree #59890, with pruning cuts

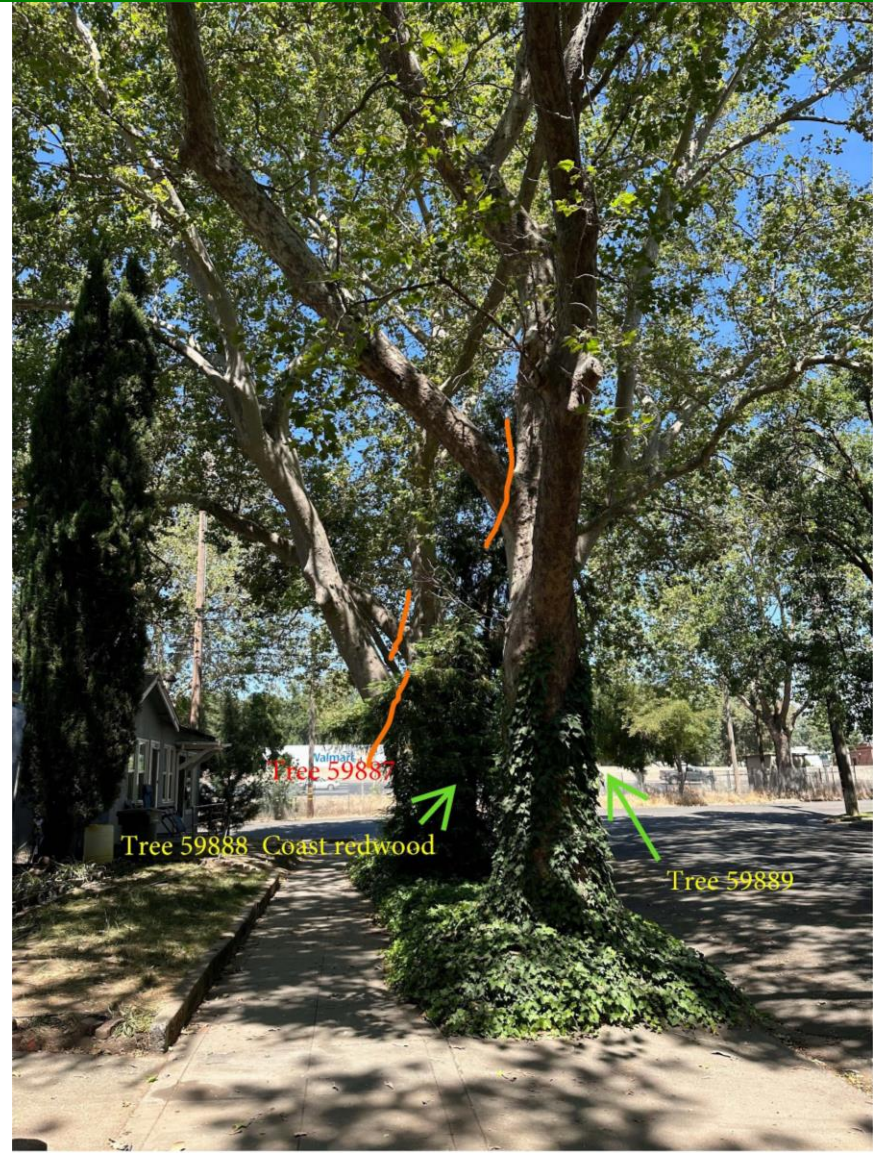
Photo #20, Shows Trees #59887 (back), #59888 (left) & #59889 (front/right), with pruning cuts

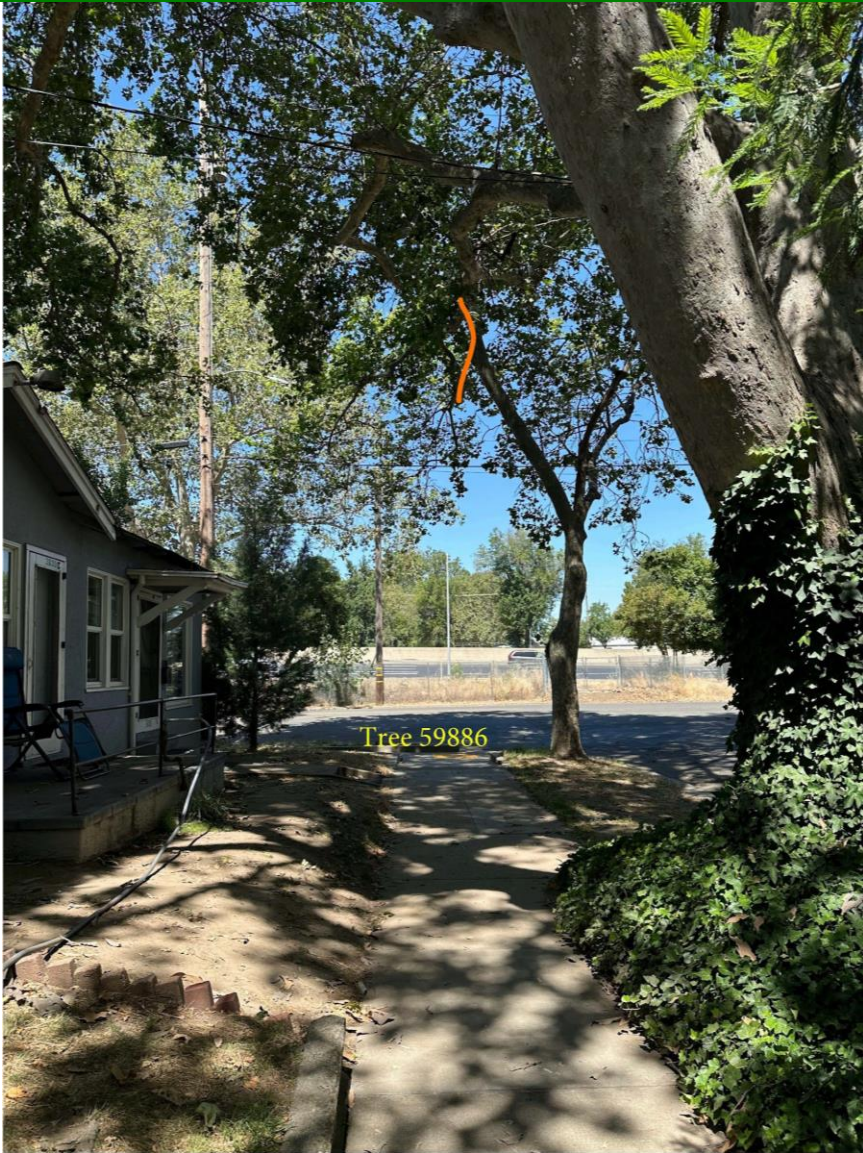
Photo #21, Shows Tree #59886, with pruning cuts

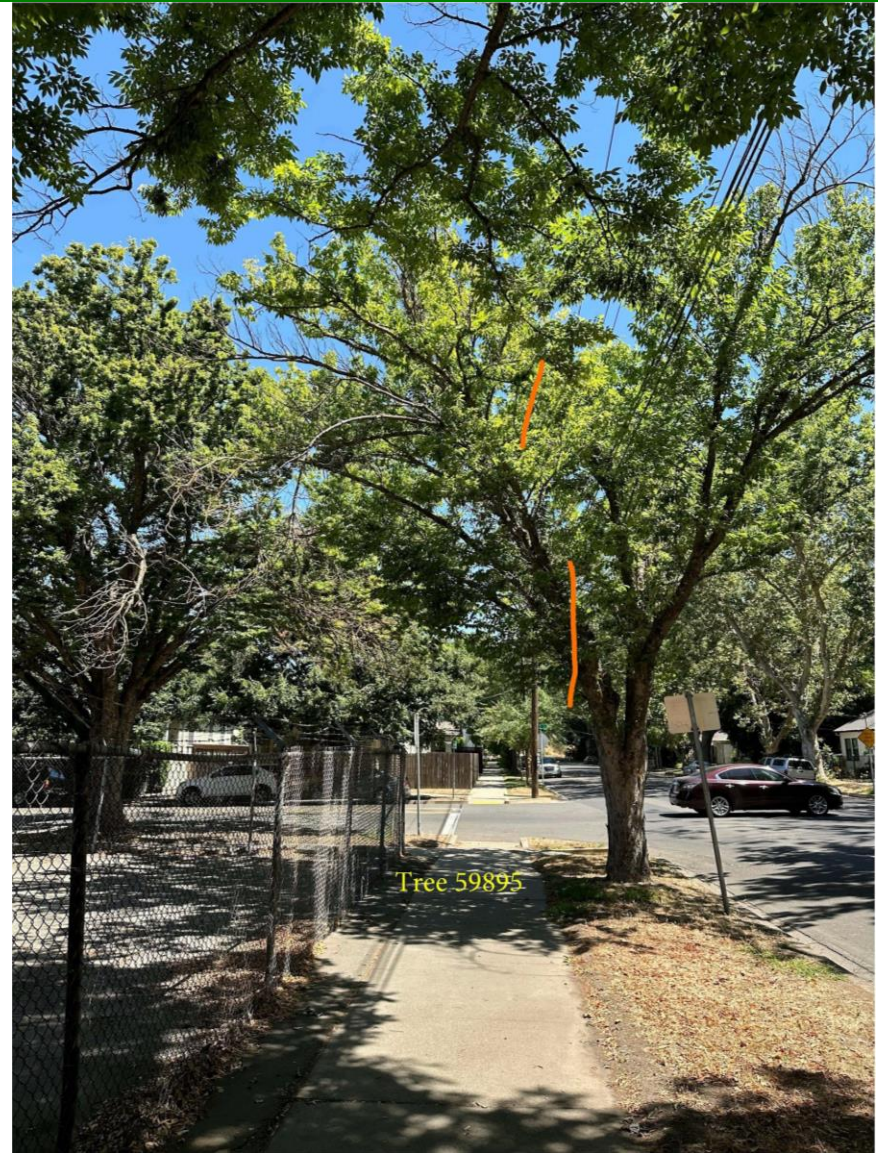
Photo #22, Shows Tree #59895, with pruning cuts

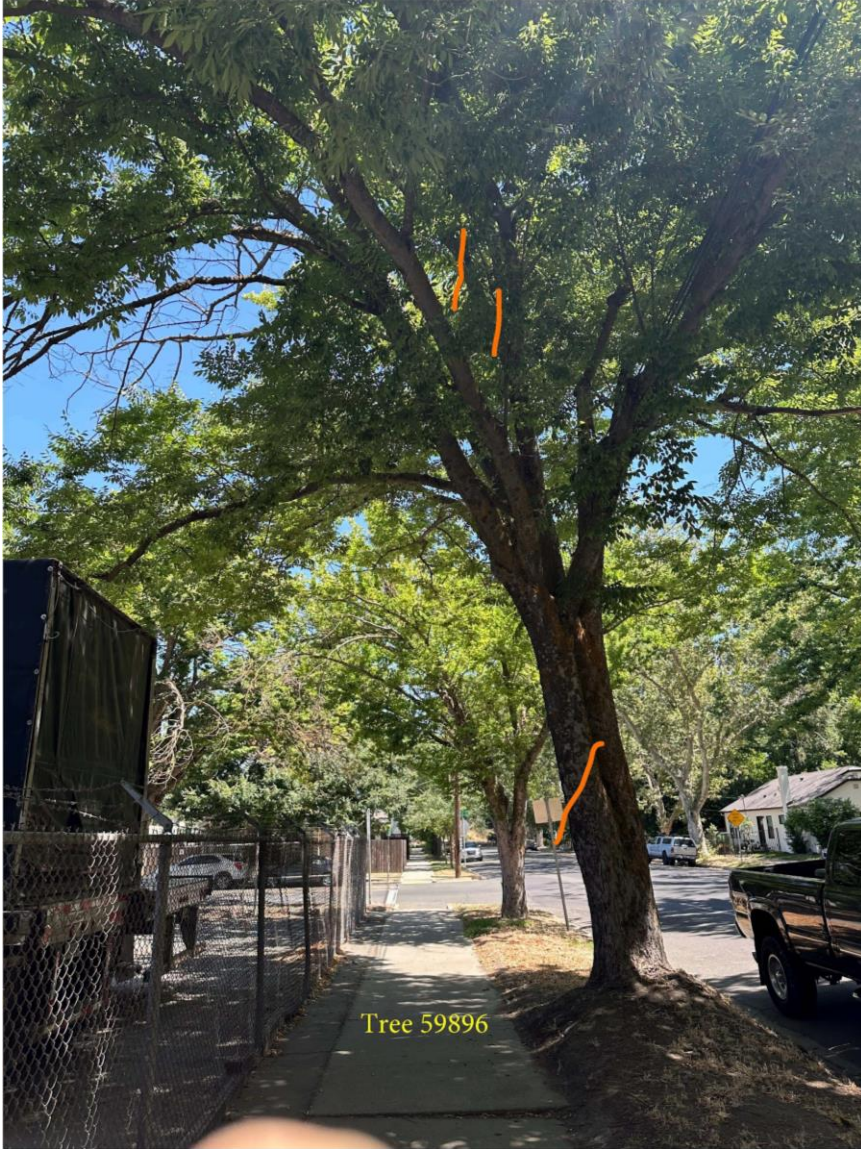
Photo #23, Shows Tree #59896, with pruning cuts

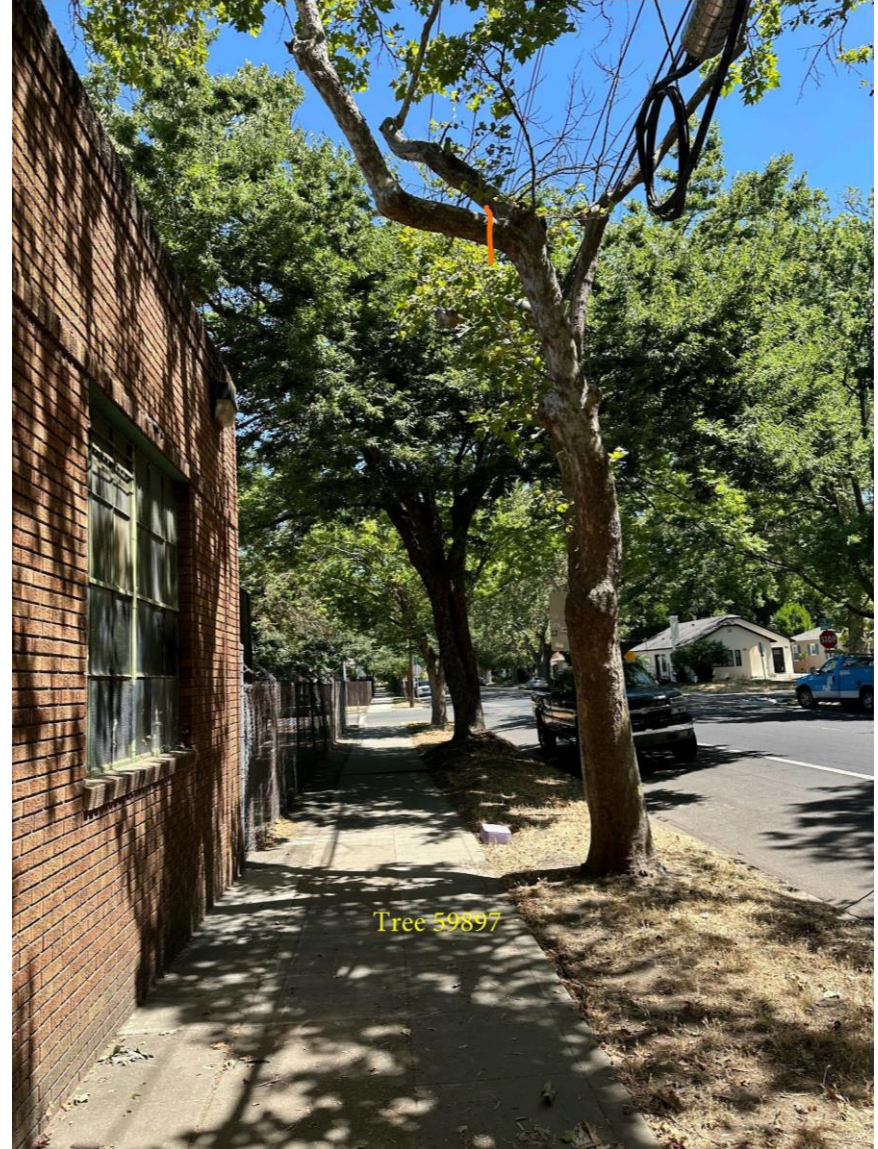
Photo #24, Shows Tree #59897, with pruning cuts

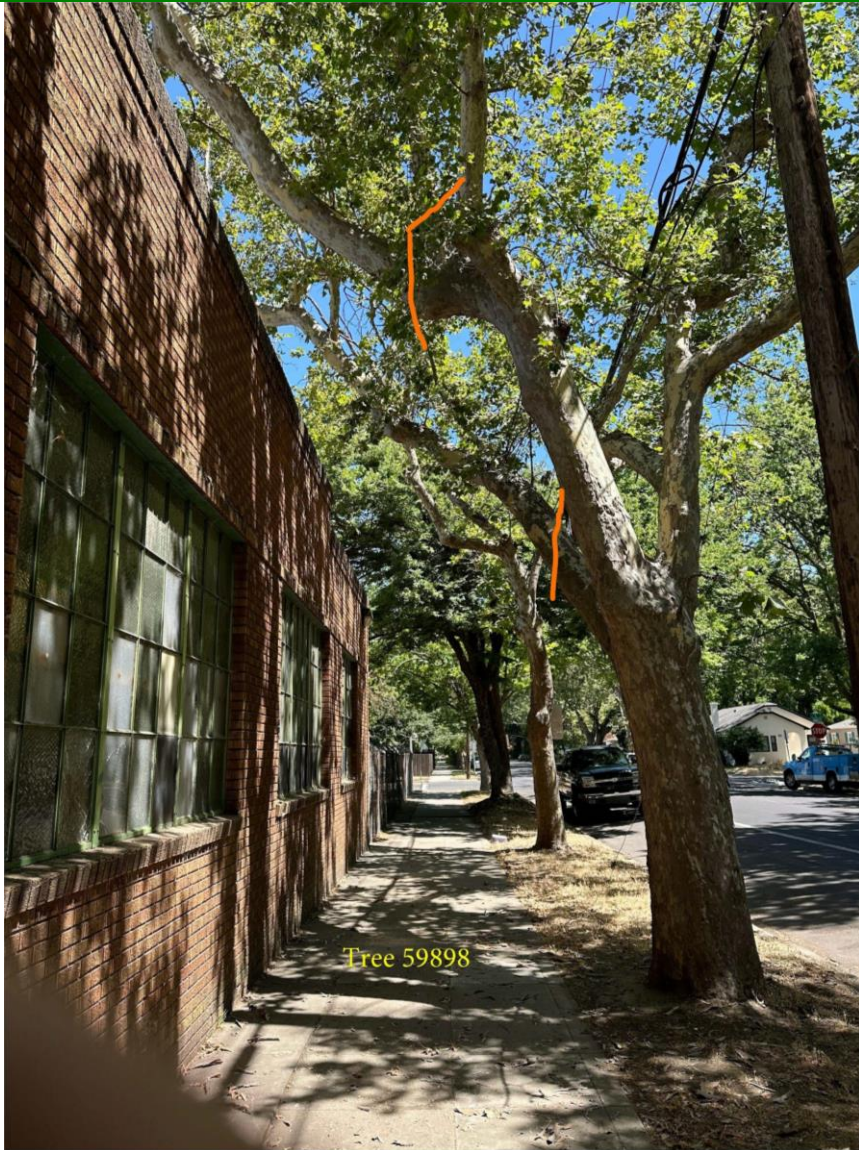
Tree 59898

Photo #25, Shows Tree #59898, with pruning cuts

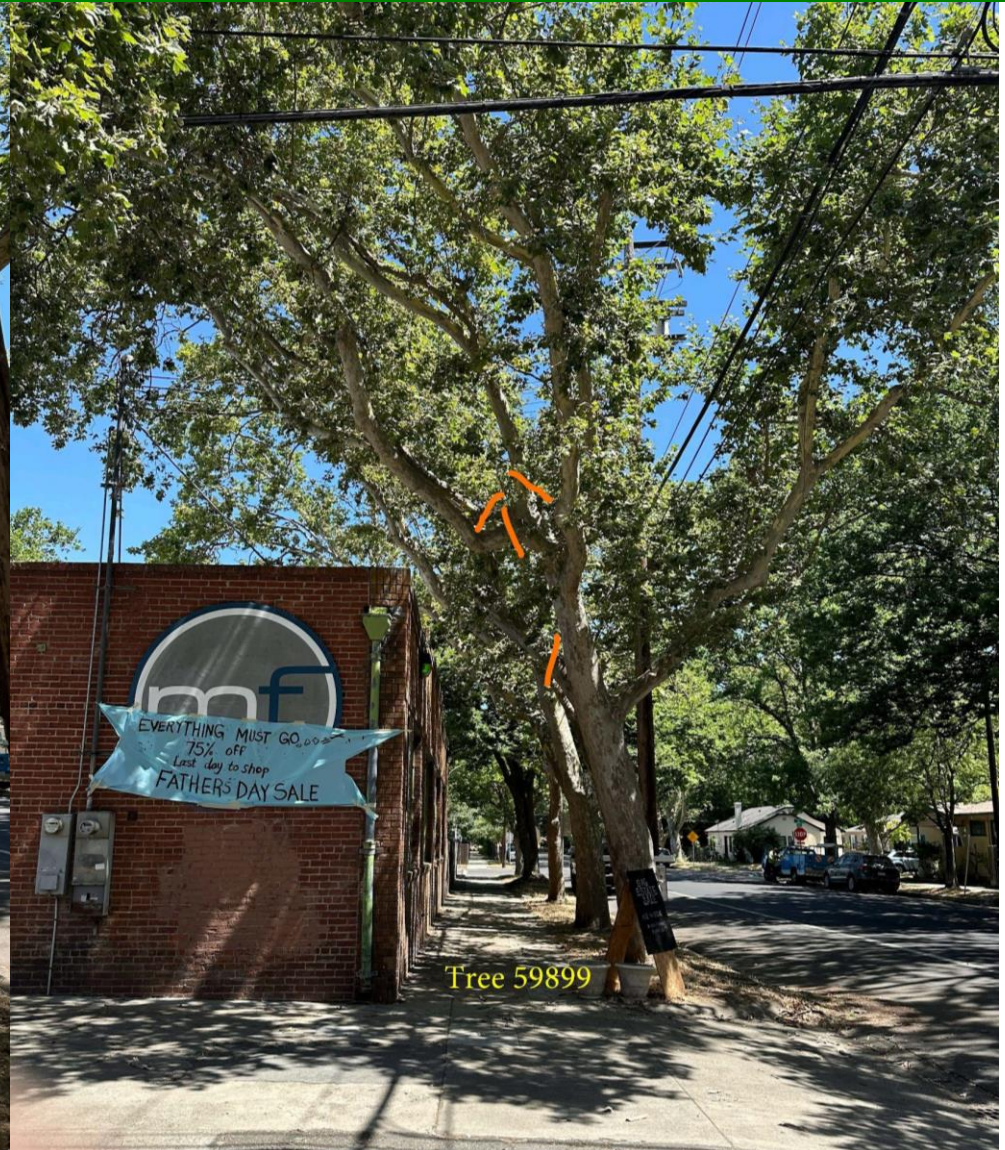
Tree 59899

Photo #26, Shows Tree #59899, with pruning cuts
