California Tree and Landscape Consulting, Inc.

June 20, 2025

RE: AMENDED ARBORIST REPORT FOR CONSTRUCTION AT 1976 EDGEWATER ROAD, SACRAMENTO, CA, APN: 275-0240-077 AND APN: 275-0172-004]

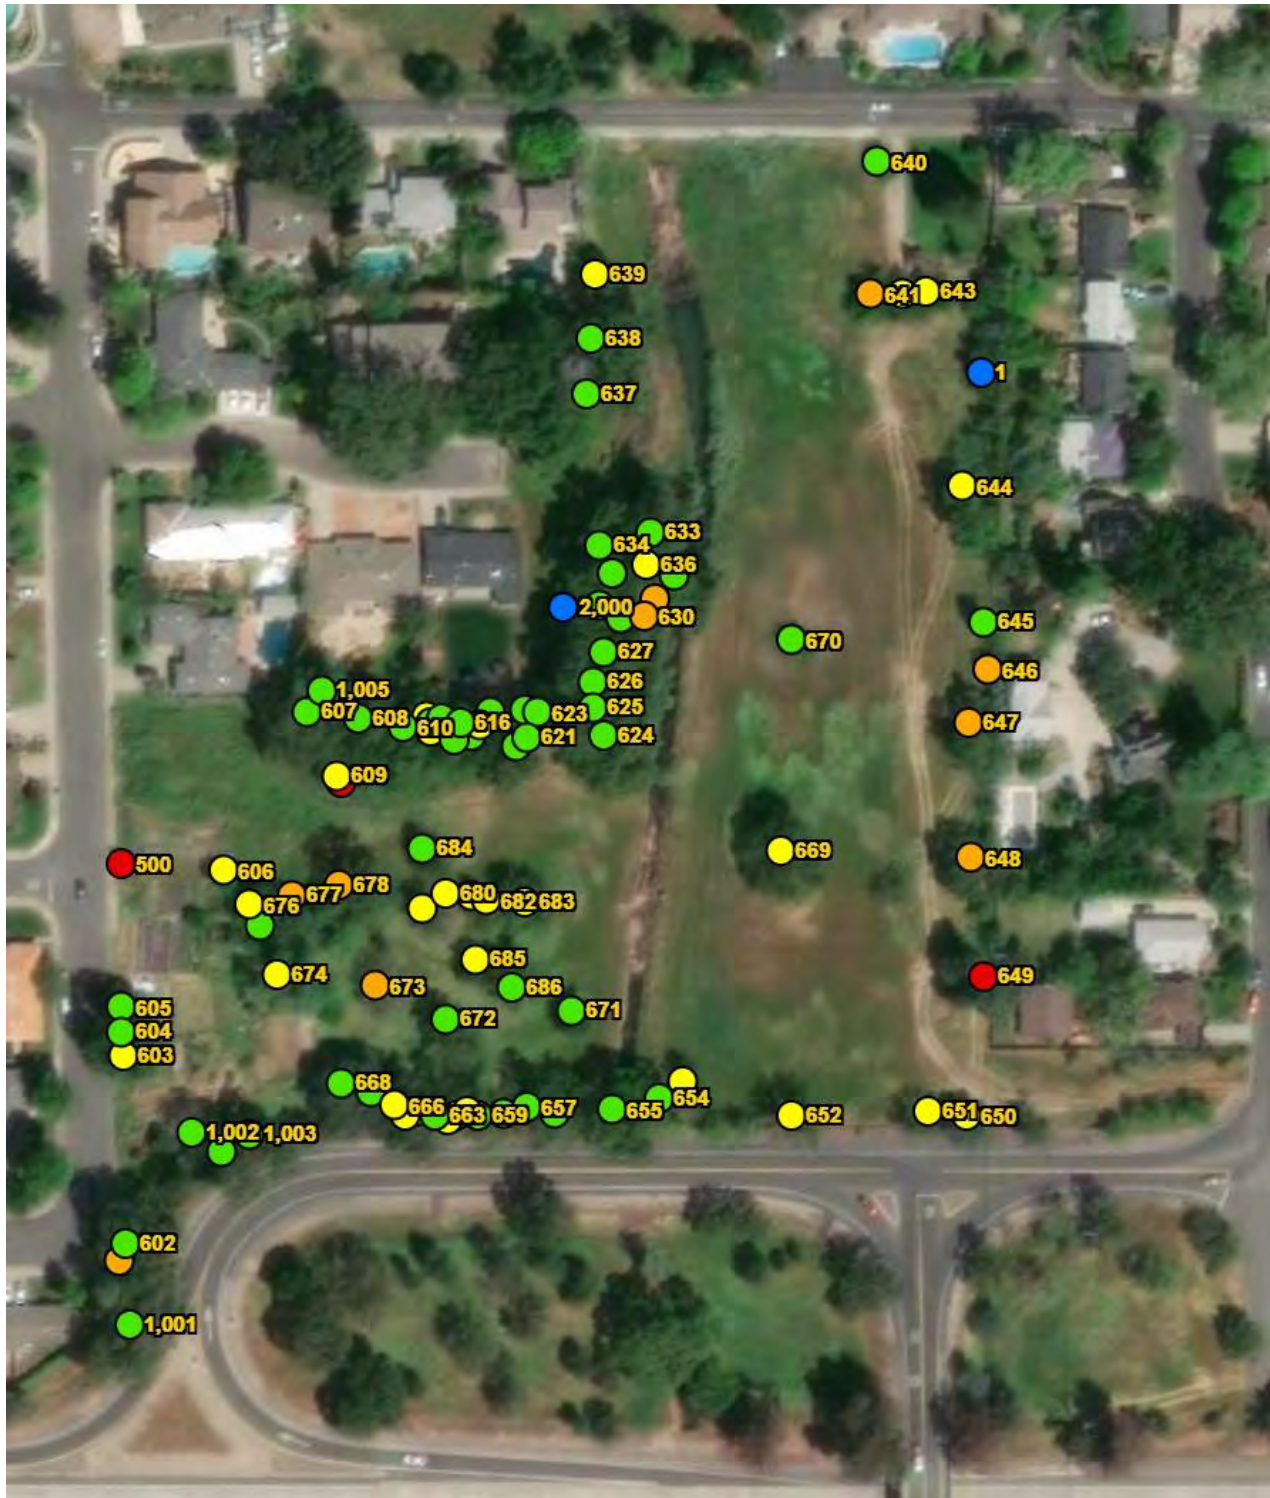
Aerial image of entire site with tree numbers in approximate locations
Green dots are fair condition trees and better; Yellow dots are poor condition trees
Orange dots are very poor condition trees; Red dots are dead trees; Blue dots are undersized trees

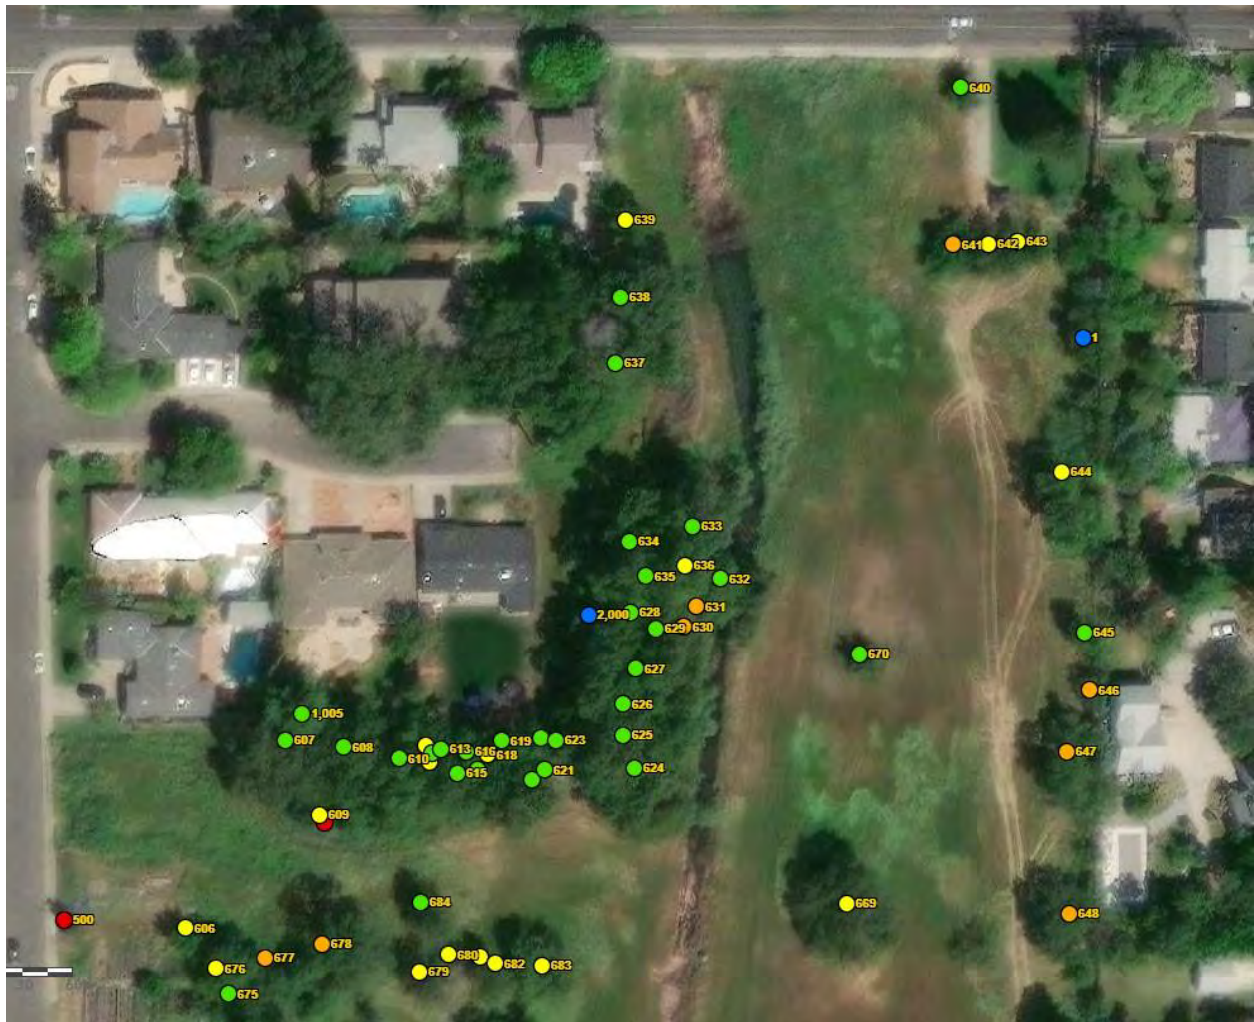
Aerial view of north portion of site enlarged with tree numbers more visible

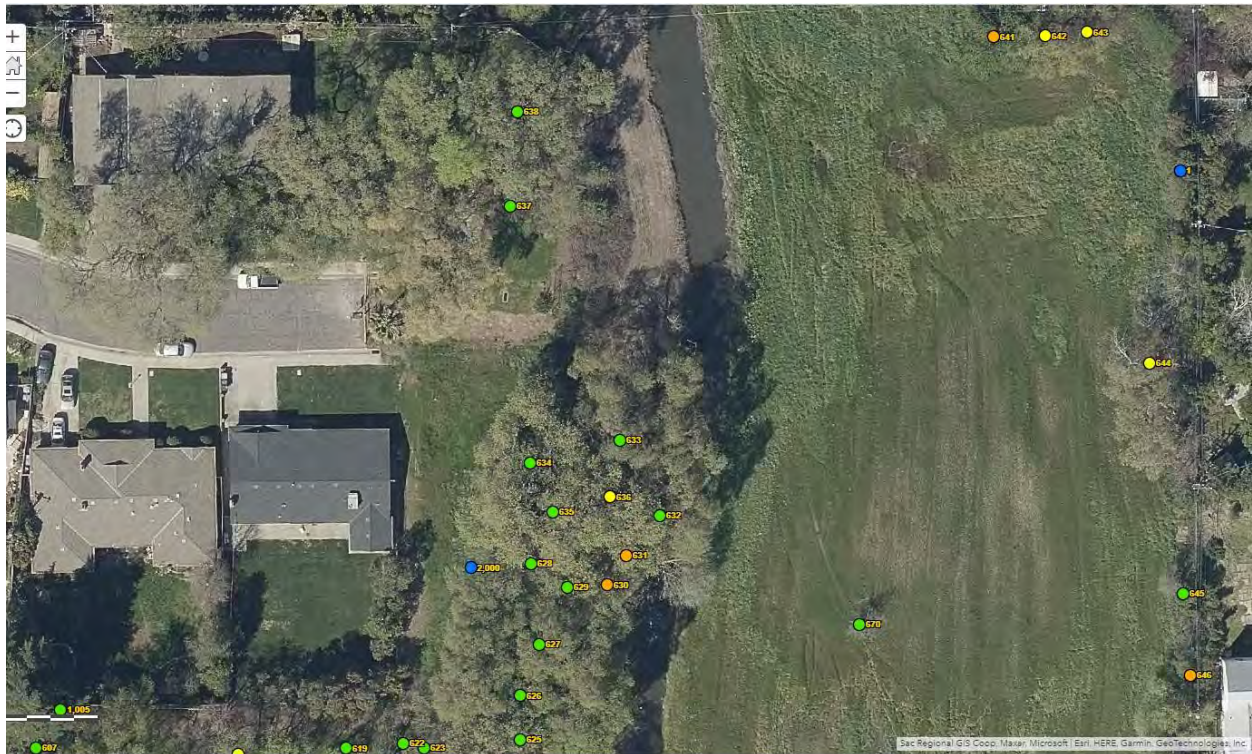
Aerial view of north portion of site further enlarged with tree numbers more visible

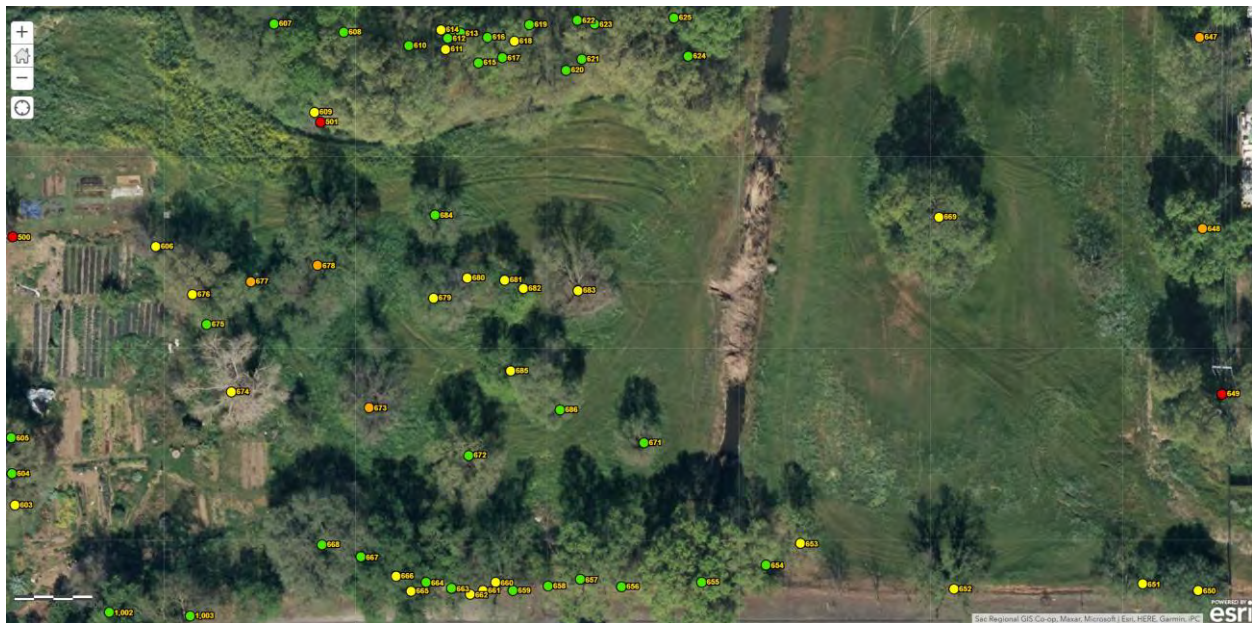
Aerial view of site with southern trees with tree numbers more visible

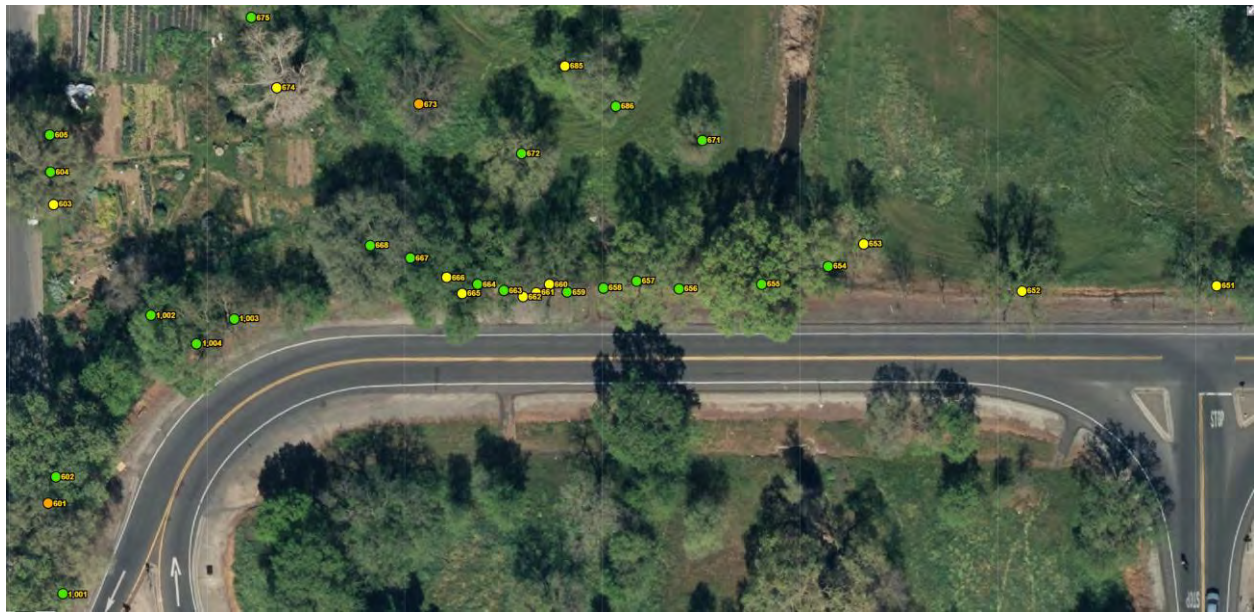
Aerial view of southwest portion of site with tree numbers more visible

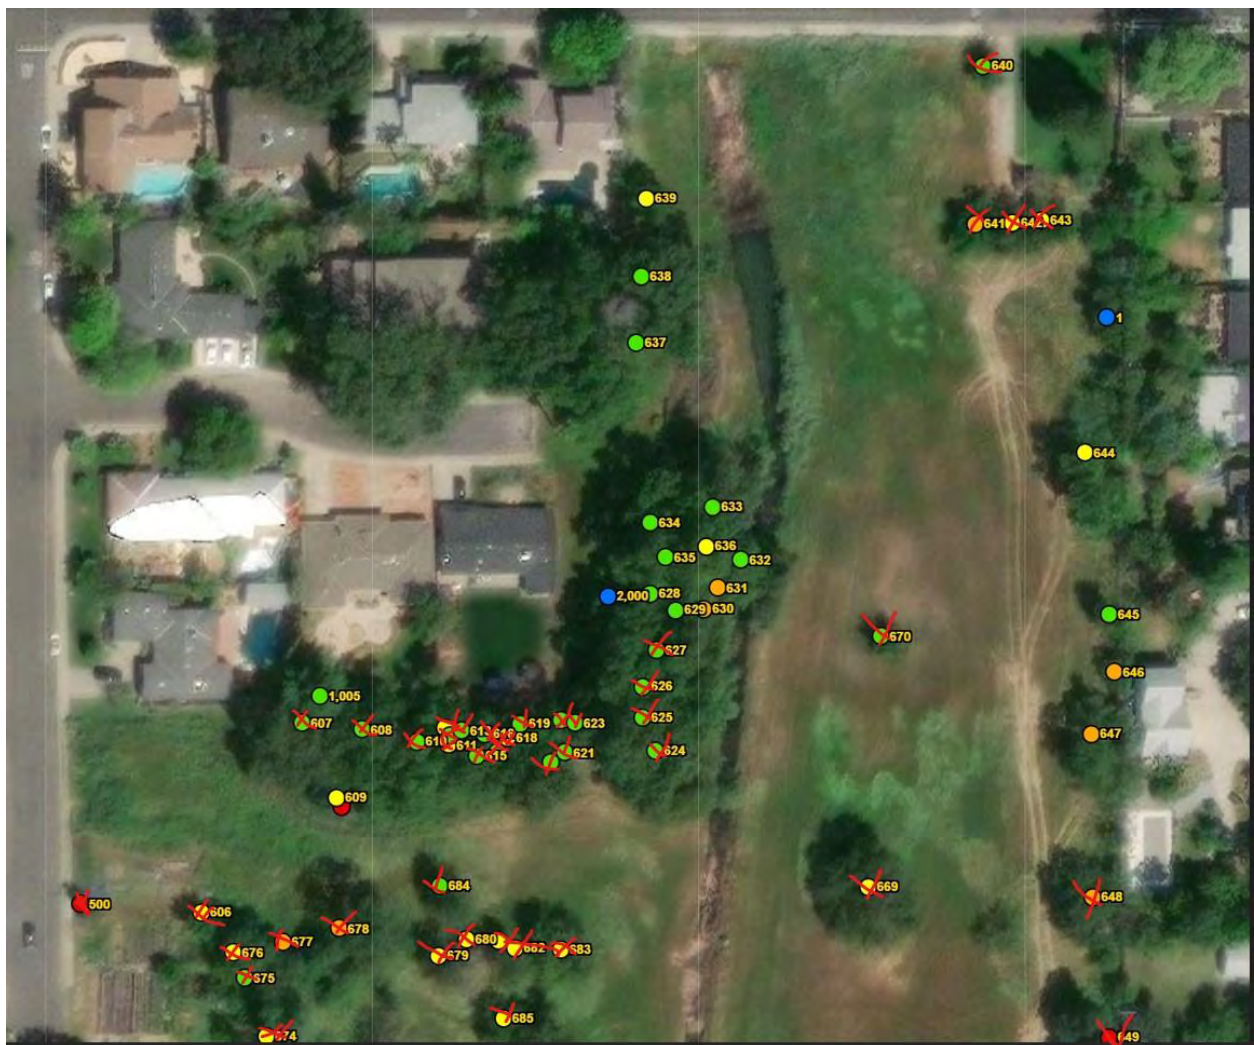
North portion of project area with tree removals shown

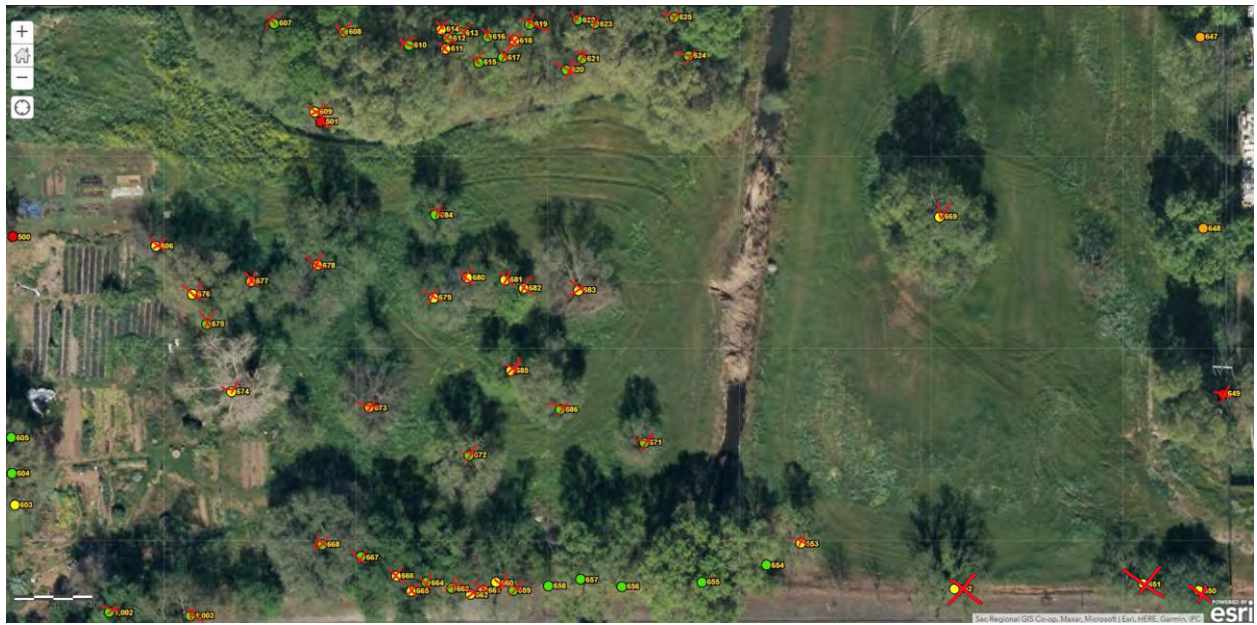
South portion of project area with tree removals shown

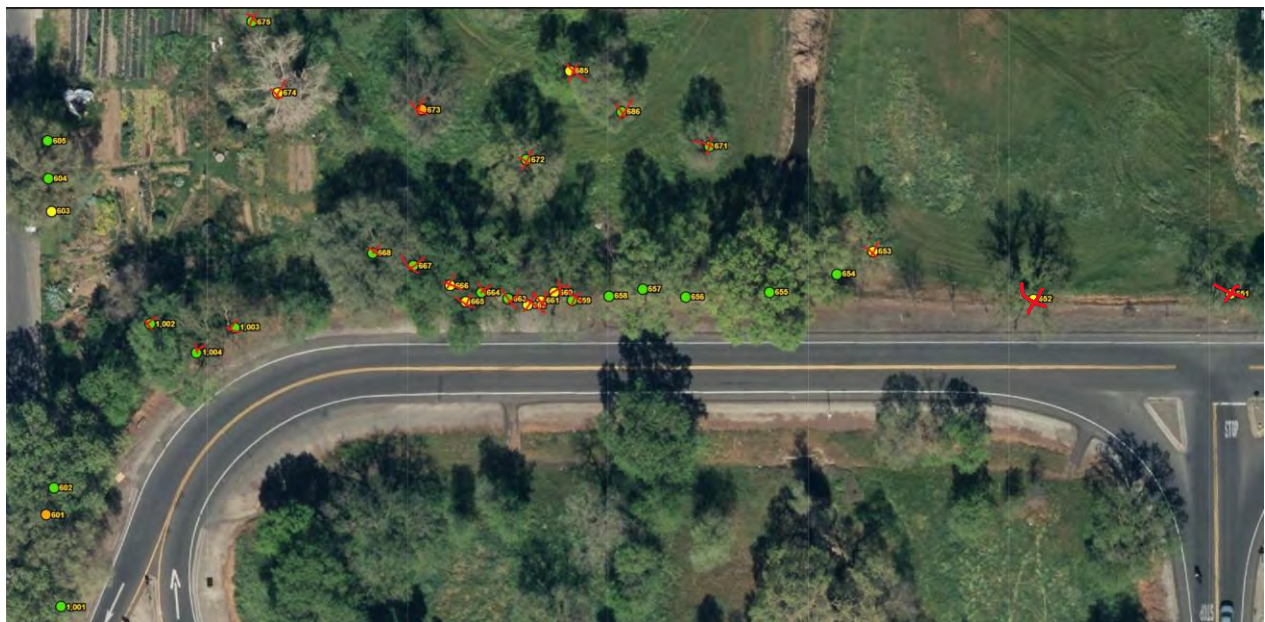
Southwest portion of project area with tree removals shown

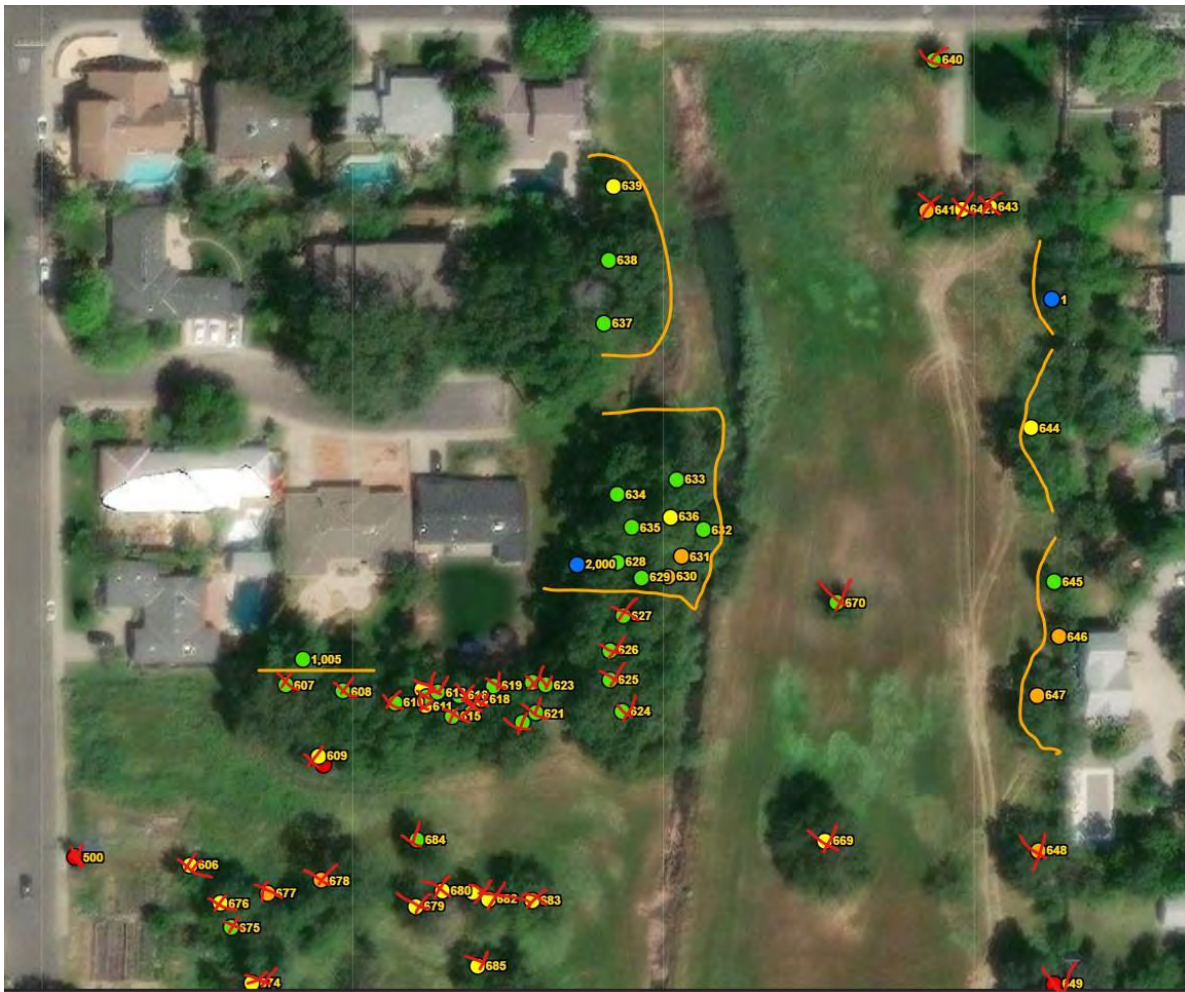
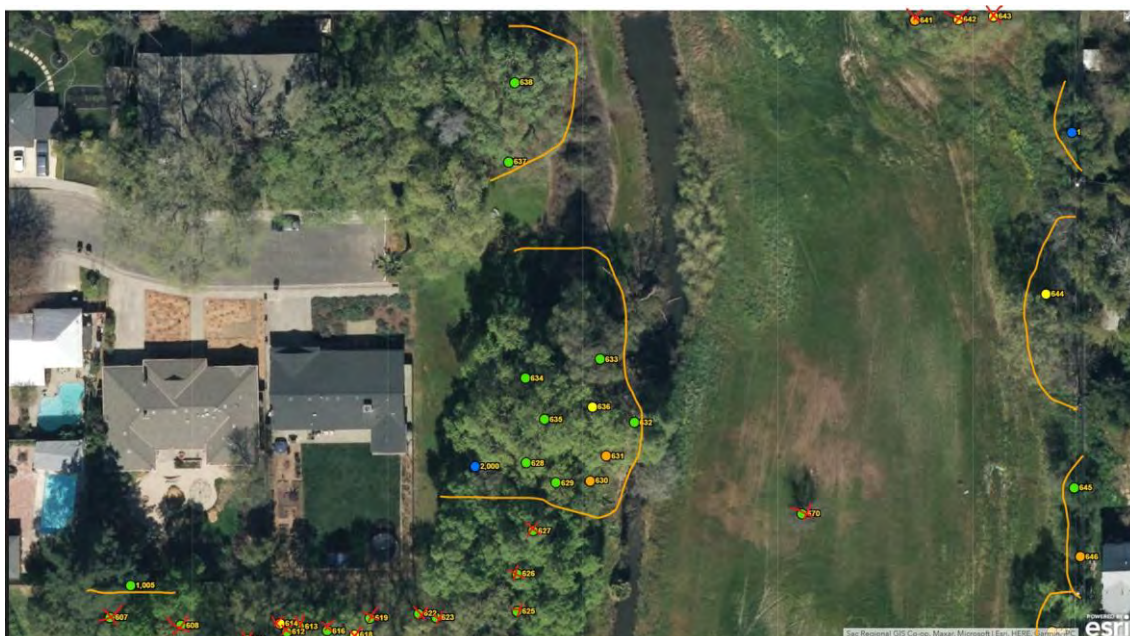
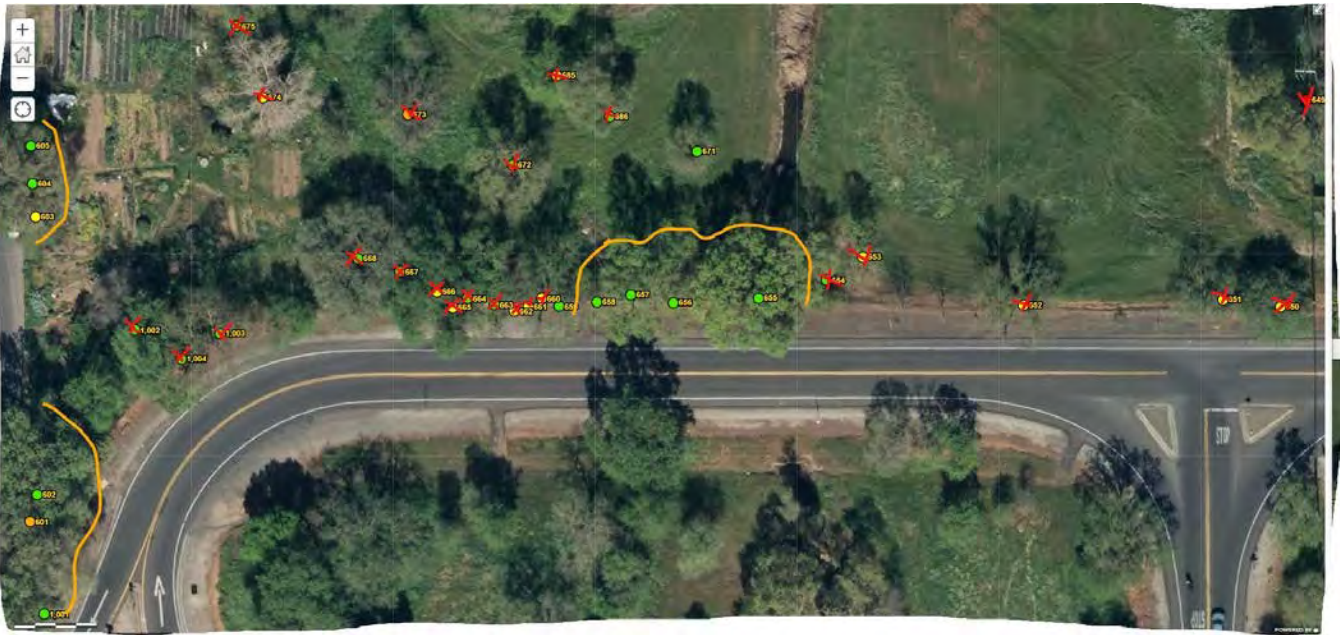
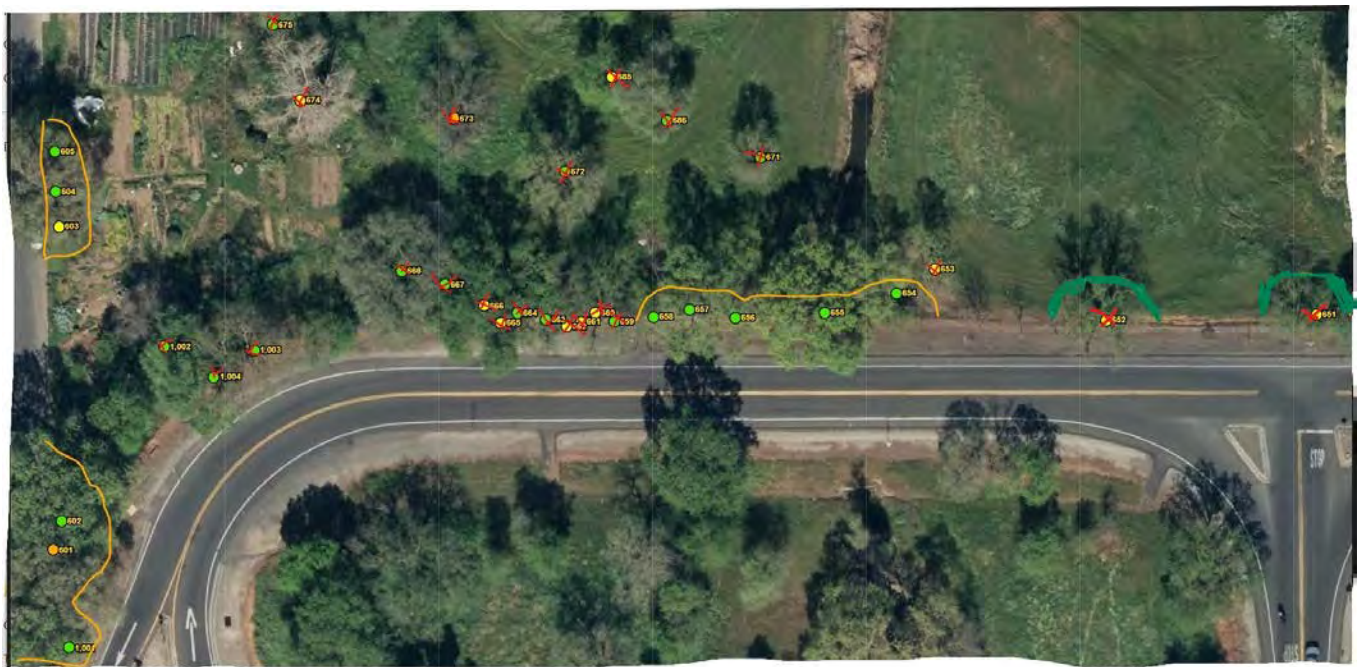
4 above images show Red Xs show trees proposed for removal Orange line shows tree protection fencing
