September 1, 2023

PRELIMINARY ARBORIST REPORT AND TREE INVENTORY

RE: Corporate Way, APN #031-0053-017, #031-0053-028, #031-0053-030; City of Sacramento Jurisdiction

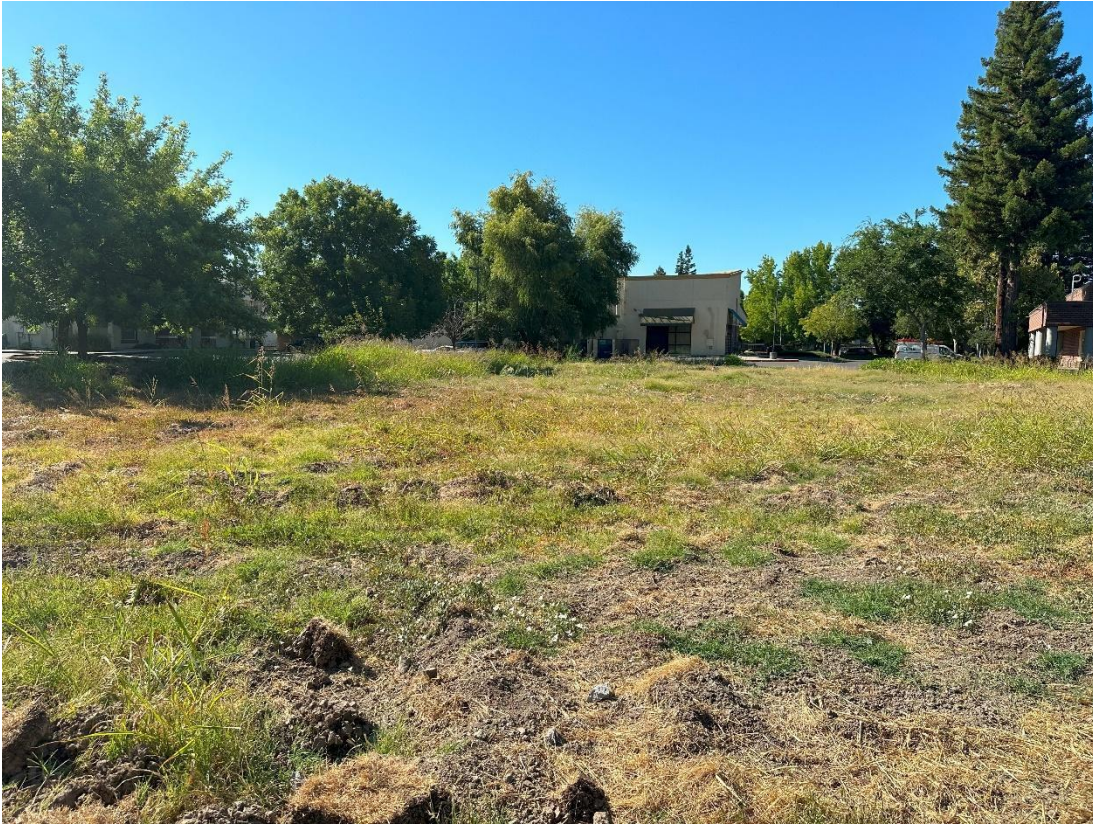
Photo #1, A portion of the site

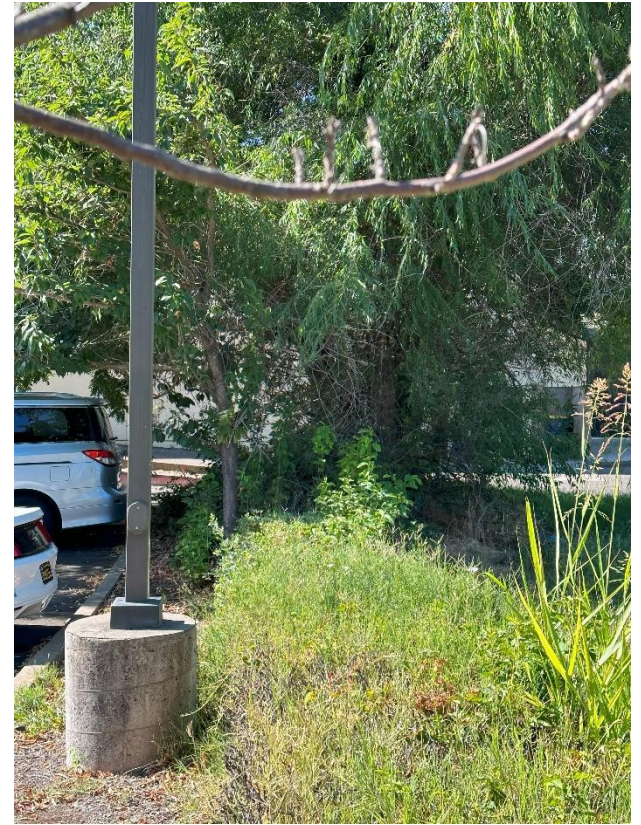
Photo #2, Pepper tree

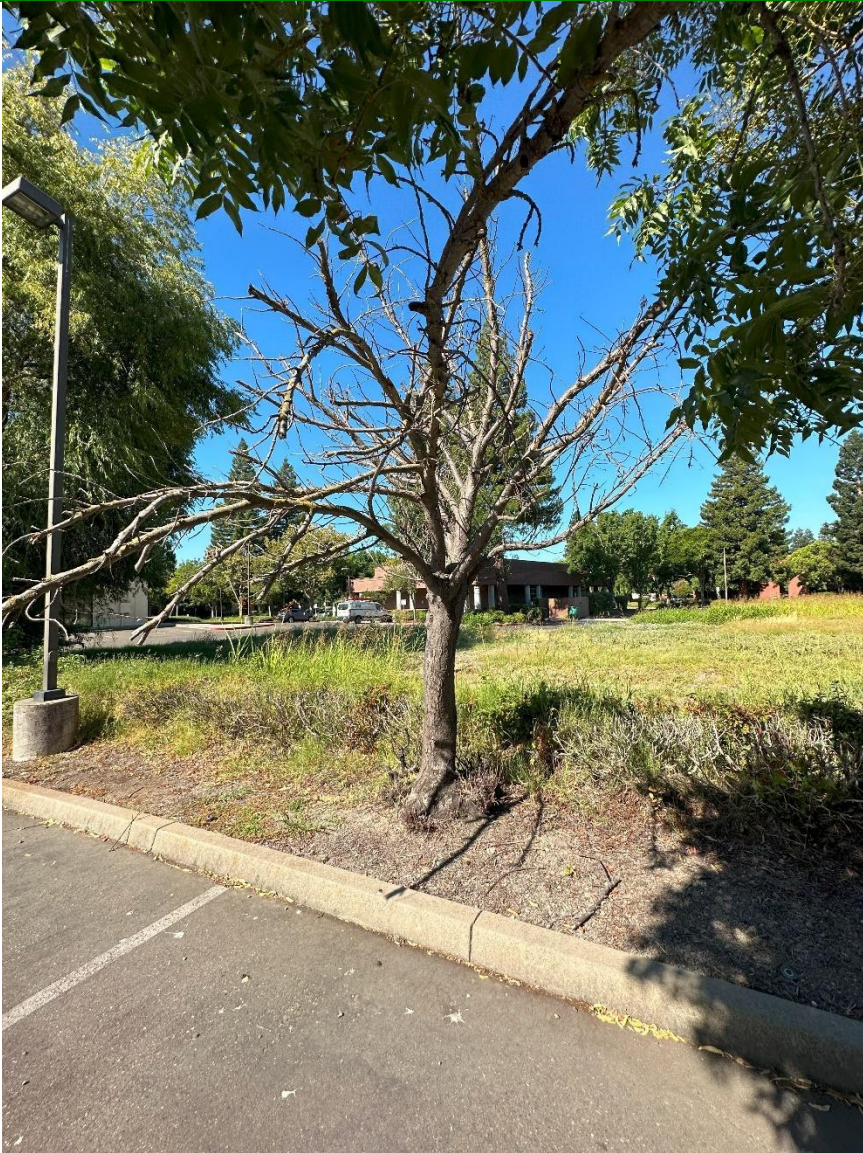
Edwin E. Stirtz, ISA Certified Arborist #WE-0510AM, visited the site on August 9, 2023. A total of 8 trees were evaluated for potential conflicts during development of the parcel. 5 trees may be on the parcel and 3 trees are located offsite. Following evaluation, 1 tree, a dead tree, is recommended for removal.

Photo #3, Dead cherry tree

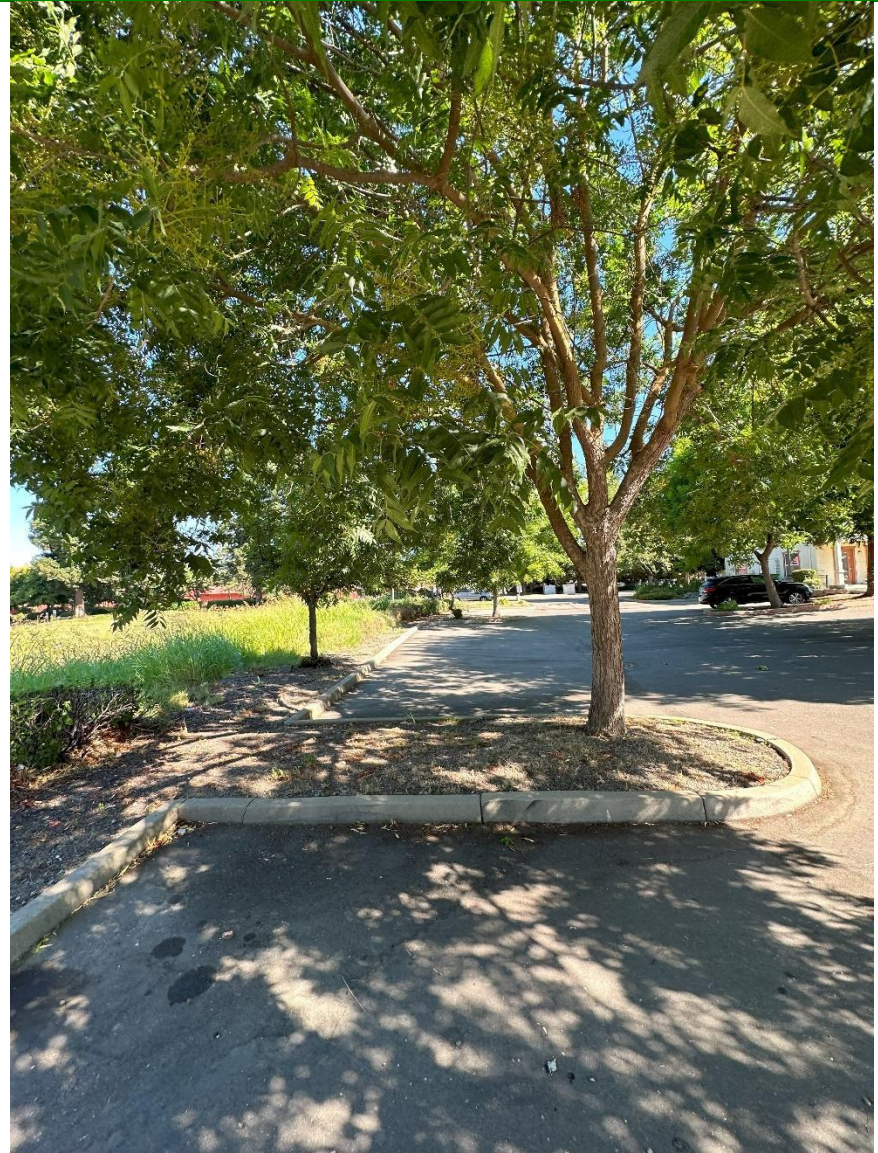
Photo #4, Offsite parking lot tree typical

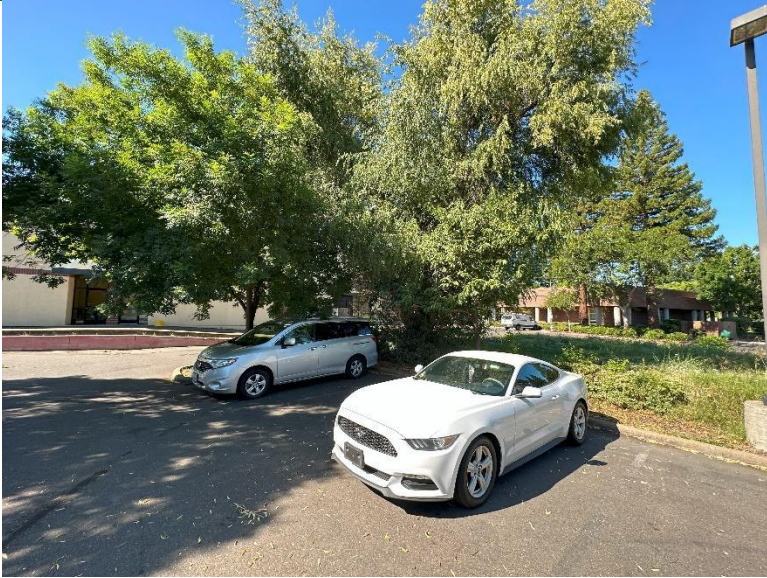
Photo #5, Southeast property corner

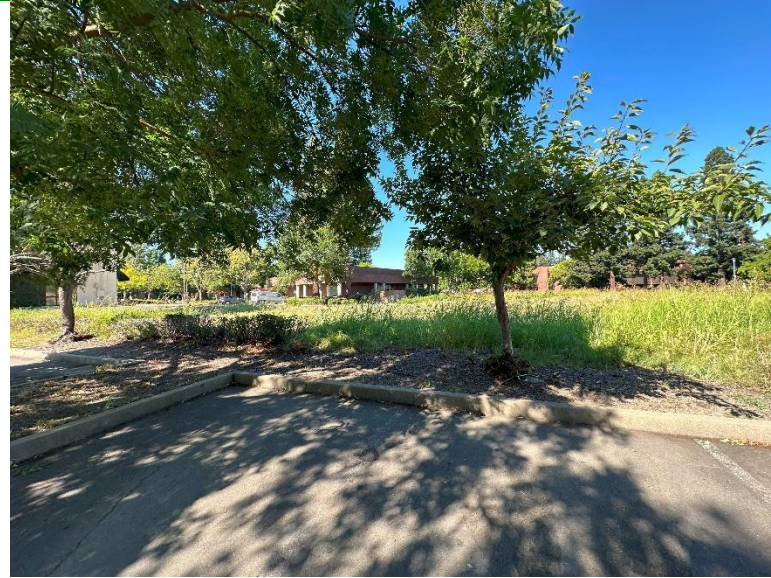
Photo #6, 2 cherry trees

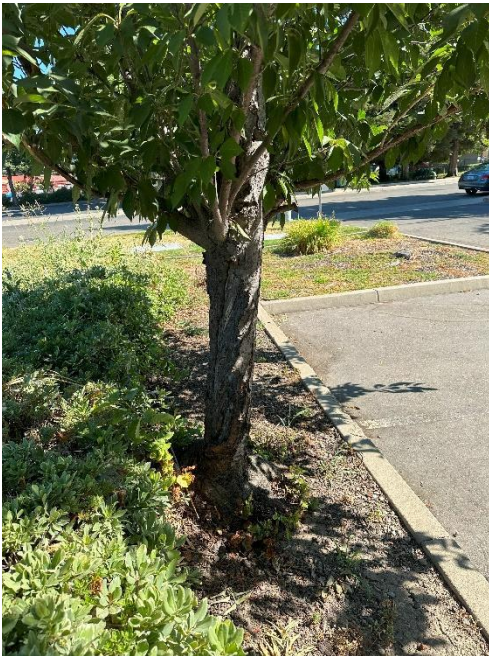
Photo #7, Cherry tree w/ trunk defect

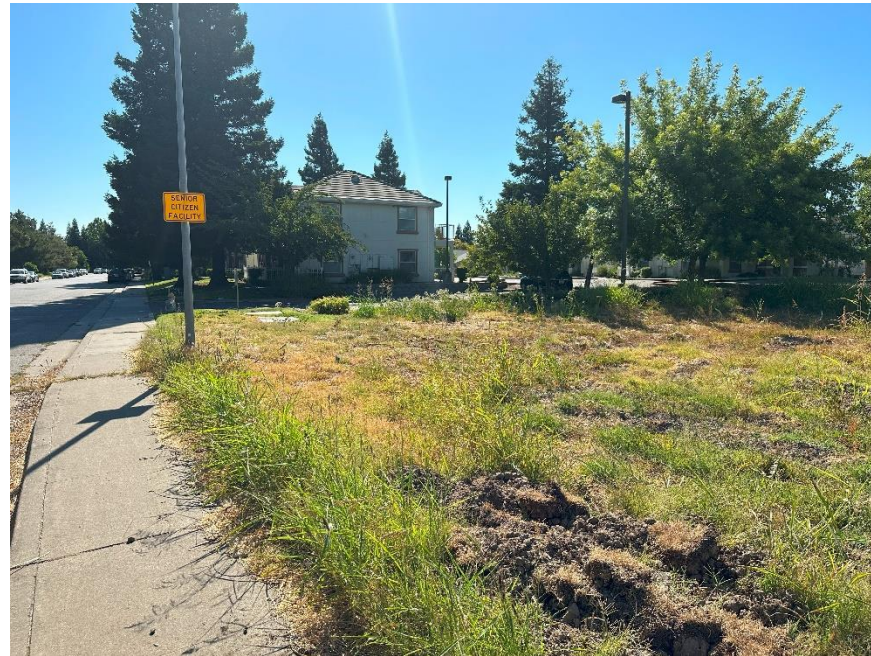
Photo #8, Northeast corner at driveway for 1501 Corporate Way
