OLD SACRAMENTO
RIVERFRONT EMBARCADERO
AND K STREET BARGE
REPAIR PROJECT # PB15-030

APPENDIX

SITE PHOTOS

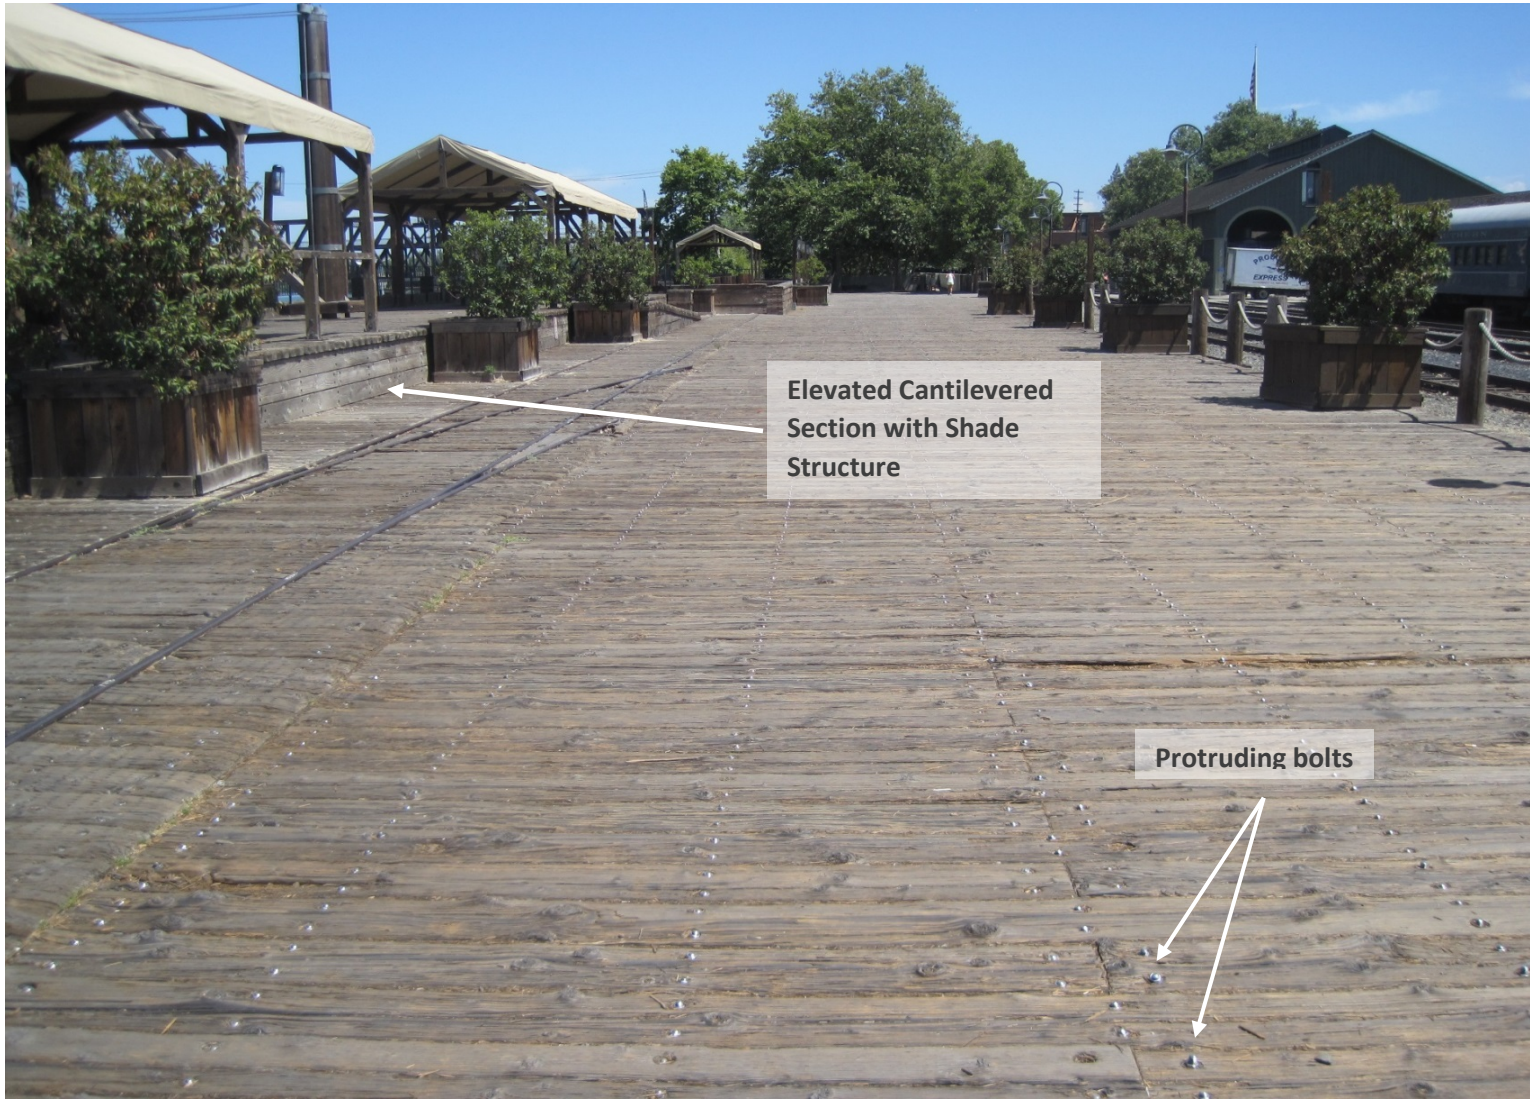
Existing Wood Deck on the Embarcadero with Protruding Bolts.

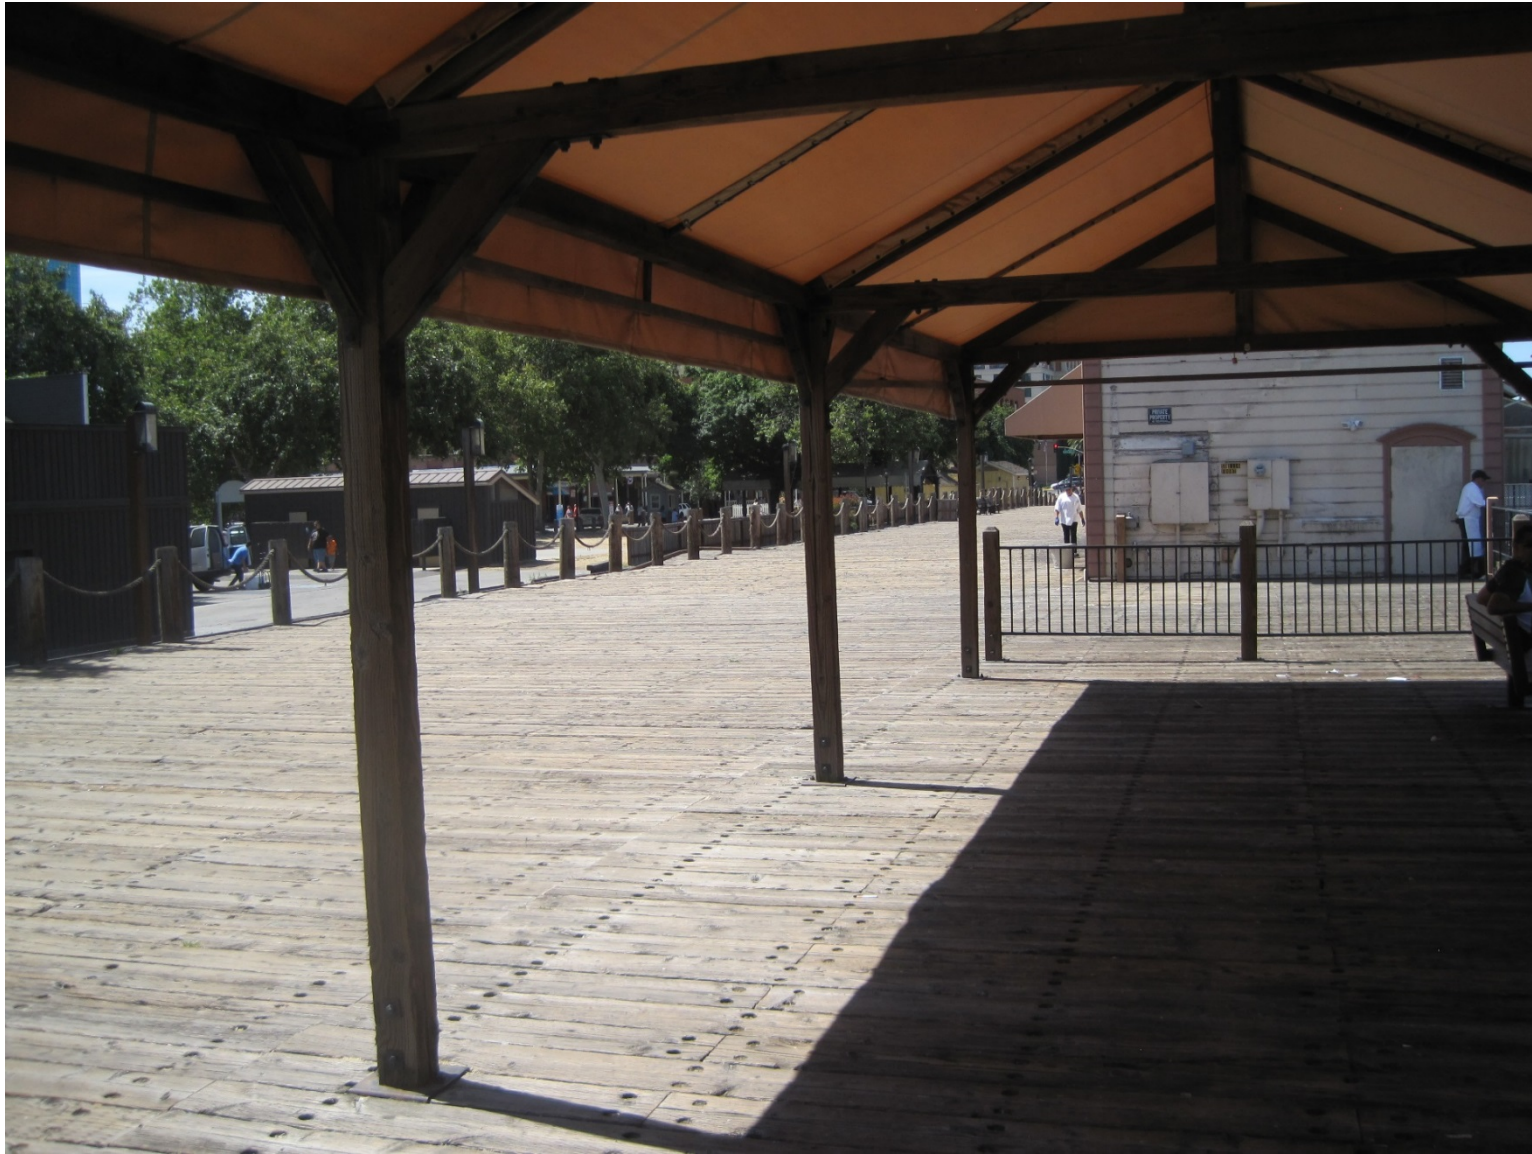
Shade Structure on the Embarcadero Showing Bolted Vertical Supports.

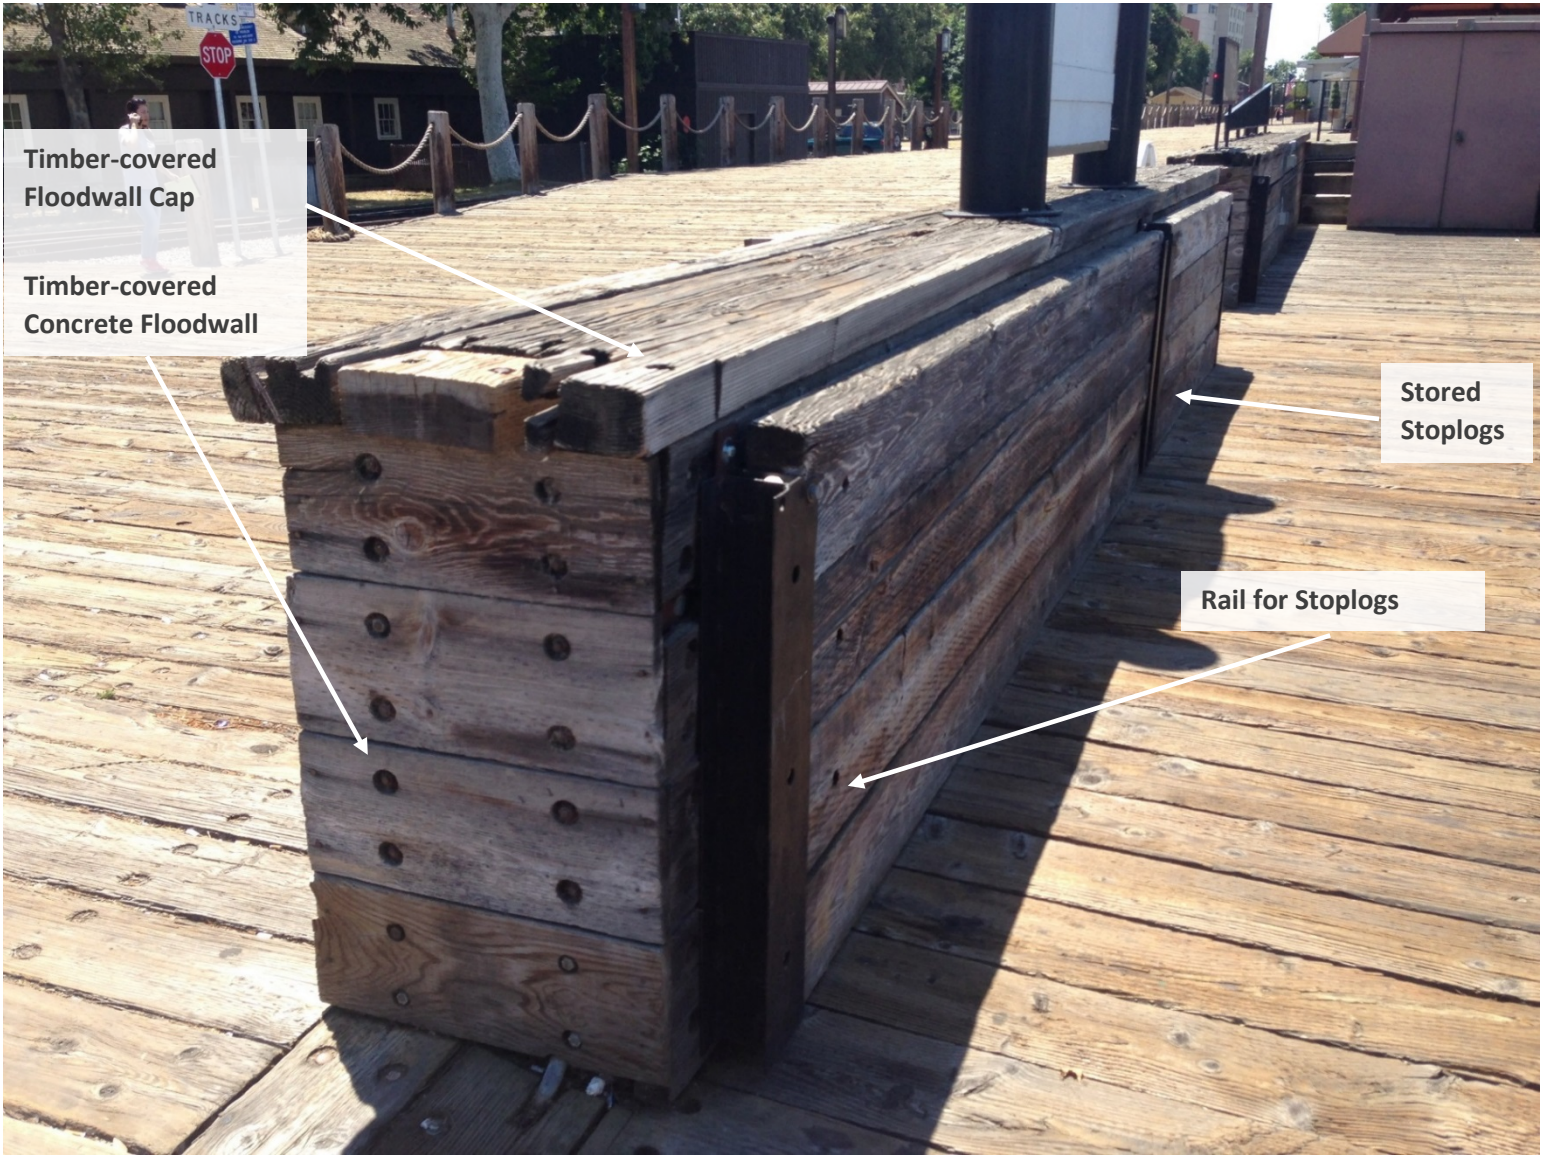
Existing Concrete Floodwall with Timber Fascia and Cap.

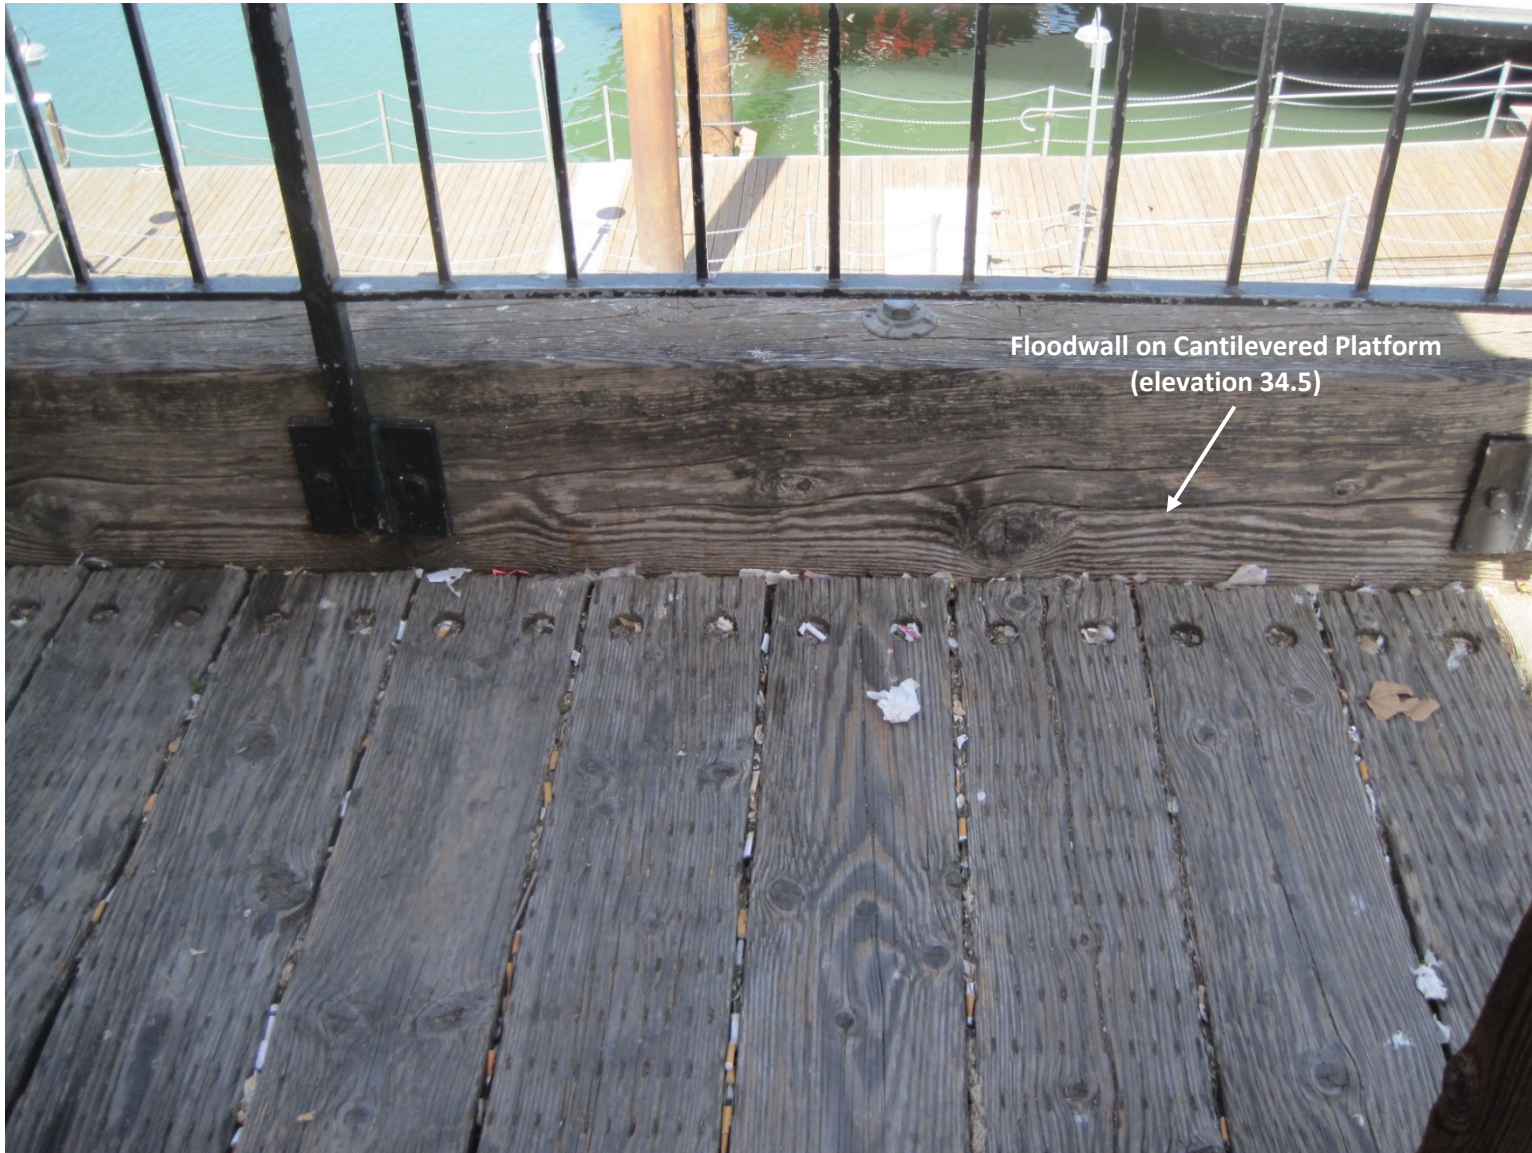
Timber Beam that Forms the Floodwall on the Elevated Embarcadero Sections.

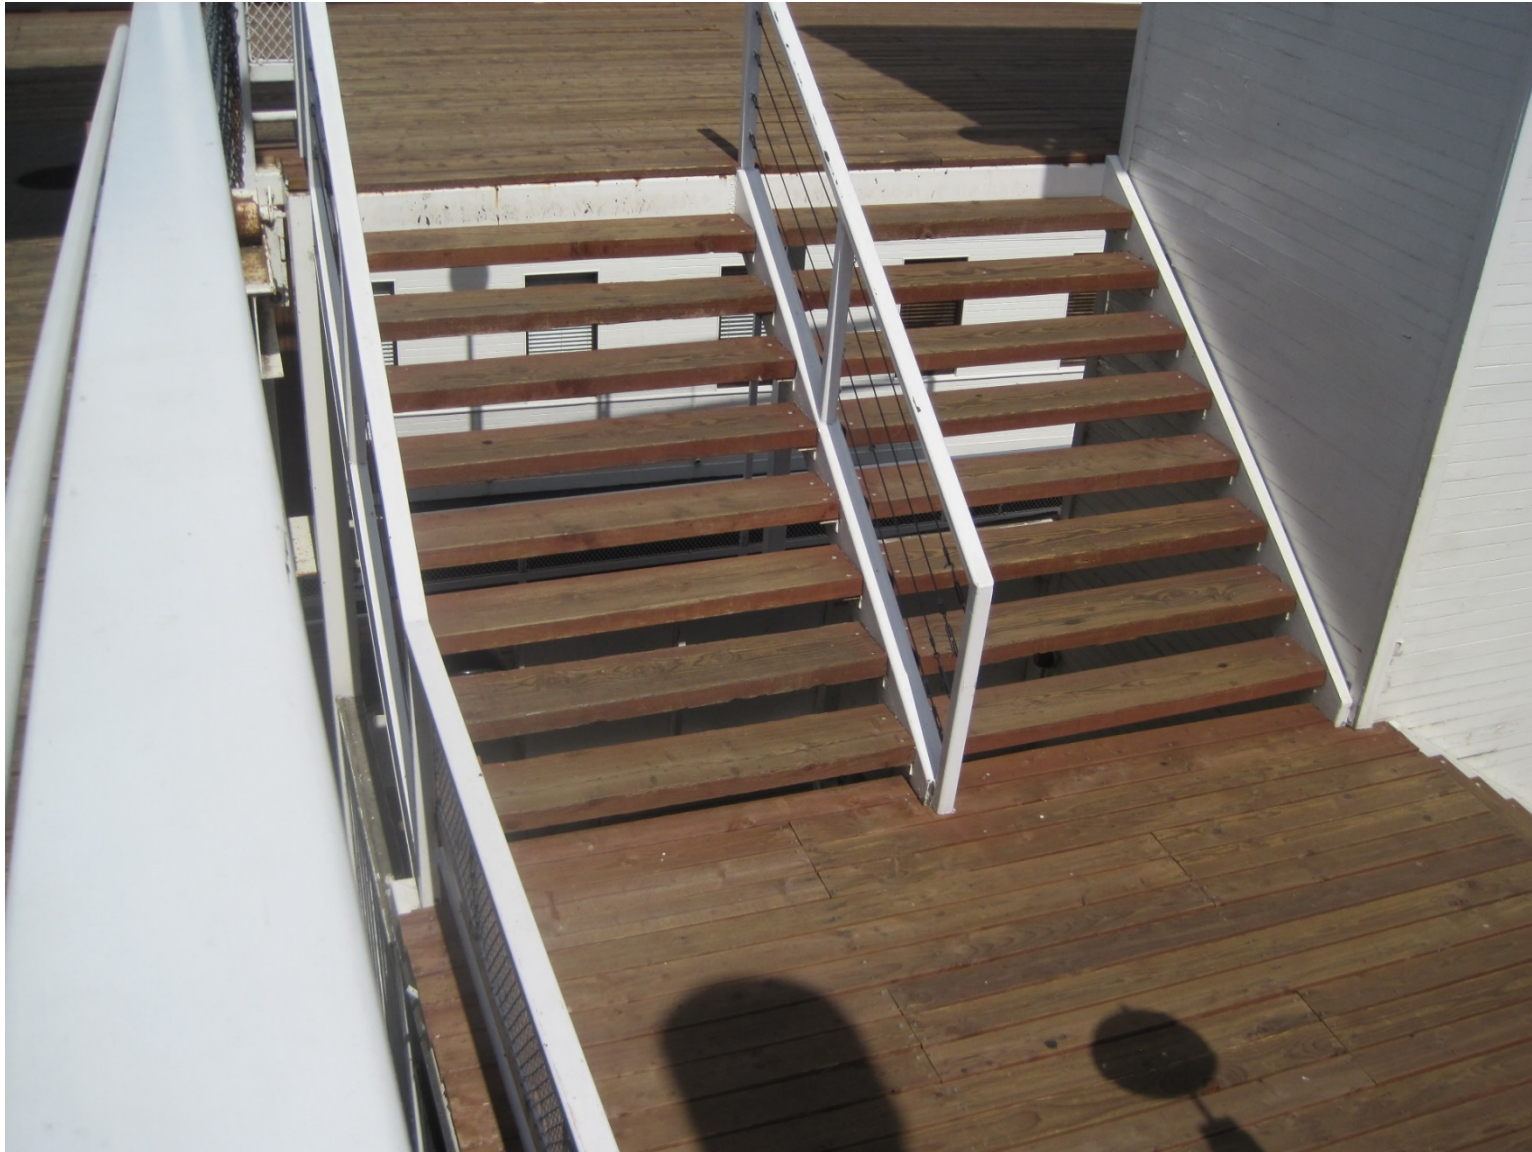
Current Condition of the Stairs.
