Arborist Report

7-Eleven Convenience Store and Fuel Station, Power Inn Road and Elder Creek Road

City of Sacramento, California 95828

July 26, 2025

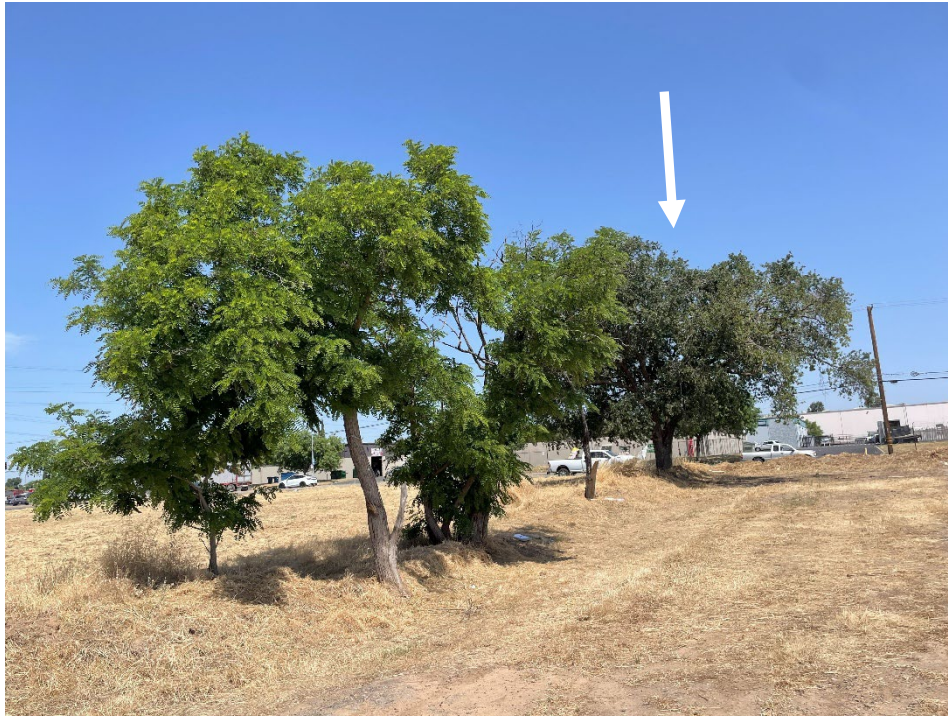
Photo 1. View of a line of trees in the former developed area in the northern portion of the Study Area. Tree# 2181, a protected valley oak, is visible in the background (white arrow). The other trees are non-native black locust trees, including some trees less than 4 inches DSH as well as Tree# 2182 and Tree# 2183. Photo taken May 16, 2025.

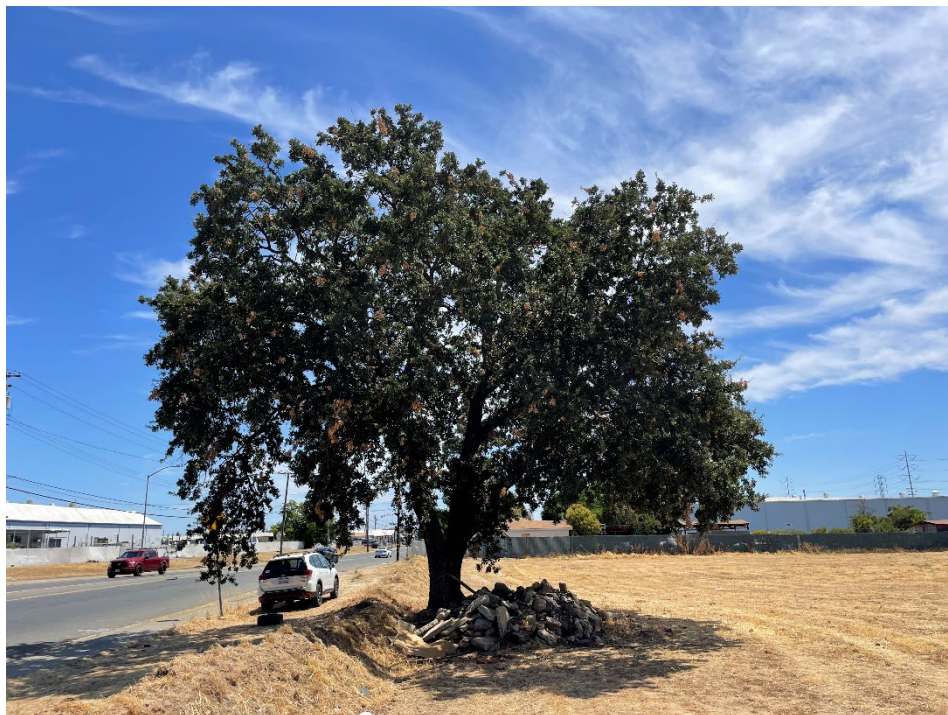
Photo 2. View of Tree# 2180, a large valley oak adjacent to Elder Creek Road. The tree is growing adjacent to a constructed berm along the road and has a debris pile at its base.

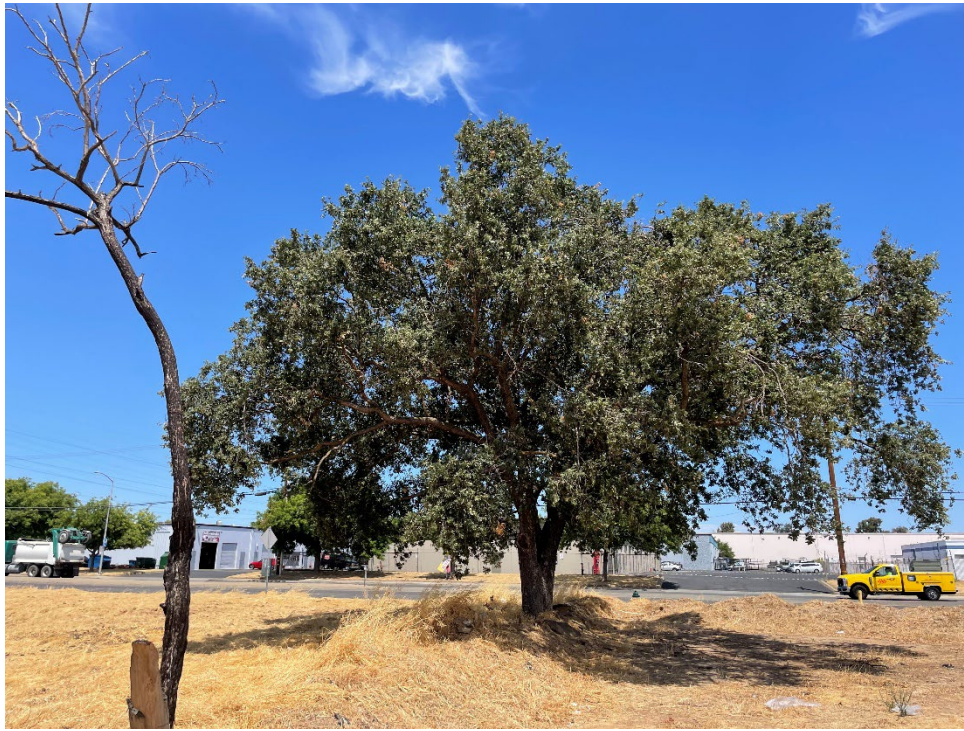
Photo 3. Close up view of Tree# 2181, a valley oak growing in a berm in the former developed portion of the site.

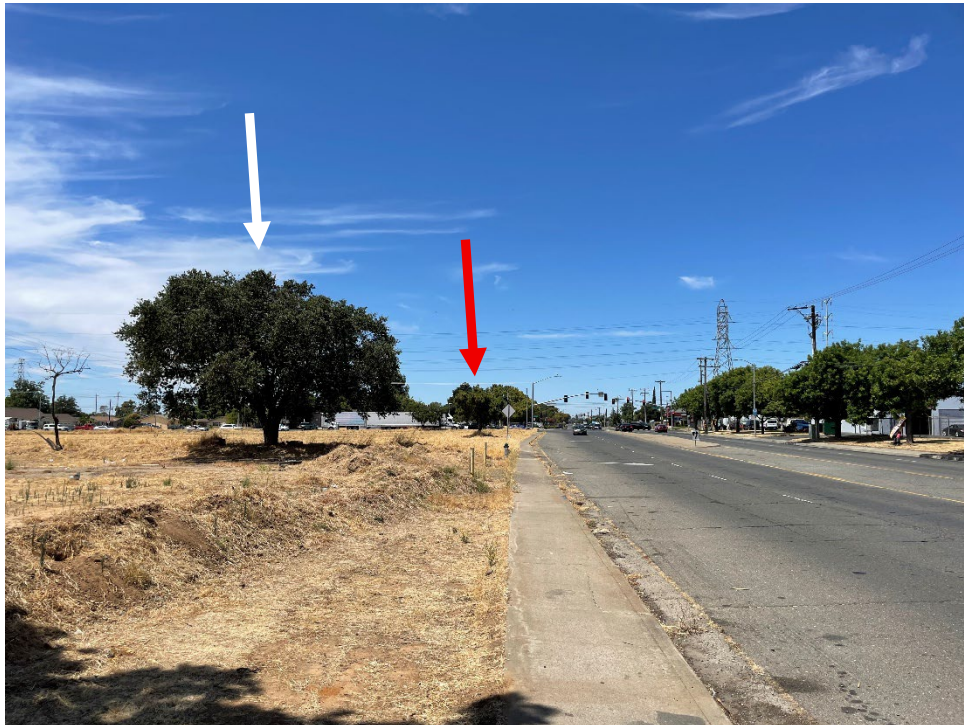
Photo 4. View looking west along Elder Creek Road along the northern boundary of the Study Area. The white arrow is pointing to Tree# 2181, a large valley oak, and the red arrow is pointing to Tree# 2184, a relatively small Italian stone pine.
