OLD SACRAMENTO RIVERFRONT EMBARCADERO AND K STREET BARGE REPAIR PROJECT # PB15-030

### **Construction Activities for the Embarcadero Material Replacement Project**

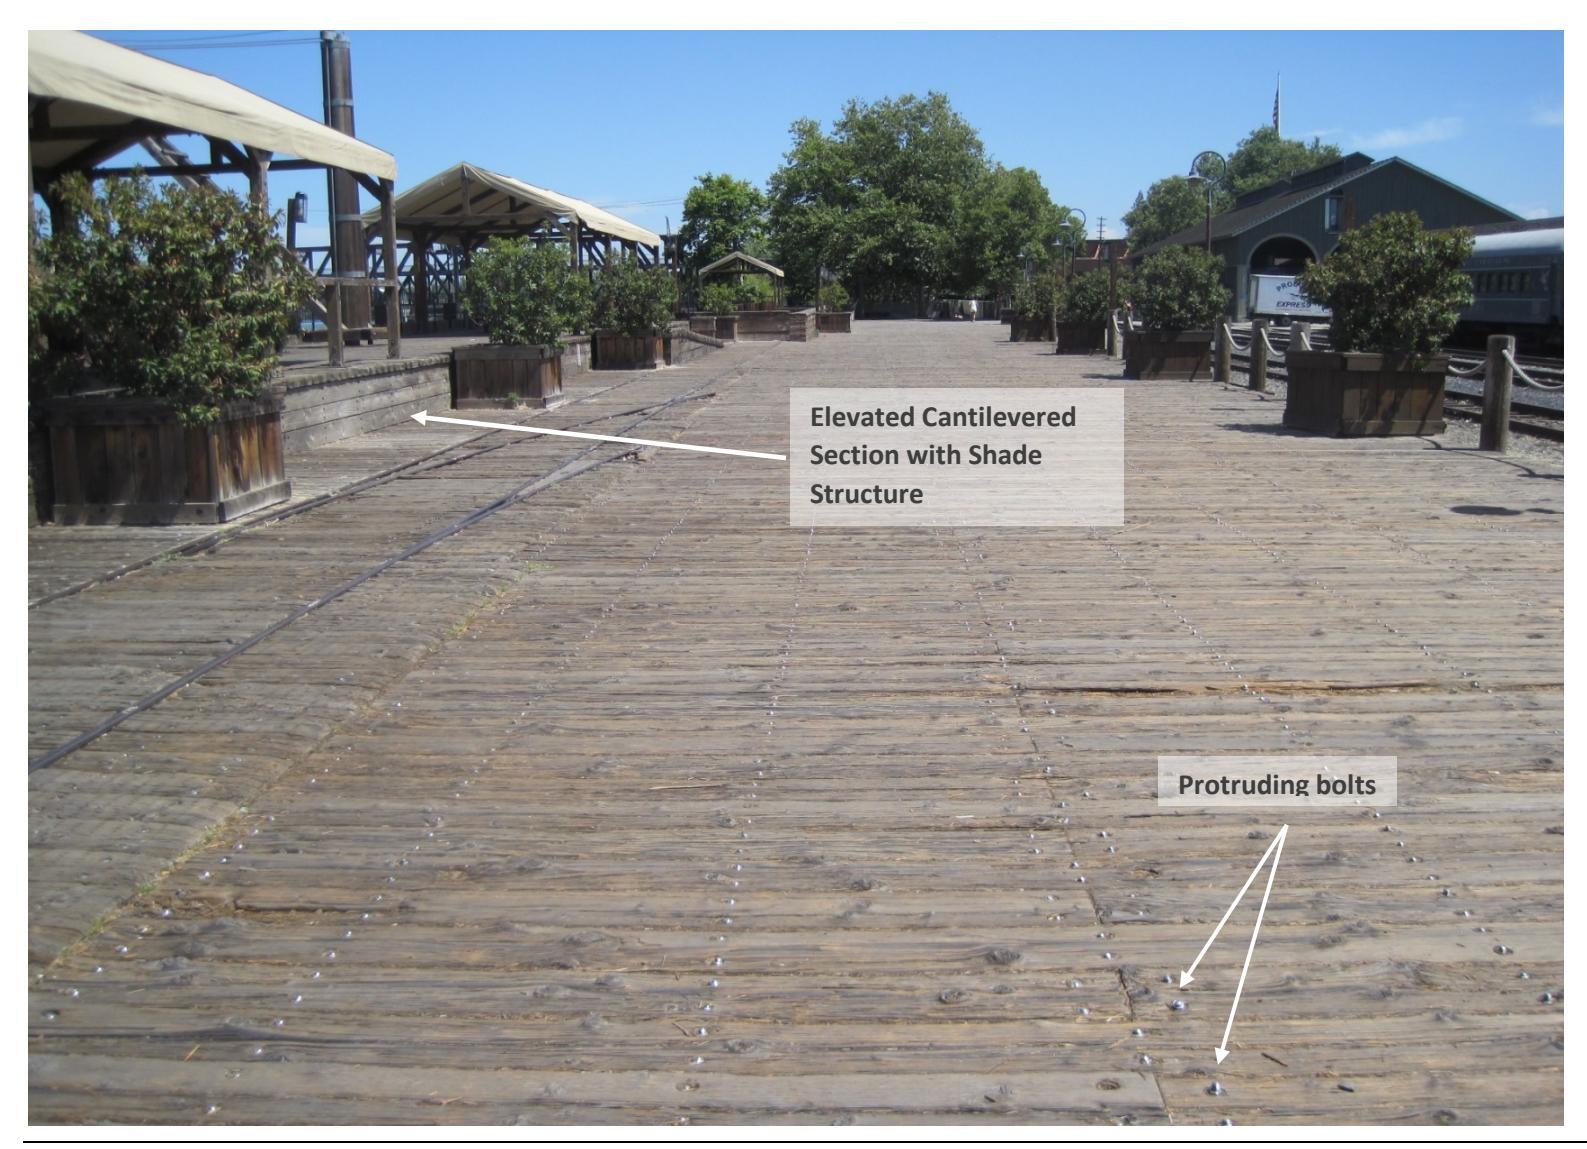
The existing wood boards were installed in the mid-1980s and are experiencing extensive wear and degradation. Numerous tripping hazards are present along the Embarcadero (Figure 5). The wood boards on top of a concrete slab-on-grade over aggregate base and bolted in place. Supporting the boards are fully threaded rods, commonly referred to as all threads and wedge anchors. The bolts were wet set in the concrete slab and if any repair to boards was performed, expansion anchors were used. The installation of the existing wood boards is covered in Reclamation Board Permit #13589 BD.

Figure 5. Existing Wood Deck on the Embarcadero with Protruding Bolts.

The repair work involves removing the wood boards with a backhoe. The remaining bolts will be snapped off at the concrete and left in place. Any damaged concrete will be repaired. The concrete slab will remain to provide the structure for installation of the new paving material replacing the existing wood boards. The new paving material will consist of stamped wood grain stained concrete placed over the existing concrete slab-on-grade.

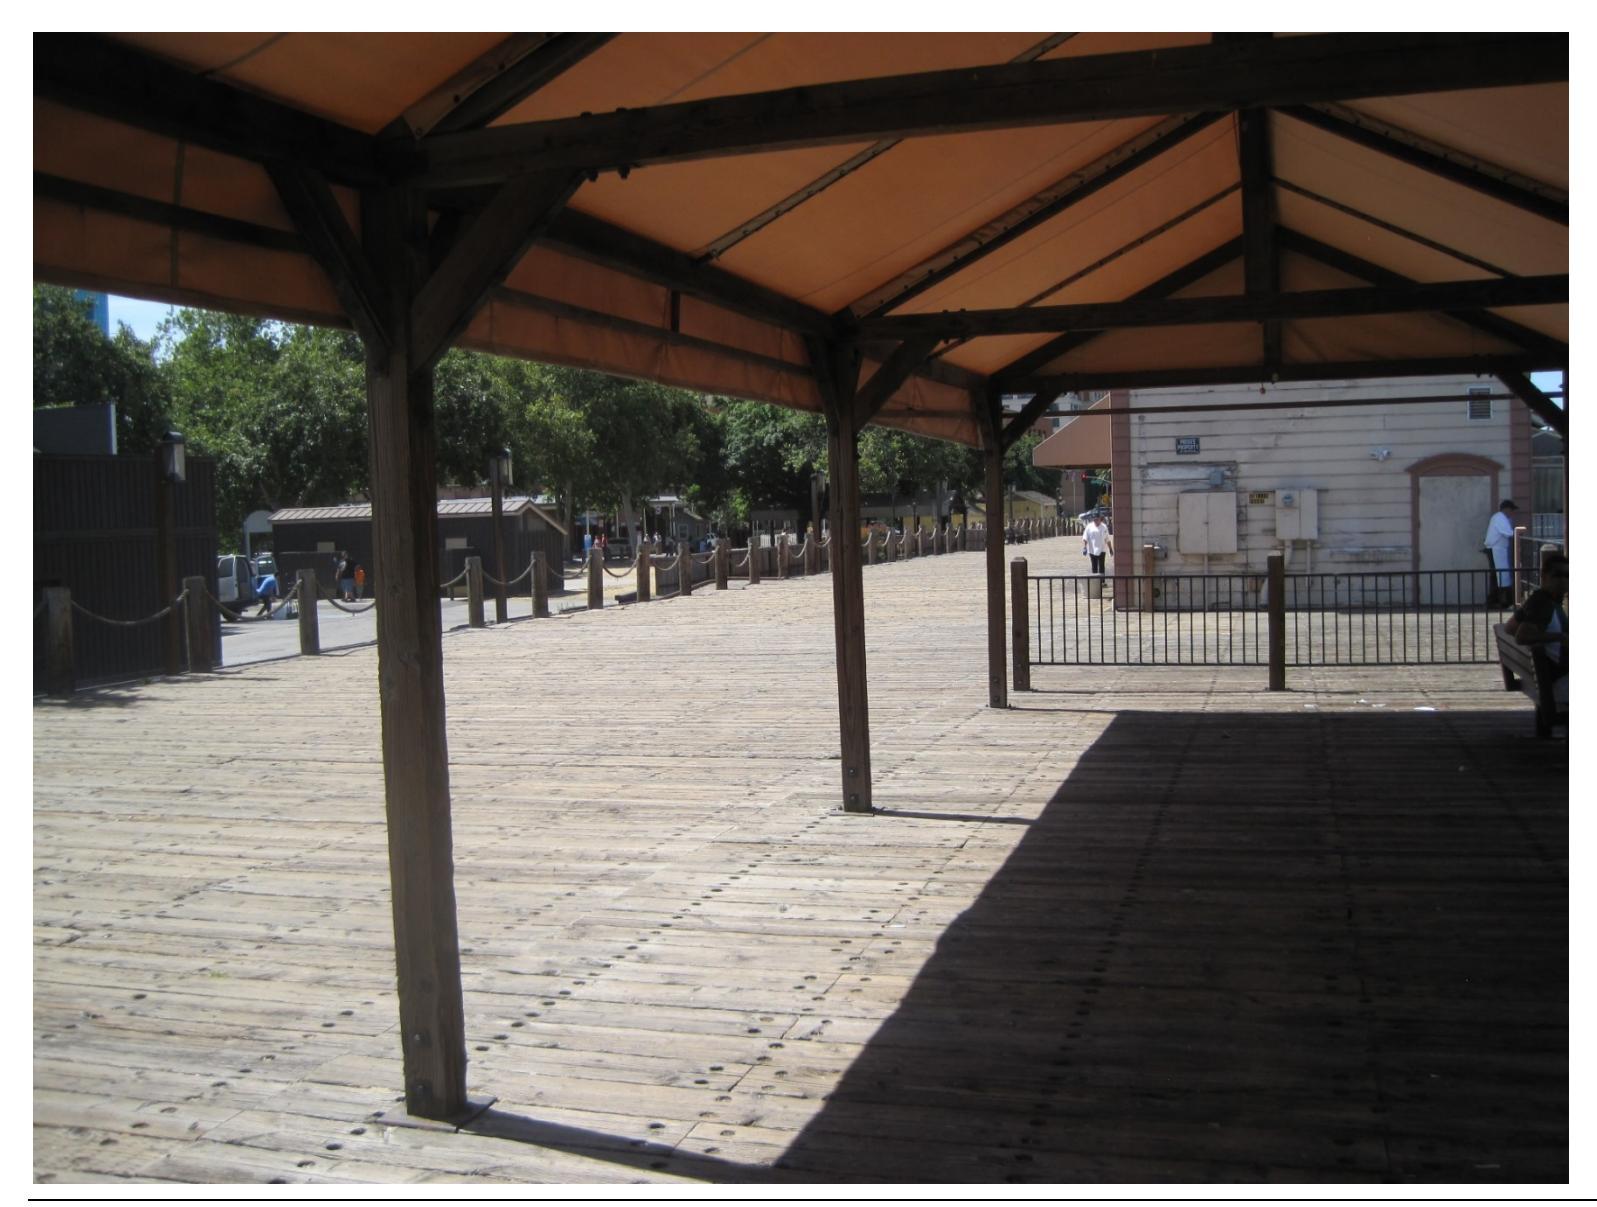
Currently there are four shade structures along the cantilevered sections of the embarcadero. The support posts for these structures are bolted to the existing wood decking (Figure 6). The wooden decking on these sections will be replaced with new wood and the shade structures will again be bolted to the deck.

Figure 6.Shade Structure on the Embarcadero Showing Bolted Vertical Supports.

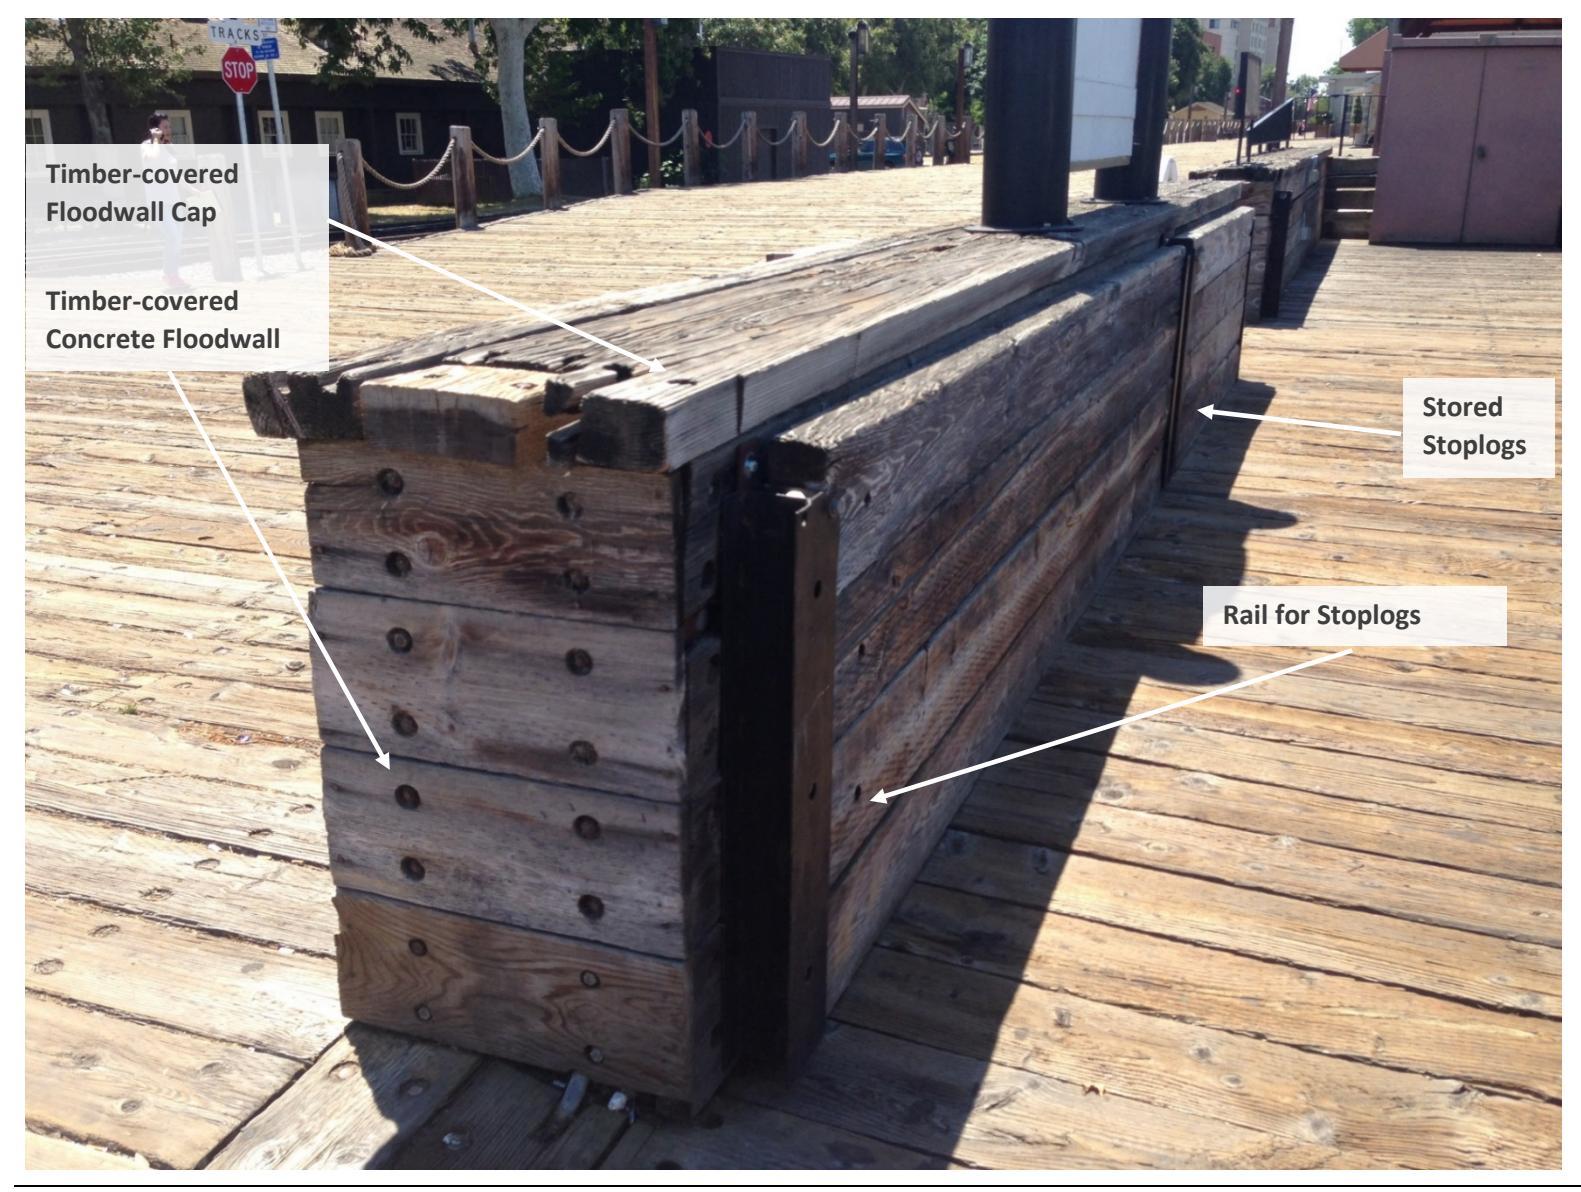
The Sacramento River floodwall is a vertical concrete wall along the Embarcadero (Figure 7). The top elevation of the wall is 34.5' msl. The face and top of the concrete wall has a wood fascia board to match the wood boards along the walking surface of the Embarcadero. There are existing openings in the floodwall, such as the entrance to the Delta King, where flood control is provided using stoplogs that slip into steel rails and cover the opening and stored in non-flood periods adjacent to the opening (Figure 7). The top of the stoplogs are at the elevation of the top of the concrete floodwall. The wood fascia board over the concrete floodwall is reflected in Reclamation Board Permit #13589 BD. There are areas on the perimeter of the precast concrete decks where the floodwall is constructed of a wood timber.

Figure 7. Existing Concrete Floodwall with Timber Fascia and Cap.

The repair will include removal of the existing wood fascia boards on both sides and top of the existing flood wall, and replacement with new wood on the easterly (land) side, and new wood on the top of the floodwall to match the existing height. The westerly (river) side of the wall will remain exposed concrete. The bolts will be cut or ground to be flush with the face of wall and existing blemishes patched to match the adjacent concrete surface. Low-profile ground-illuminating lights will be placed in the wood veneer on the easterly (land) side of the floodwall (Figure 4). The lights will be fed from new conduit which will be run behind the new wood, where there are currently existing conduits for other feeds.

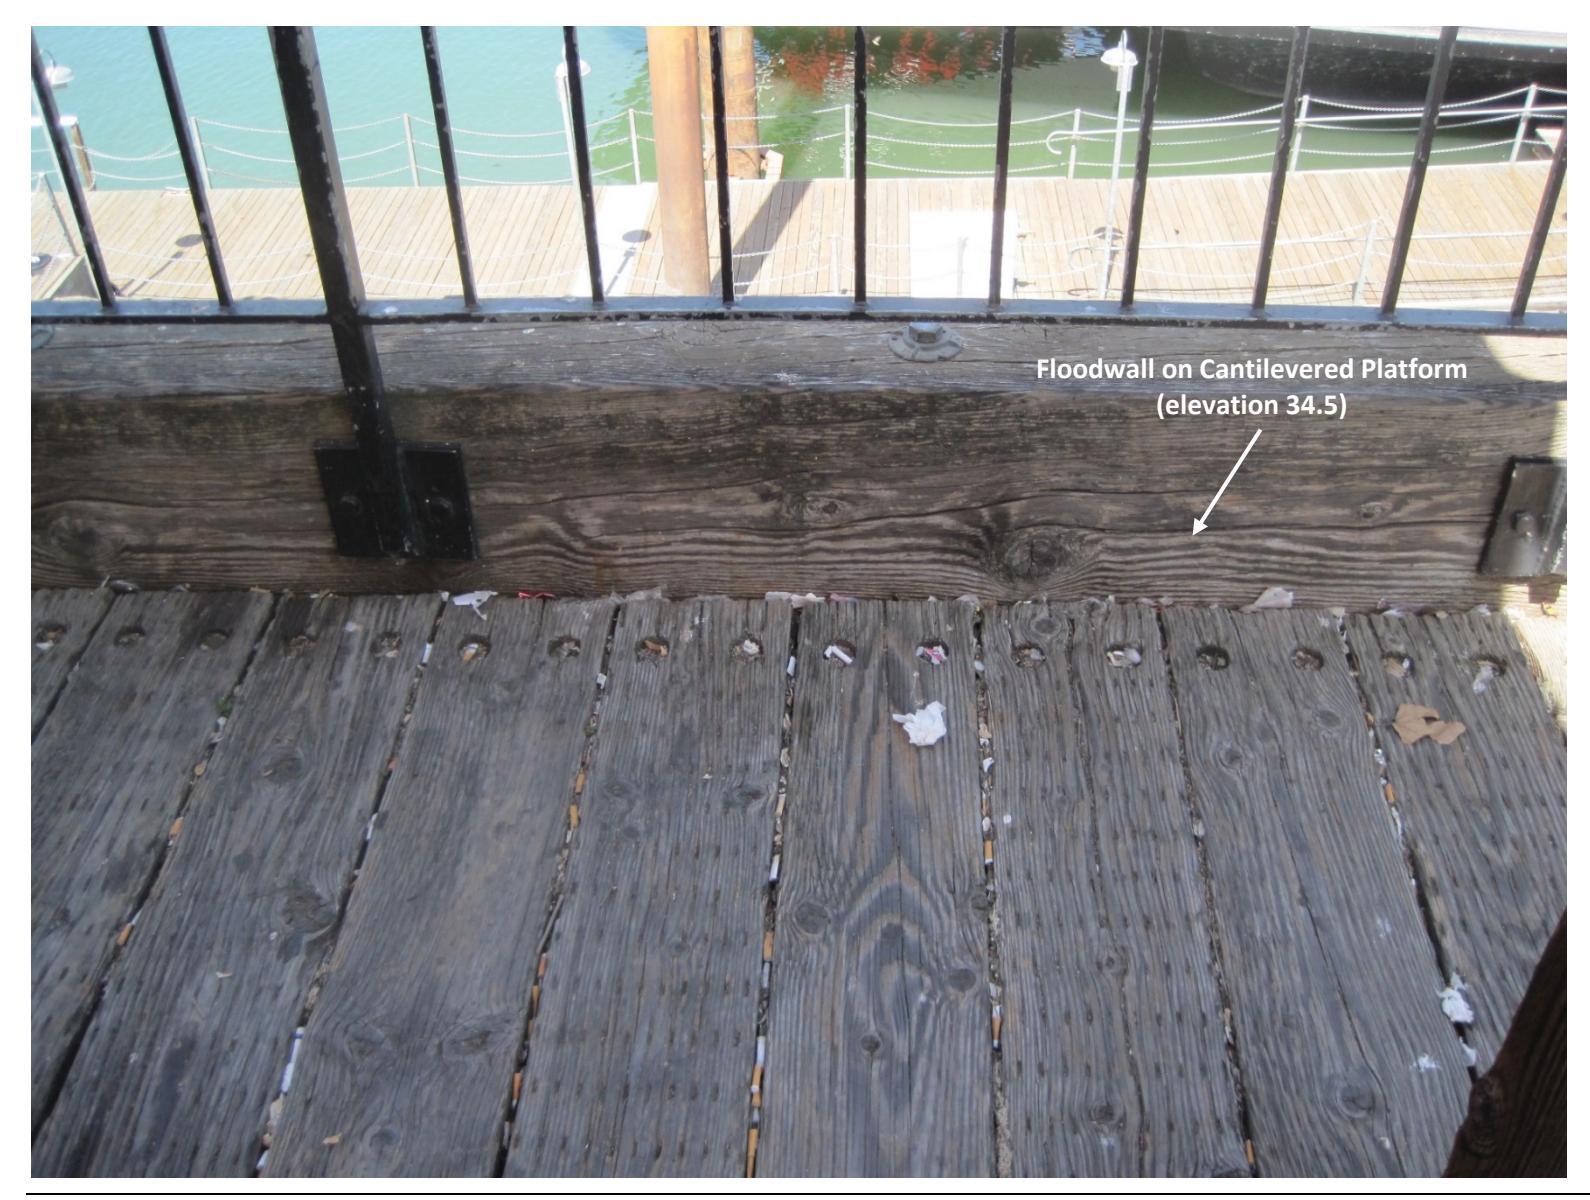
On the elevated sections of the embarcadero and around the buildings, the floodwall is comprised of a timber beam bolted to the concrete slab under the embarcadero (Figure 8).

Figure 8. Timber Beam that Forms the Floodwall on the Elevated Embarcadero Sections.

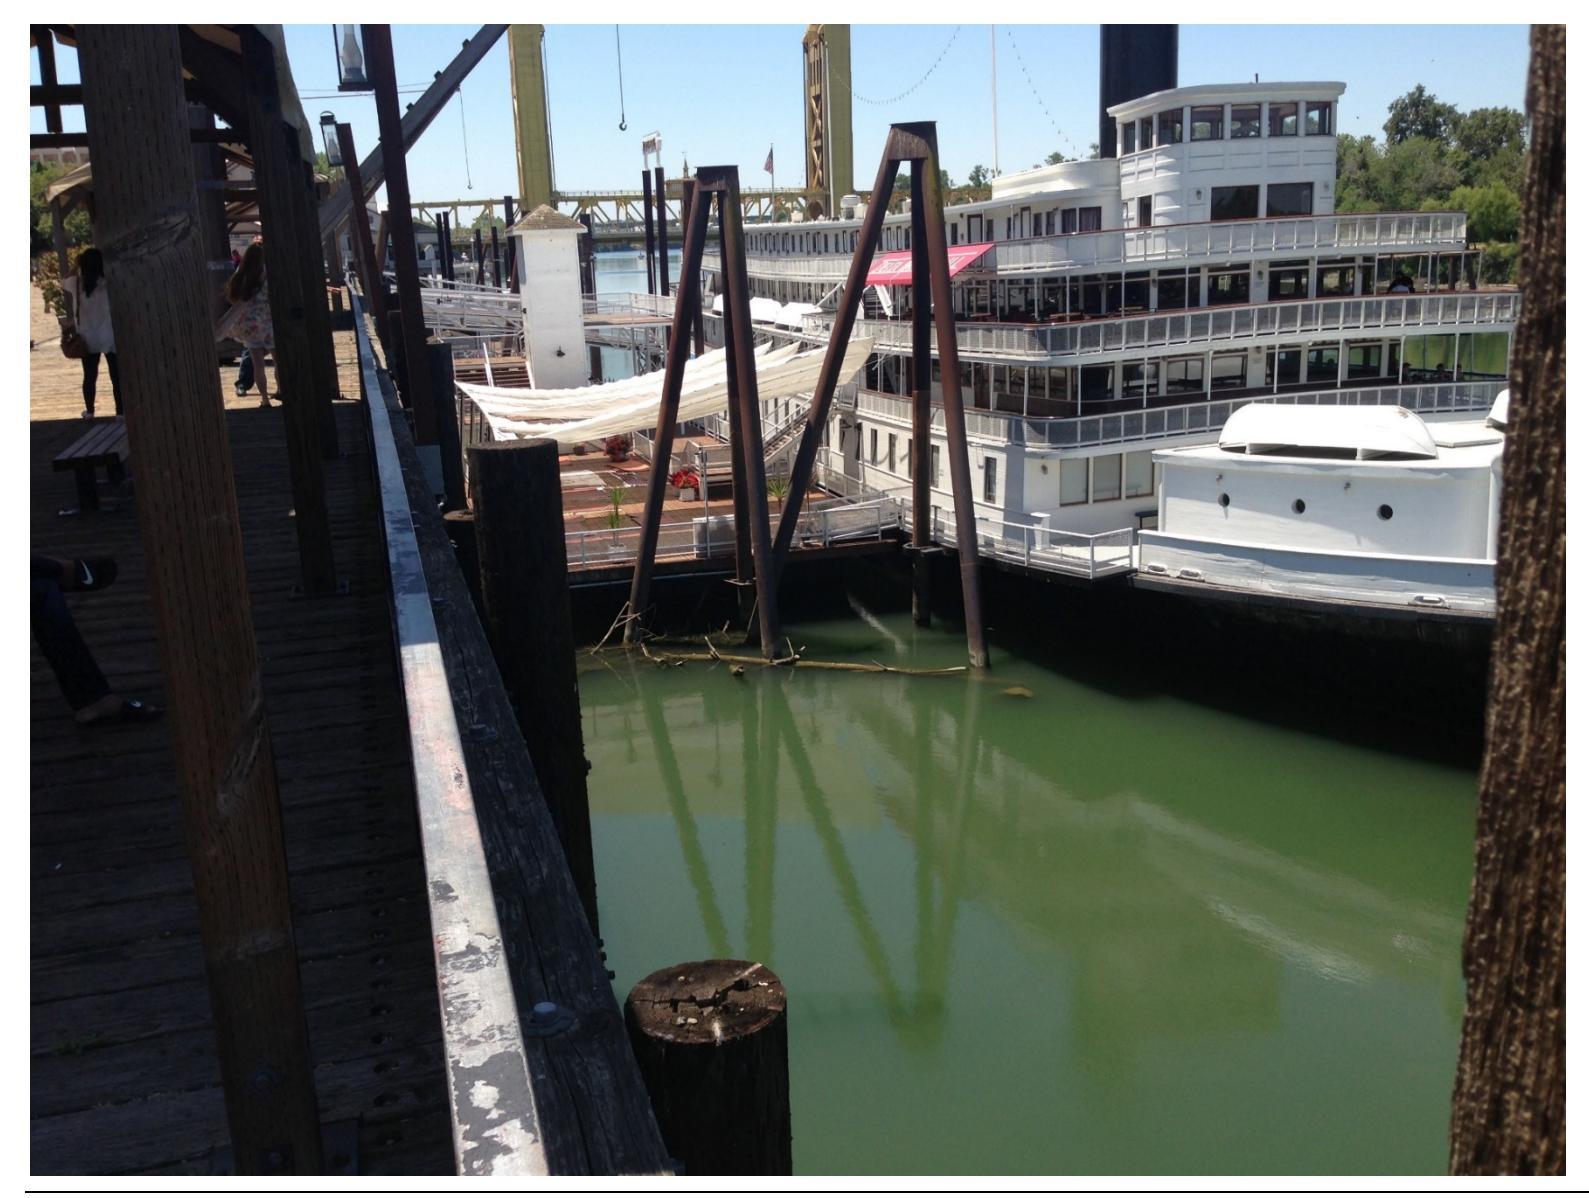
The Delta King is moored to a dock that is mounted on the hull of a barge. On top of the barge is also an elevator, gangway, and stairs that provide a mostly accessible (ADA compliant) path of travel from street level to the Delta King (Figure 9). The barge, as with the associated elements, rises and falls with the elevation of the river. These are not overtopped in a flood event. The use of the Barge is covered in Reclamation Board Permit #13589 BD.

The barge is in need of interior repairs to address leakage, rust, and proper closure to the elements. These repairs will be conducted on the interior of the barge and will not involve any alterations that will modify the obstruction to flow resulting from the current barge.

Figure 9. View of the Gangway and the Barge Facilities adjacent to the Delta King.

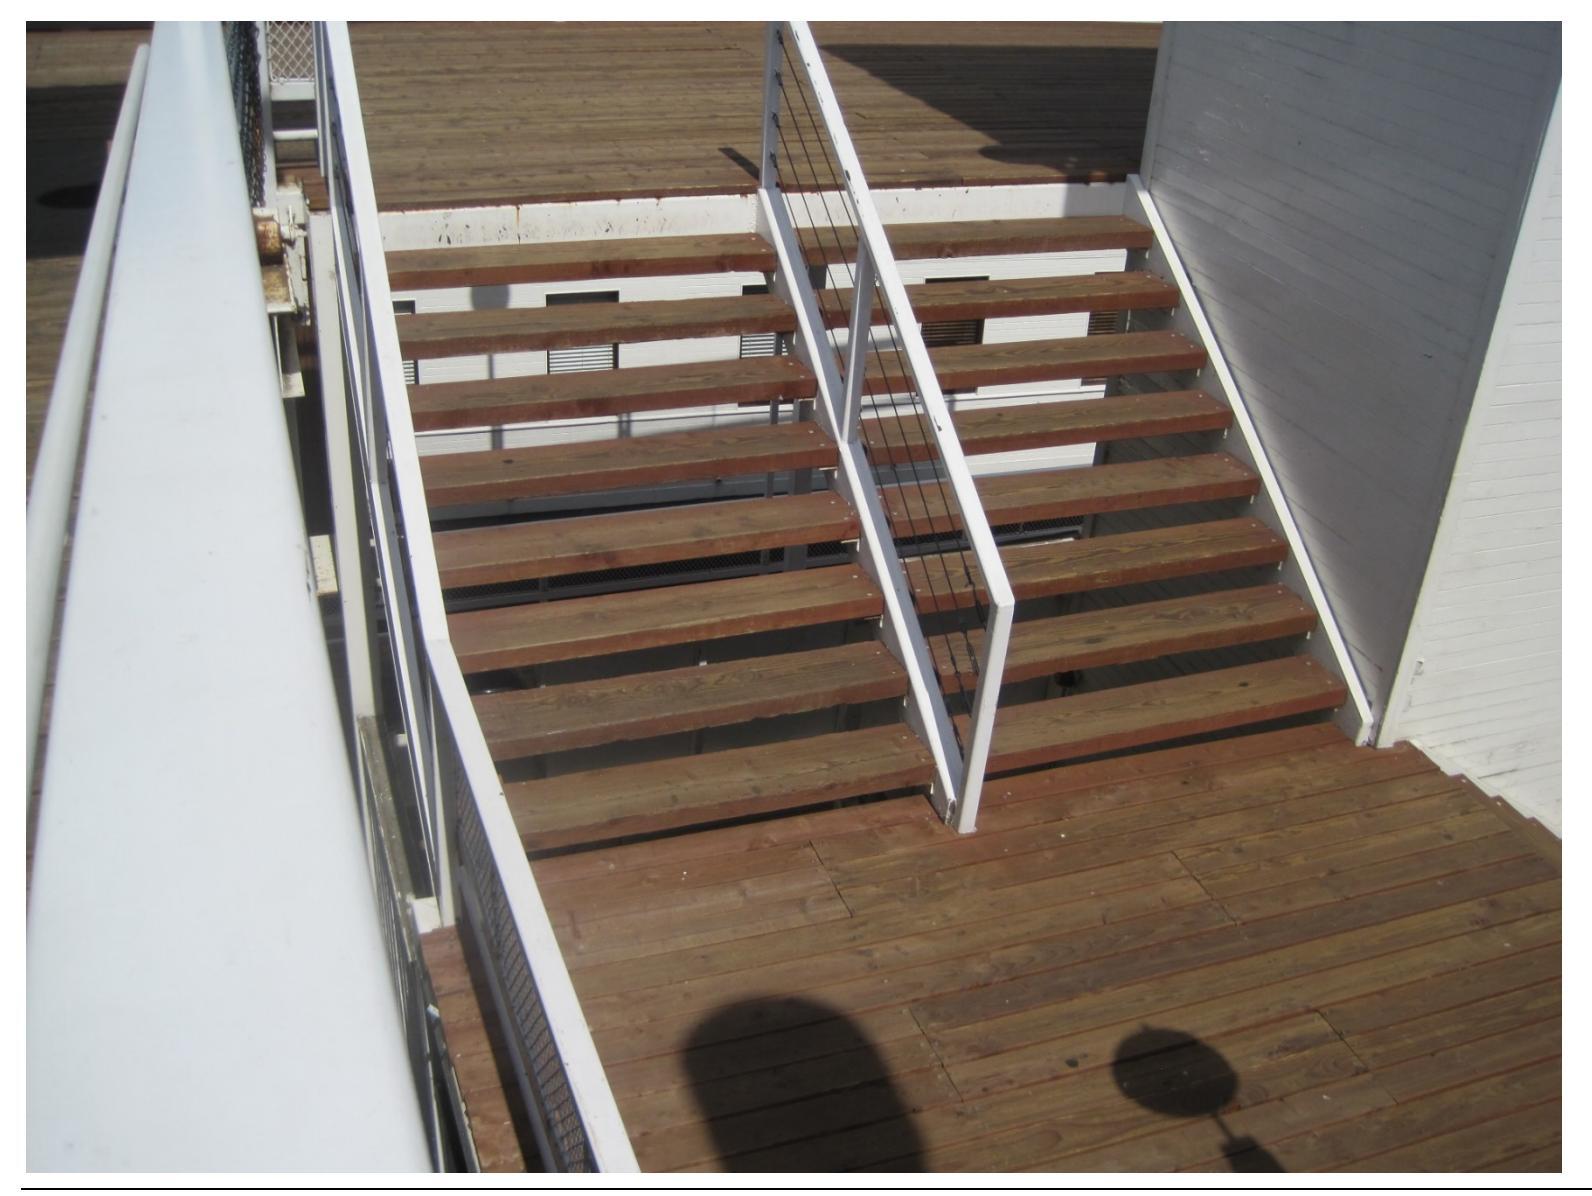
Figure 10: Current Condition of the Stairs.

Stairs and decking are part of the barge structure (Figure 10). The existing steel framed stairs that extend from the upper landing to the barge level will be modified to conform to current code requirements for stairs as part of the project. Replacement includes modifying the rise/run ratio and closing the vertical gap between the stairs (Figure 10). The existing riser height exceeds code maximum, the risers are open, and openings in the railings exceed code maximum. The existing wood treads will be reused, and new detailing will match the existing conditions.

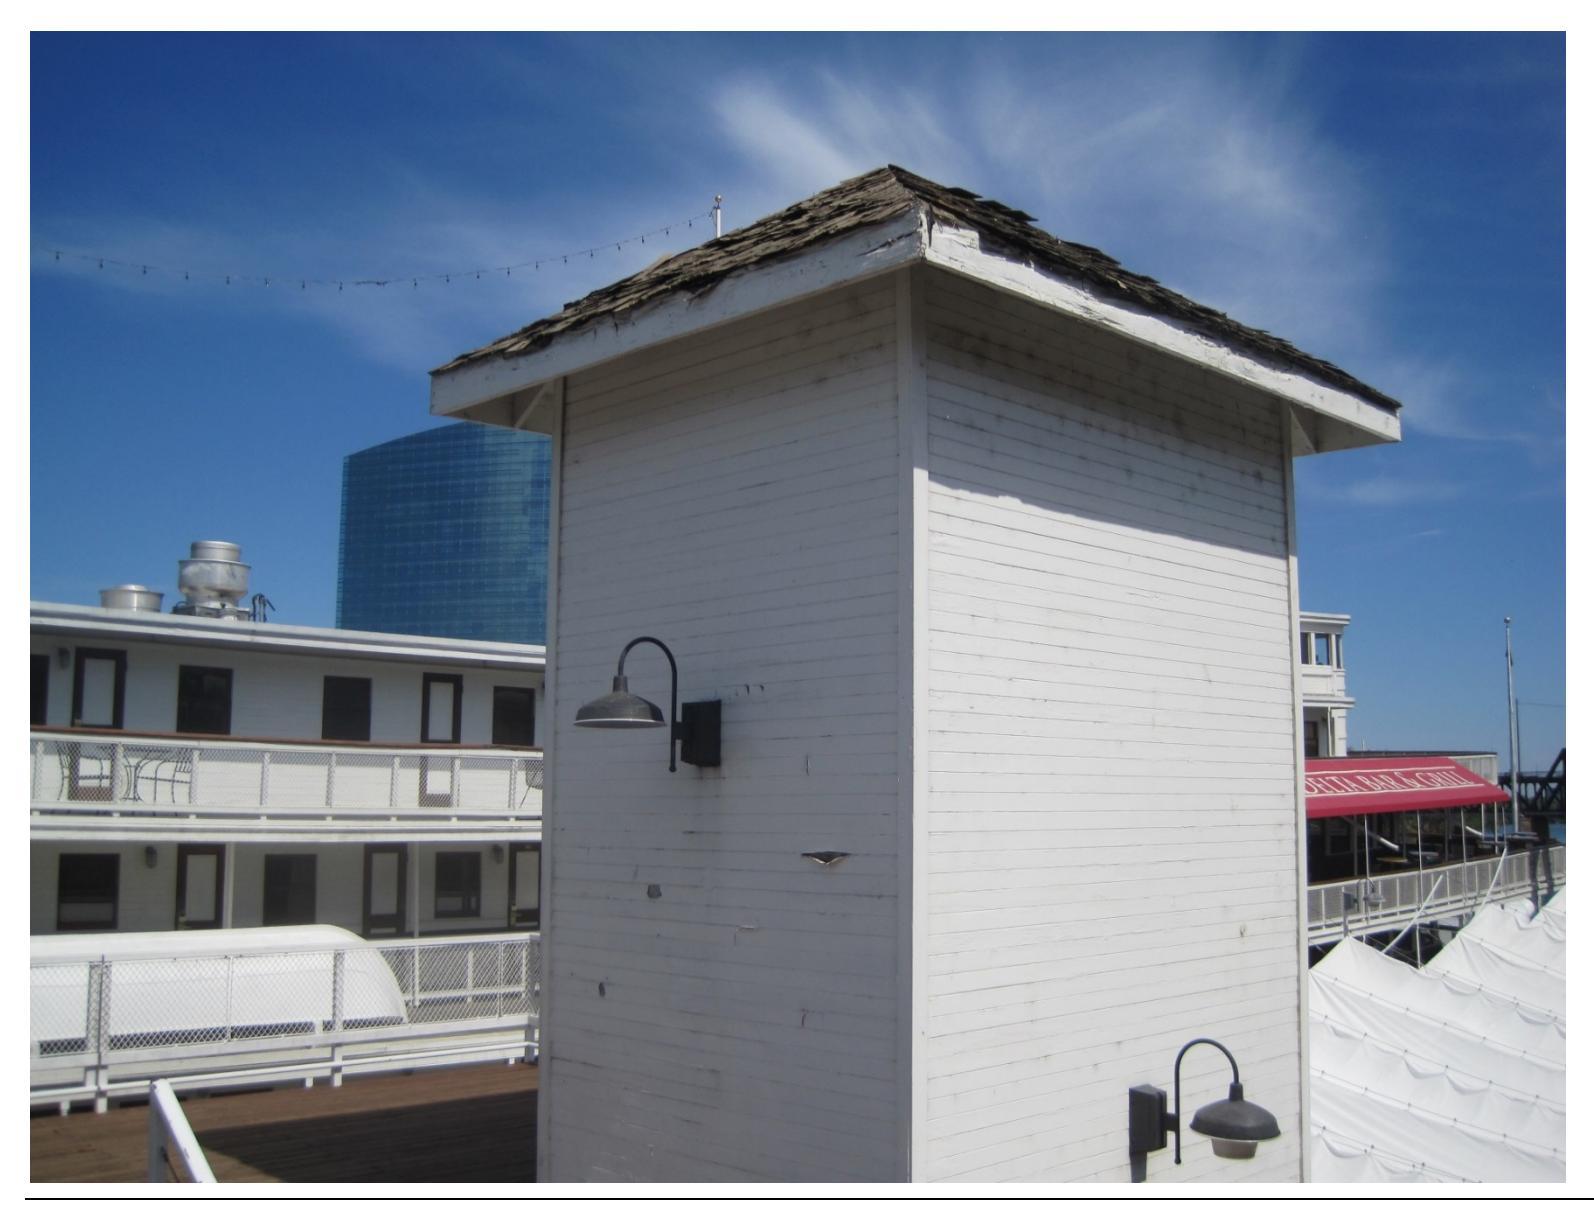
The elevator is contained in a steel and wood framed hoistway enclosure originally designed to reflect the architecture found within the Old Sacramento Historic District (Figure 11). The horizontal footprint is 8'-0" by 10'-0" and top of roof is 35'-0" feet above the barge deck. Repairs to the elevator will occur inside the hoistway and will not alter the horizontal or vertical footprint of the facility. There will also be repairs to some of the exterior siding and roof of the enclosure to address areas of rot or other wood decay. The repairs will replace in-kind and will not alter the footprint.

Figure 11. Hoistway Housing.

A new intermediate elevator stop and landing will be added midway between the barge level and upper level that connects to the gangway from the Embarcadero. The elevator enclosure will be modified to add the required opening. The landing at the new elevator stop will be connected directly to the Delta King by a new gangway. The new landing and walkway will match the existing architectural design style.

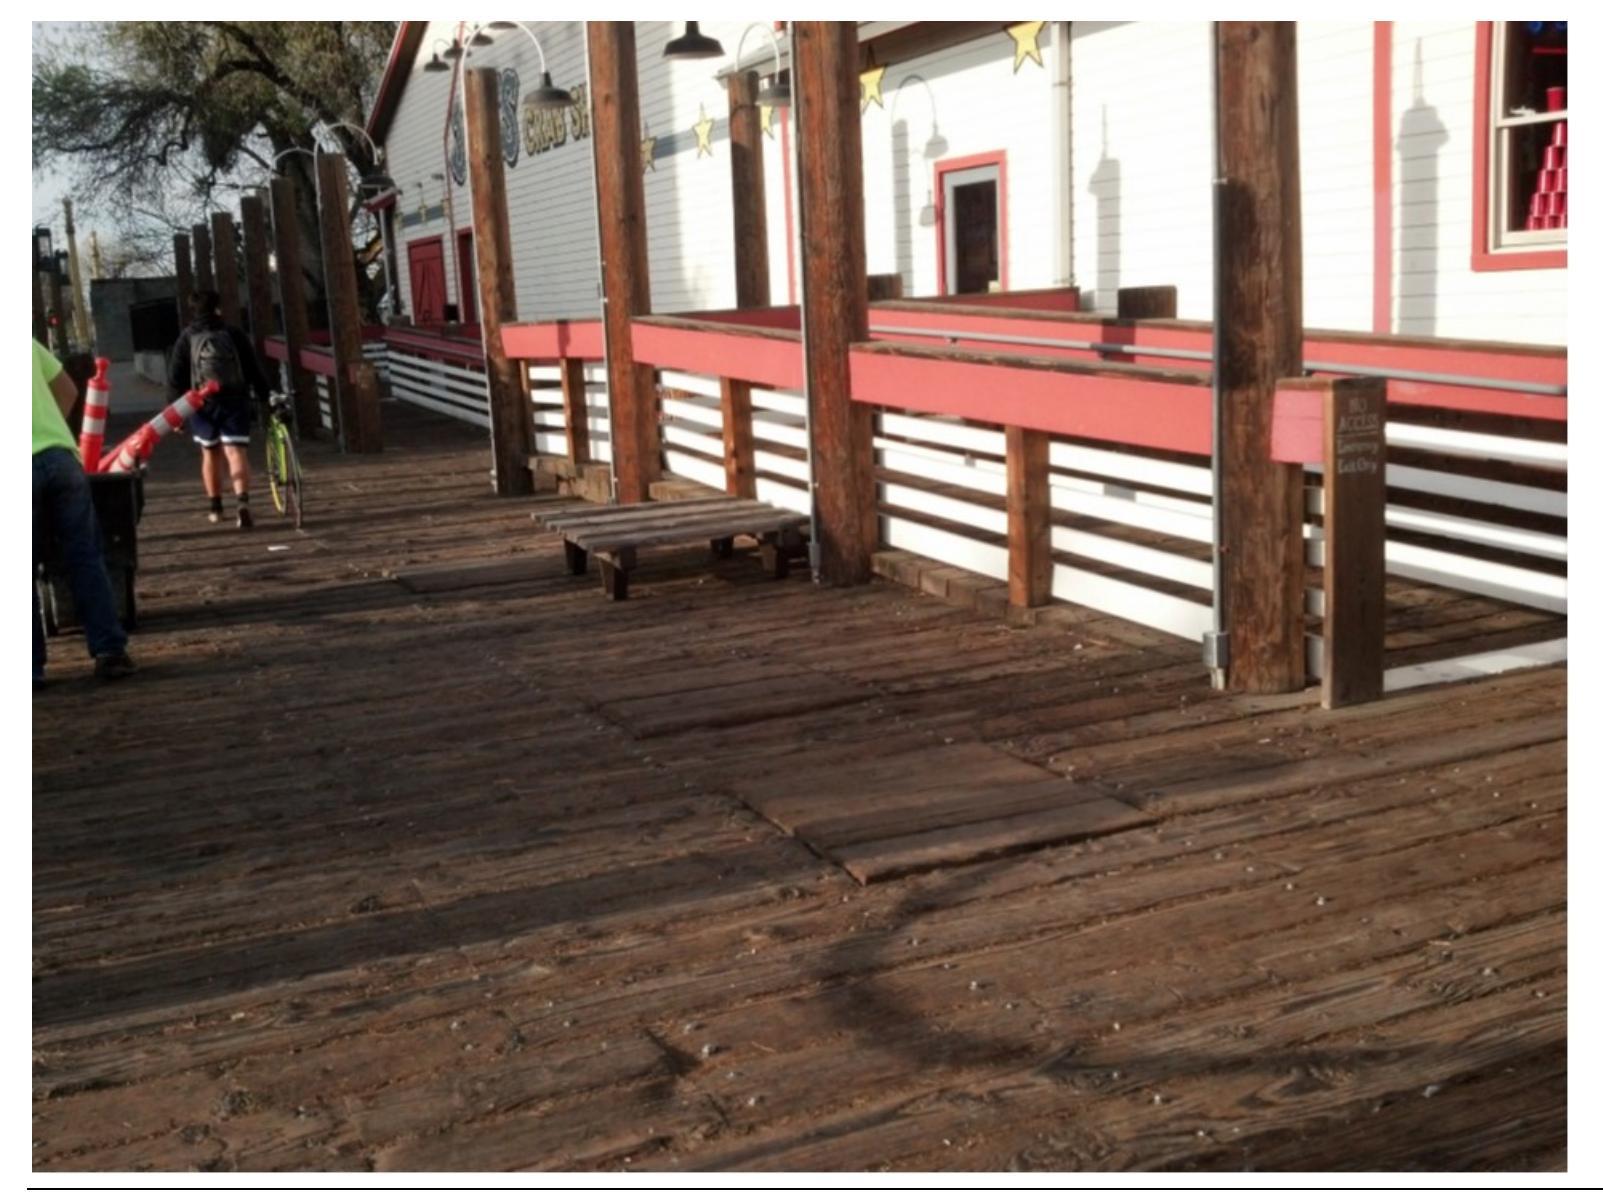
Figure 12. Joe's Crab Shack.

The existing Joe's Crab Shack is located south of the California Pacific Steamers Building on the Embarcadero. The existing wood boards will be removed and the concrete exposed (Figure 12). The existing wood ramps will be removed and the grade will be raised in this area to FF 34.60'. This will be

accomplished by placing AB on the existing concrete slab and placing a new capping slab on top of the compacted AB.
