**CITY OF SACRAMENTO
COMMUNITY DEVELOPMENT DEPARTMENT
DIRECTOR HEARING**
300 Richards Blvd, 3rd Floor, Sacramento, CA 95811

Staff recommend the Design Director approve with conditions the Site Plan and Design Review for the **Parks Residence Addition** as file **DR24-149**. Draft Findings of Fact and Conditions of Approval for the project are included below.

Arborist and Tree Protection Report

3551 Elvas Ave.
Sacramento, CA 95819

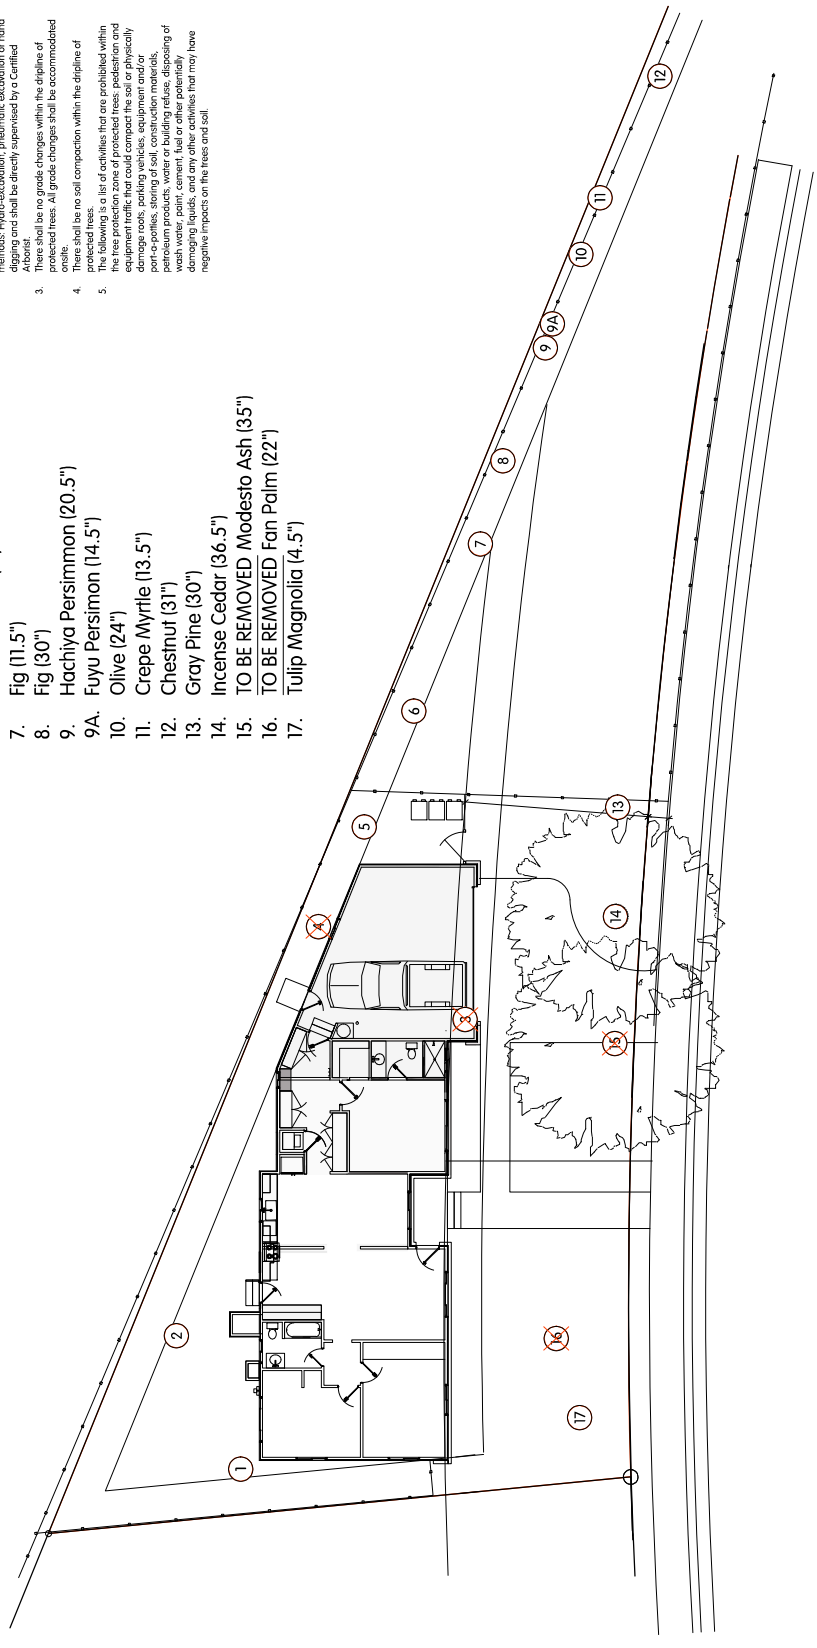
TREE PLAN

- TREES**
1. Naval Orange (19.5")
 2. Rainier Cherry (15.5")
 3. TO BE REMOVED Crepe Myrtle (13.5")
 4. TO BE REMOVED Mandarin Orange (6")
 5. Puot (16")
 6. Fruitless Plum (7")
 7. Fig (30")
 8. Hachiya Persimmon (20.5")
 - 9A. Fuyu Persimmon (14.5")
 10. Olive (24")
 11. Crepe Myrtle (13.5")
 12. Chestnut (31")
 13. Gray Pine (30")
 14. Incense Cedar (36.5")
 15. TO BE REMOVED Modesto Ash (35")
 16. TO BE REMOVED Fan Palm (22")
 17. Tulip Magnolia (4.5")

- (X) TREE
- (X) TREE TO BE REMOVED

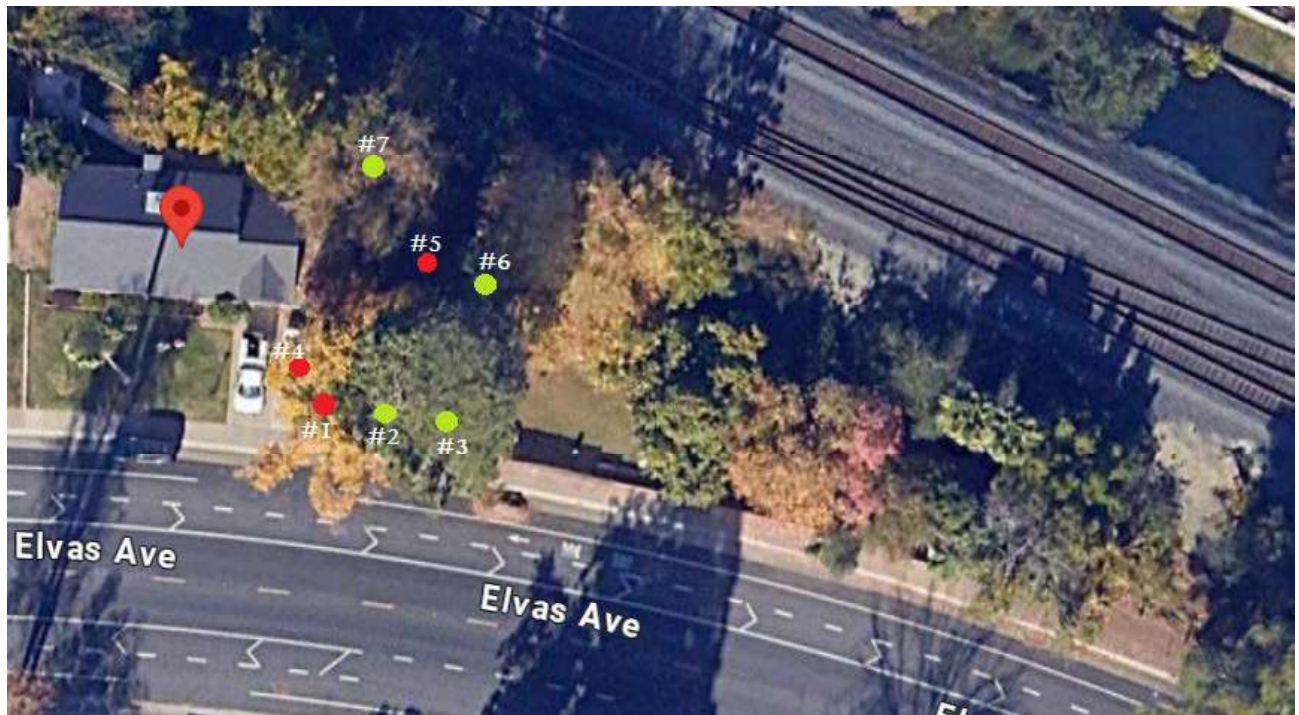
Appendix A – Location Map

Aerial view of site and tree locations. Red dot indicates tree planned for removal, green dot indicates tree to be preserved.

A map of tree locations can be found in Appendix A, a complete Tree Inventory and Condition Assessment can be found in Appendix B, and tree photographs can be found in Appendix C.

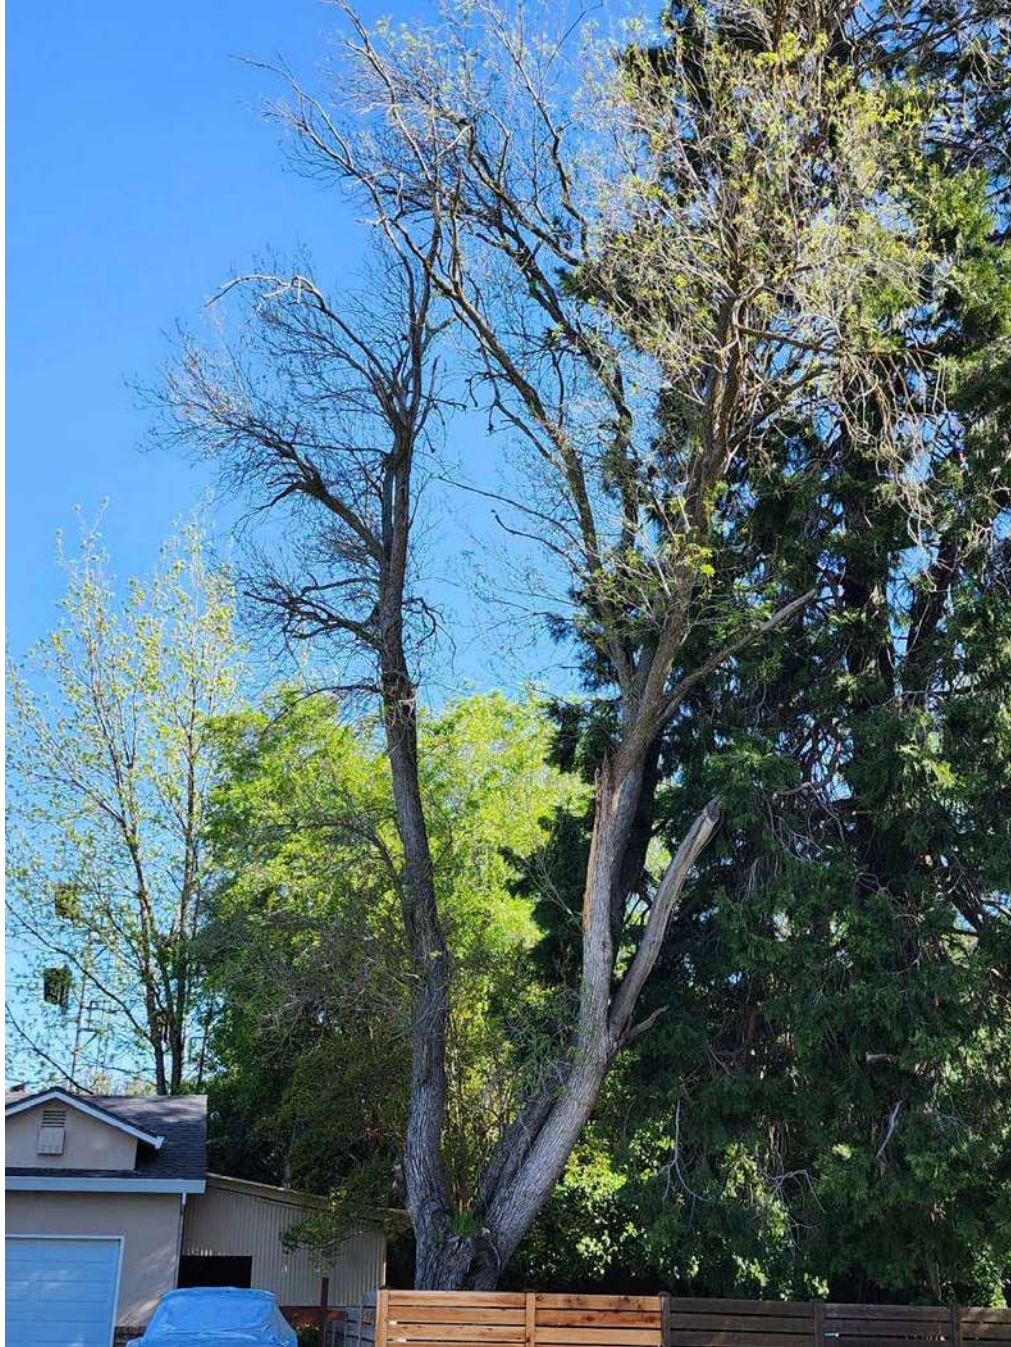
1. Tree #1 is in poor overall condition and is recommended for removal.

- **Remove Tree ID#’s 1, 4, & 5.** These trees are within the project's footprint, and impacts will be high. Tree #1, the Modesto ash, is considered a protected tree due to its trunk diameter. Due to the poor condition of this tree, removal of this tree would be recommended regardless of the construction project.

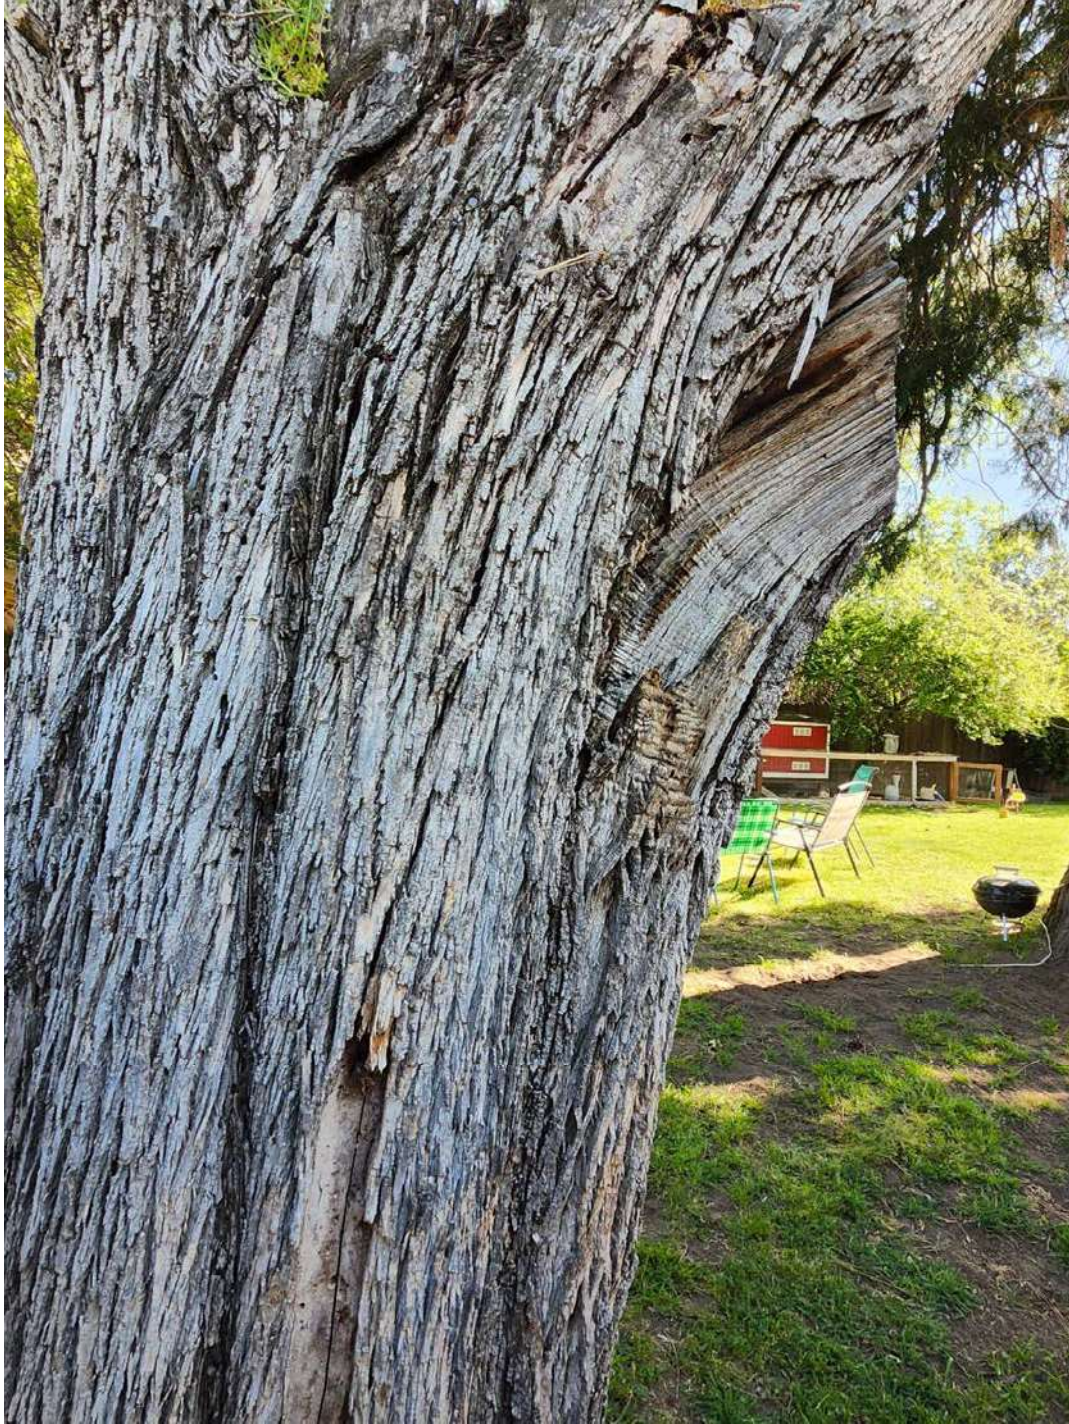
3. Crack in trunk on tree #1.

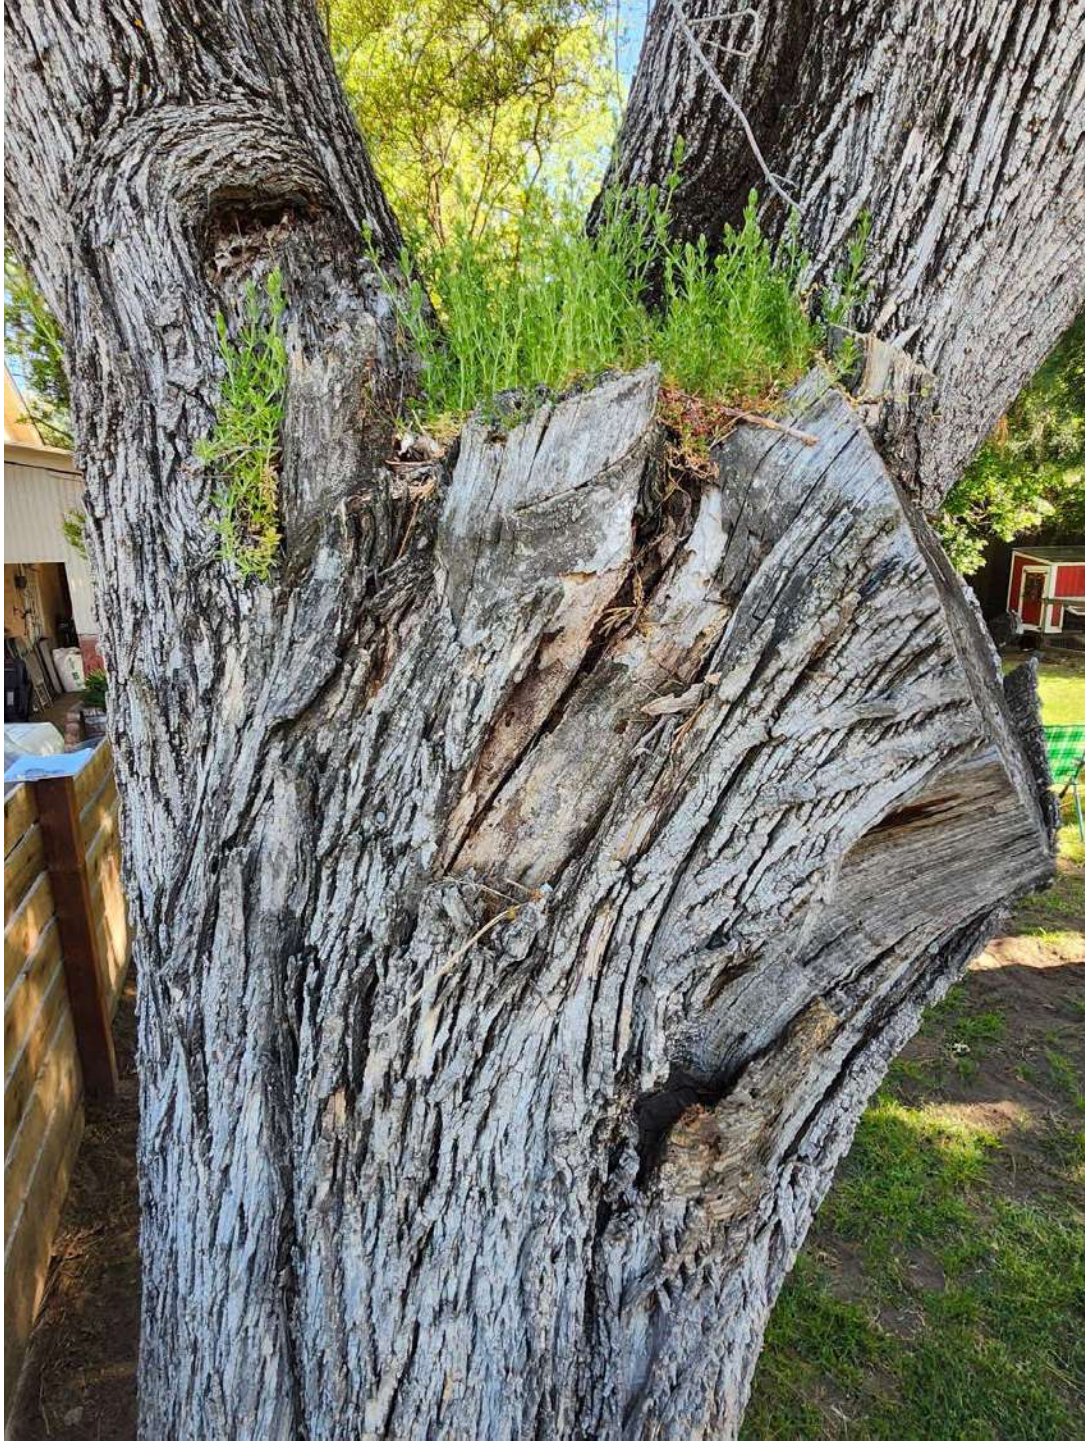
4. Cracks and decay in tree #1.

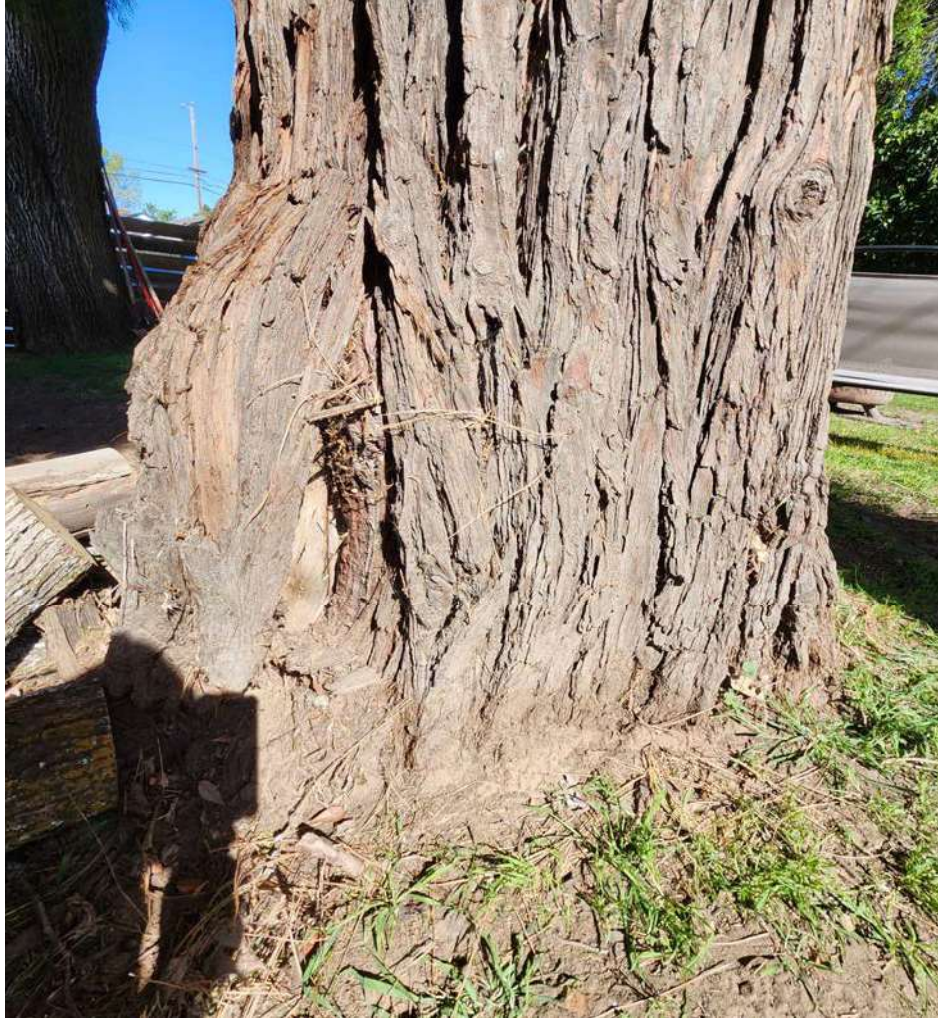
7. Trunk wound on tree #2 caused by passing trailer.
