**WETLAND DELINEATION
FOR THE**

±25.8-ACRE ROBLA ESTATES STUDY AREA

CITY OF SACRAMENTO, SACRAMENTO COUNTY, CALIFORNIA

JUNE 2020

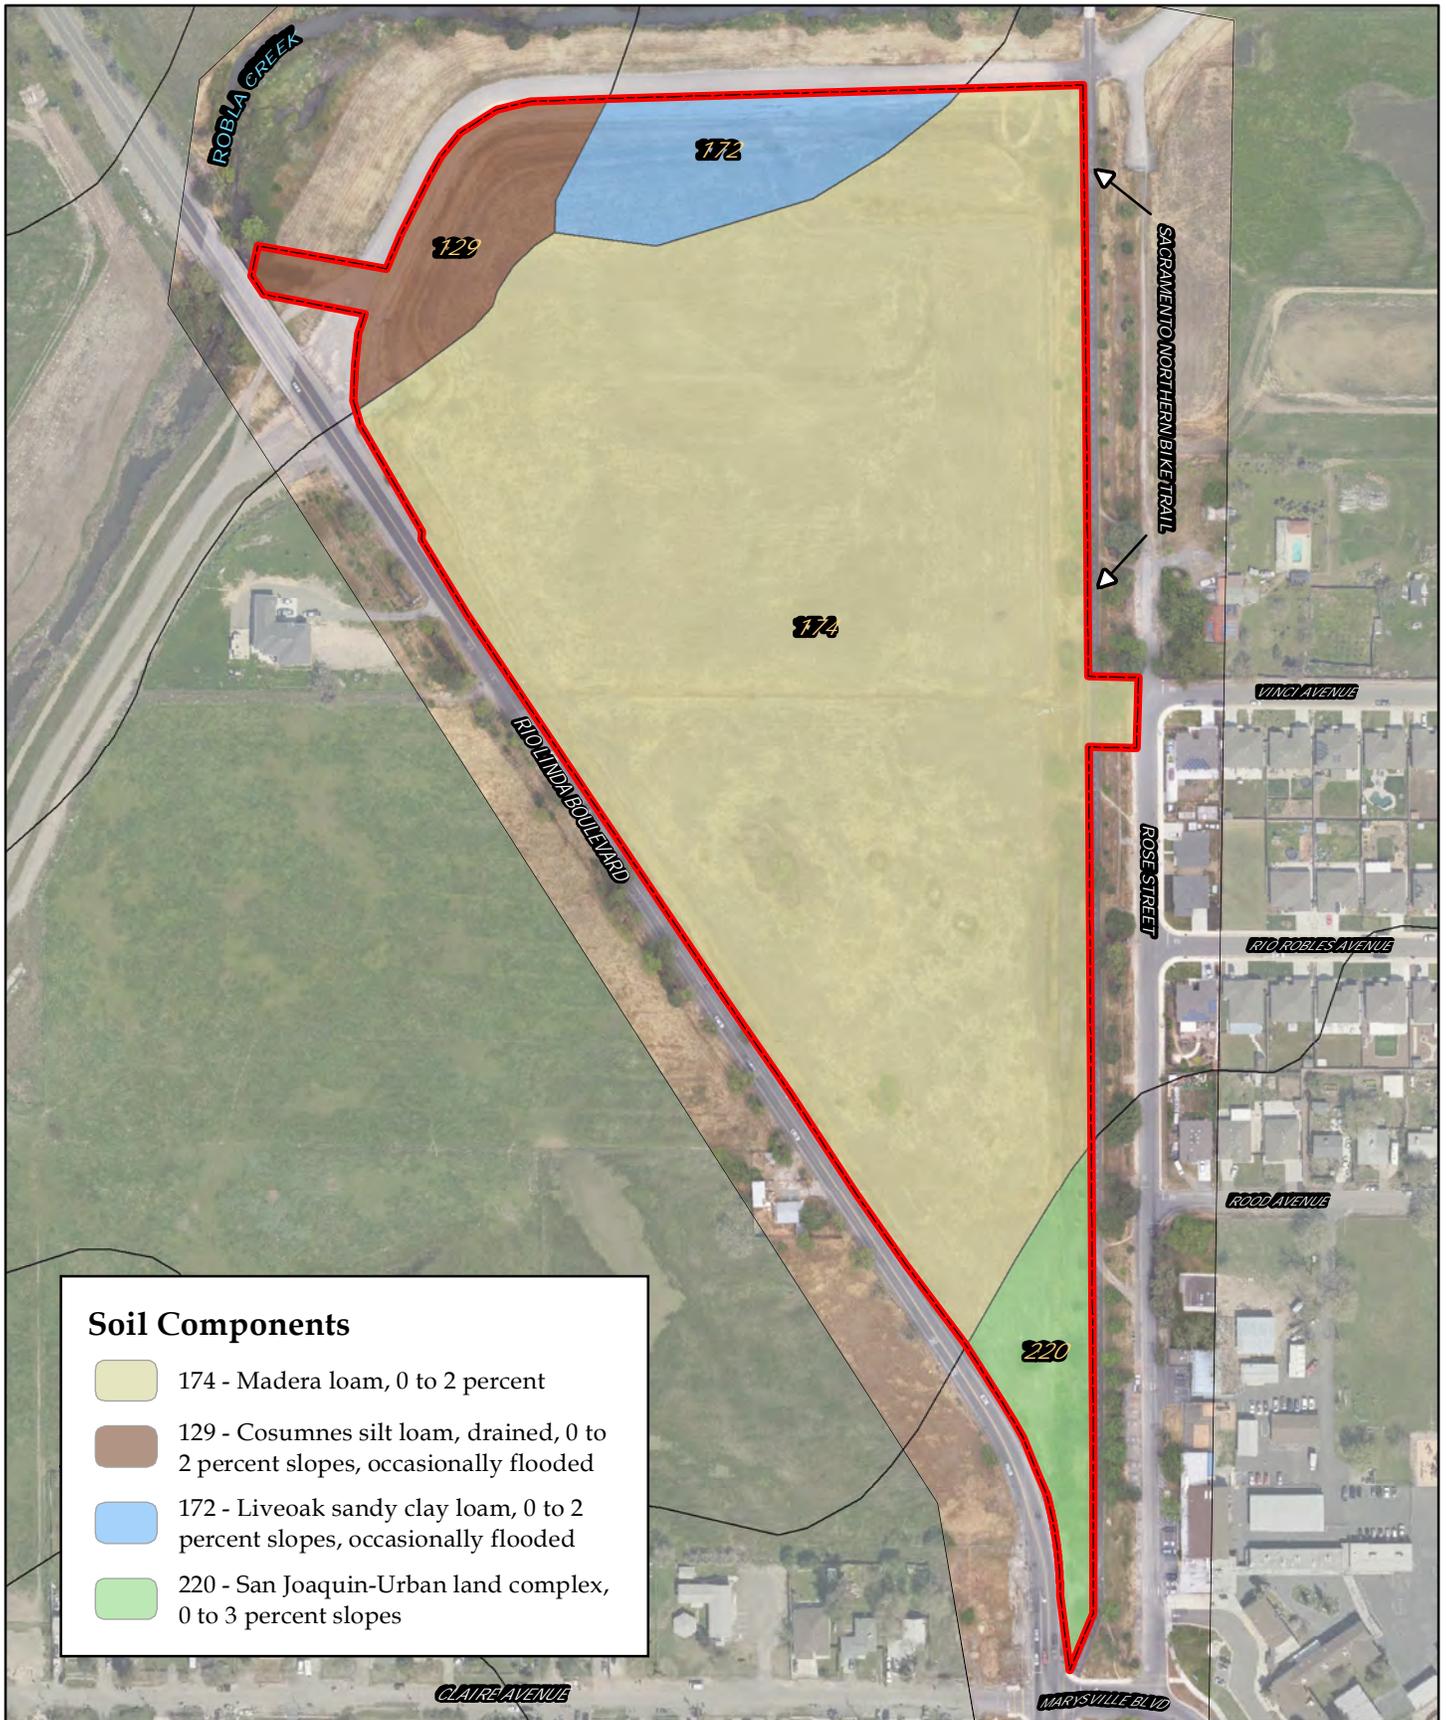
Figure 3
SOIL COMPONENTS
Robla Estates
City of Sacramento, Sacramento County, CA

Four soil units have been mapped on the property (Figure 3): Andregg coarse sandy loam, 2 to 9 percent slopes, Andregg-Rock outcrop complex, 5 to 30 percent slopes, Xerorthents, cut and fill areas and Xerorthents, placer areas (NCRS 2020). The components of each complex are described below.

- 174 - Madera loam, 0 to 2 percent
- 129 - Cosumnes silt loam, drained, 0 to 2 percent slopes, occasionally flooded
- 172 - Liveoak sandy clay loam, 0 to 2 percent slopes, occasionally flooded
- 220 - San Joaquin-Urban land complex, 0 to 3 percent slopes

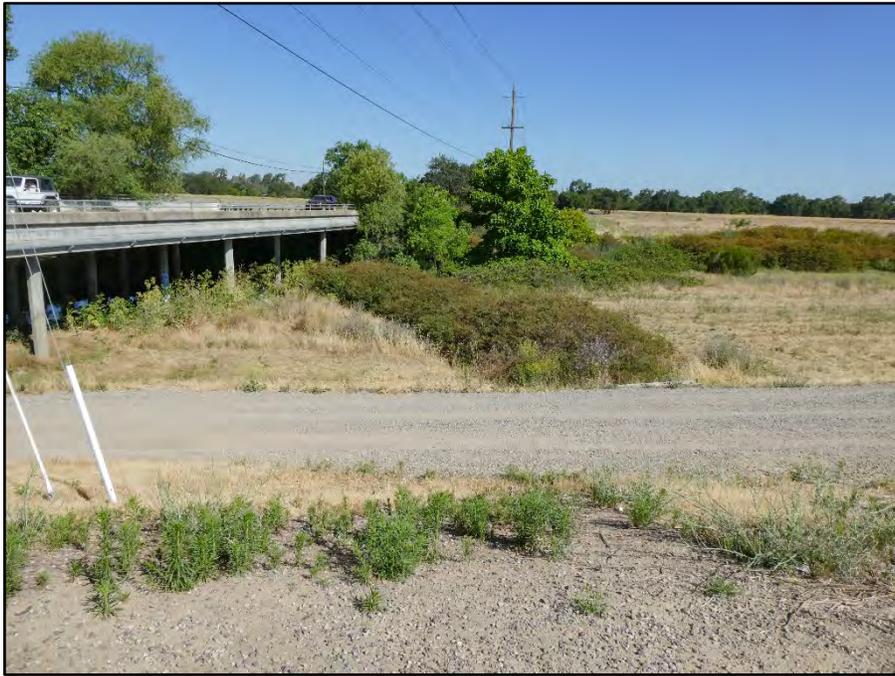
Figure 4a

Looking west over outfall into Robla Creek toward Rio Linda Boulevard. Swale WS-1 choked with red sesbania. *Photo Date: 6-03-20.*

A wetland swale is mapped between the levee near Robla Creek to Robla Creek. This constructed swale originates at an outfall situated beneath the levee, which drains ditches located on the south side of the levee. The swale supports a dense population of red sesbania (*Sesbania punicea*). The herbaceous layer in the upper portion of the swale near the levee is mostly Bermudagrass (*Cynodon dactylon*), while the lower portion of the swale (near the confluence with Robla Creek) receives backwater from the creek and supports a mix of marsh species (Figure 4a).

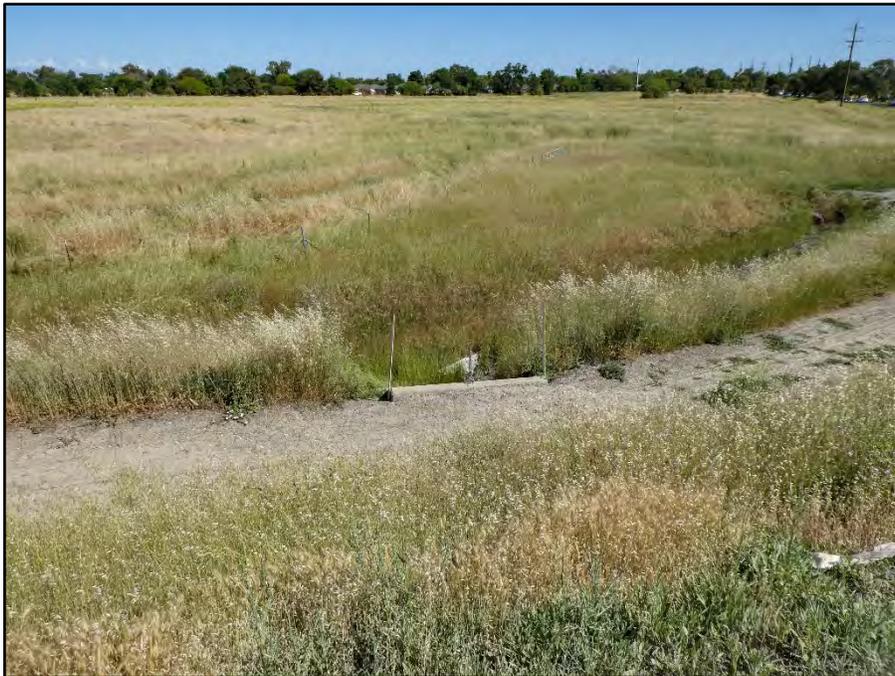
Looking southeast along western side of study area over culvert that drains into Robla Creek. *Photo Date: 5-03-20.*

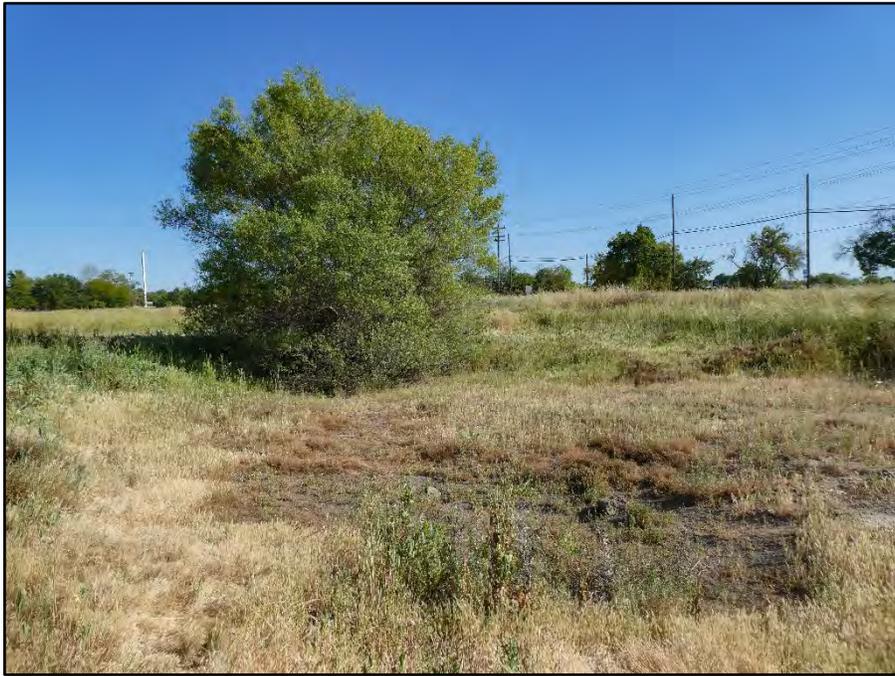
Figure 4b

Looking southeast over SW-1. One large Goodding's willow occupies the center of the wetland. *Photo Date: 5-03-20.*

Three seasonal wetlands are mapped in the study area totaling 0.435 acre. Seasonal Wetland 1 (SW-1), which appears to be an excavated feature, is located in the western area of the site. It is approximately three feet deep and has exposed hardpan in the bottom. There is no outlet but the feature does not appear to fill to maximum. It supports a variable flora of mostly annual species, the most abundant being annual beard grass (*Polypogon monspeliensis*). Stalked popcorn-flower (*Plagiobothrys stipitatus*) is abundant in the basin as is prickly lettuce (*Lactuca serriola*), Italian ryegrass, curly dock (*Rumex crispus*) and creeping spikerush (*Eleocharis macrostachya*). One large Goodding's black willow also grows in the basin of Seasonal Wetland 1 (Figure 4b).

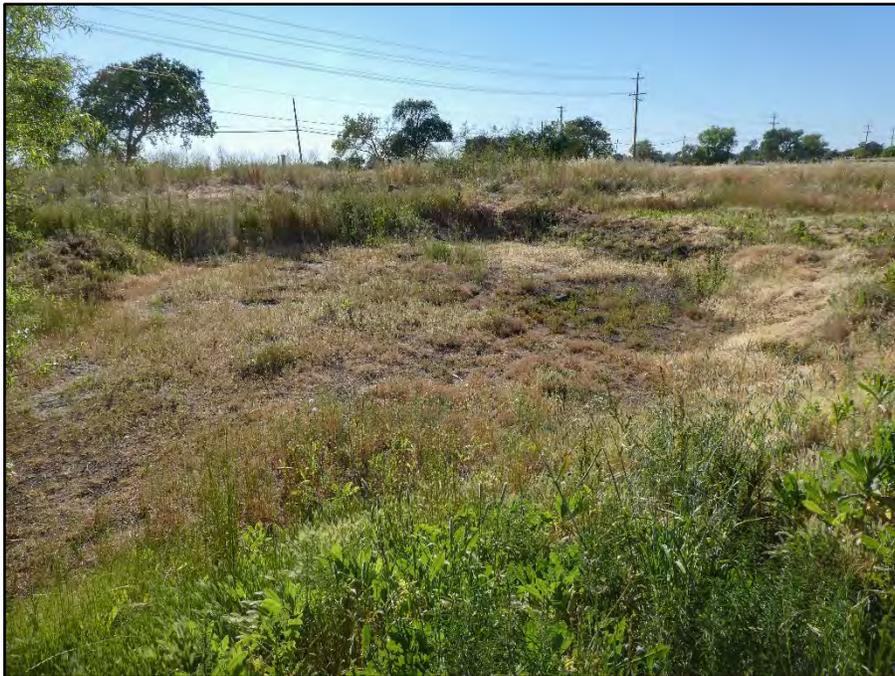
Looking northwest over northern portion of SW-1. *Photo Date: 5-03-20.*

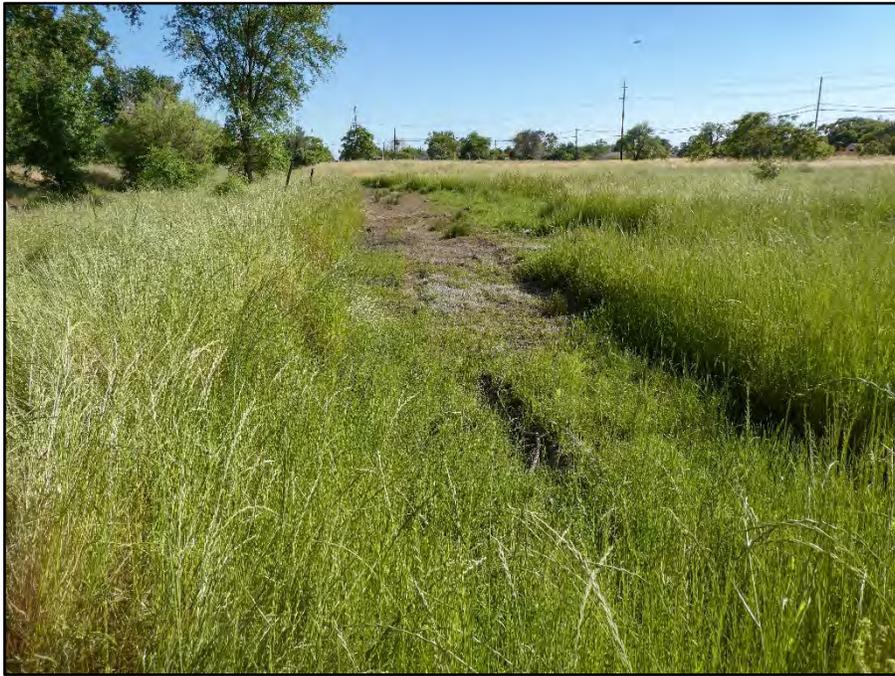
Figure 4c

Looking south over SW-2 along eastern project area fence line.
Photo Date: 5-03-20.

Seasonal Wetland 2 (SW-2) is located along the eastern study area boundary and is generally a low area of the field near the outfall of a storm drain originating in the subdivision just east of the study area. The wetland supports a mix of seasonal wetland and vernal pool species including spikerush, purslane speedwell (*Veronica peregrina* subsp. *xalapensis*), double-horned downingia (*Downingia bicornuta* var. *bicornuta*), common knotweed (*Polygonum aviculare*), and hyssop loosestrife (*Lythrum hyssopifolia*). The wetland is quite compromised by frequent disking and the subtle edge of the wetland is covered by dense Italian ryegrass (Figure 4c).

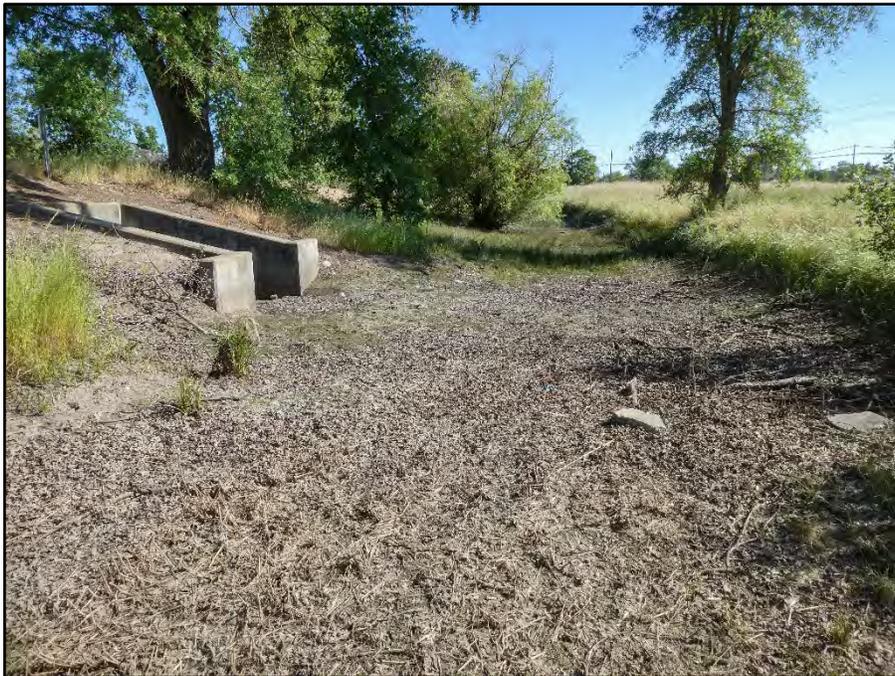
Looking south from within SW-3 at outfall culvert that provides much of the water to this wetland. *Photo Date: 5-03-20.*

Seasonal Wetland 3 (SW-3) is adjacent to SW-2 but it is situated between the fence line and the bike trail within the mixed woodland strip. It is not as frequently disturbed and has a more well-defined edge. It contains more organic matter and is sparsely vegetated by Italian ryegrass, curly dock, and other wetland generalists (Figure 4c).

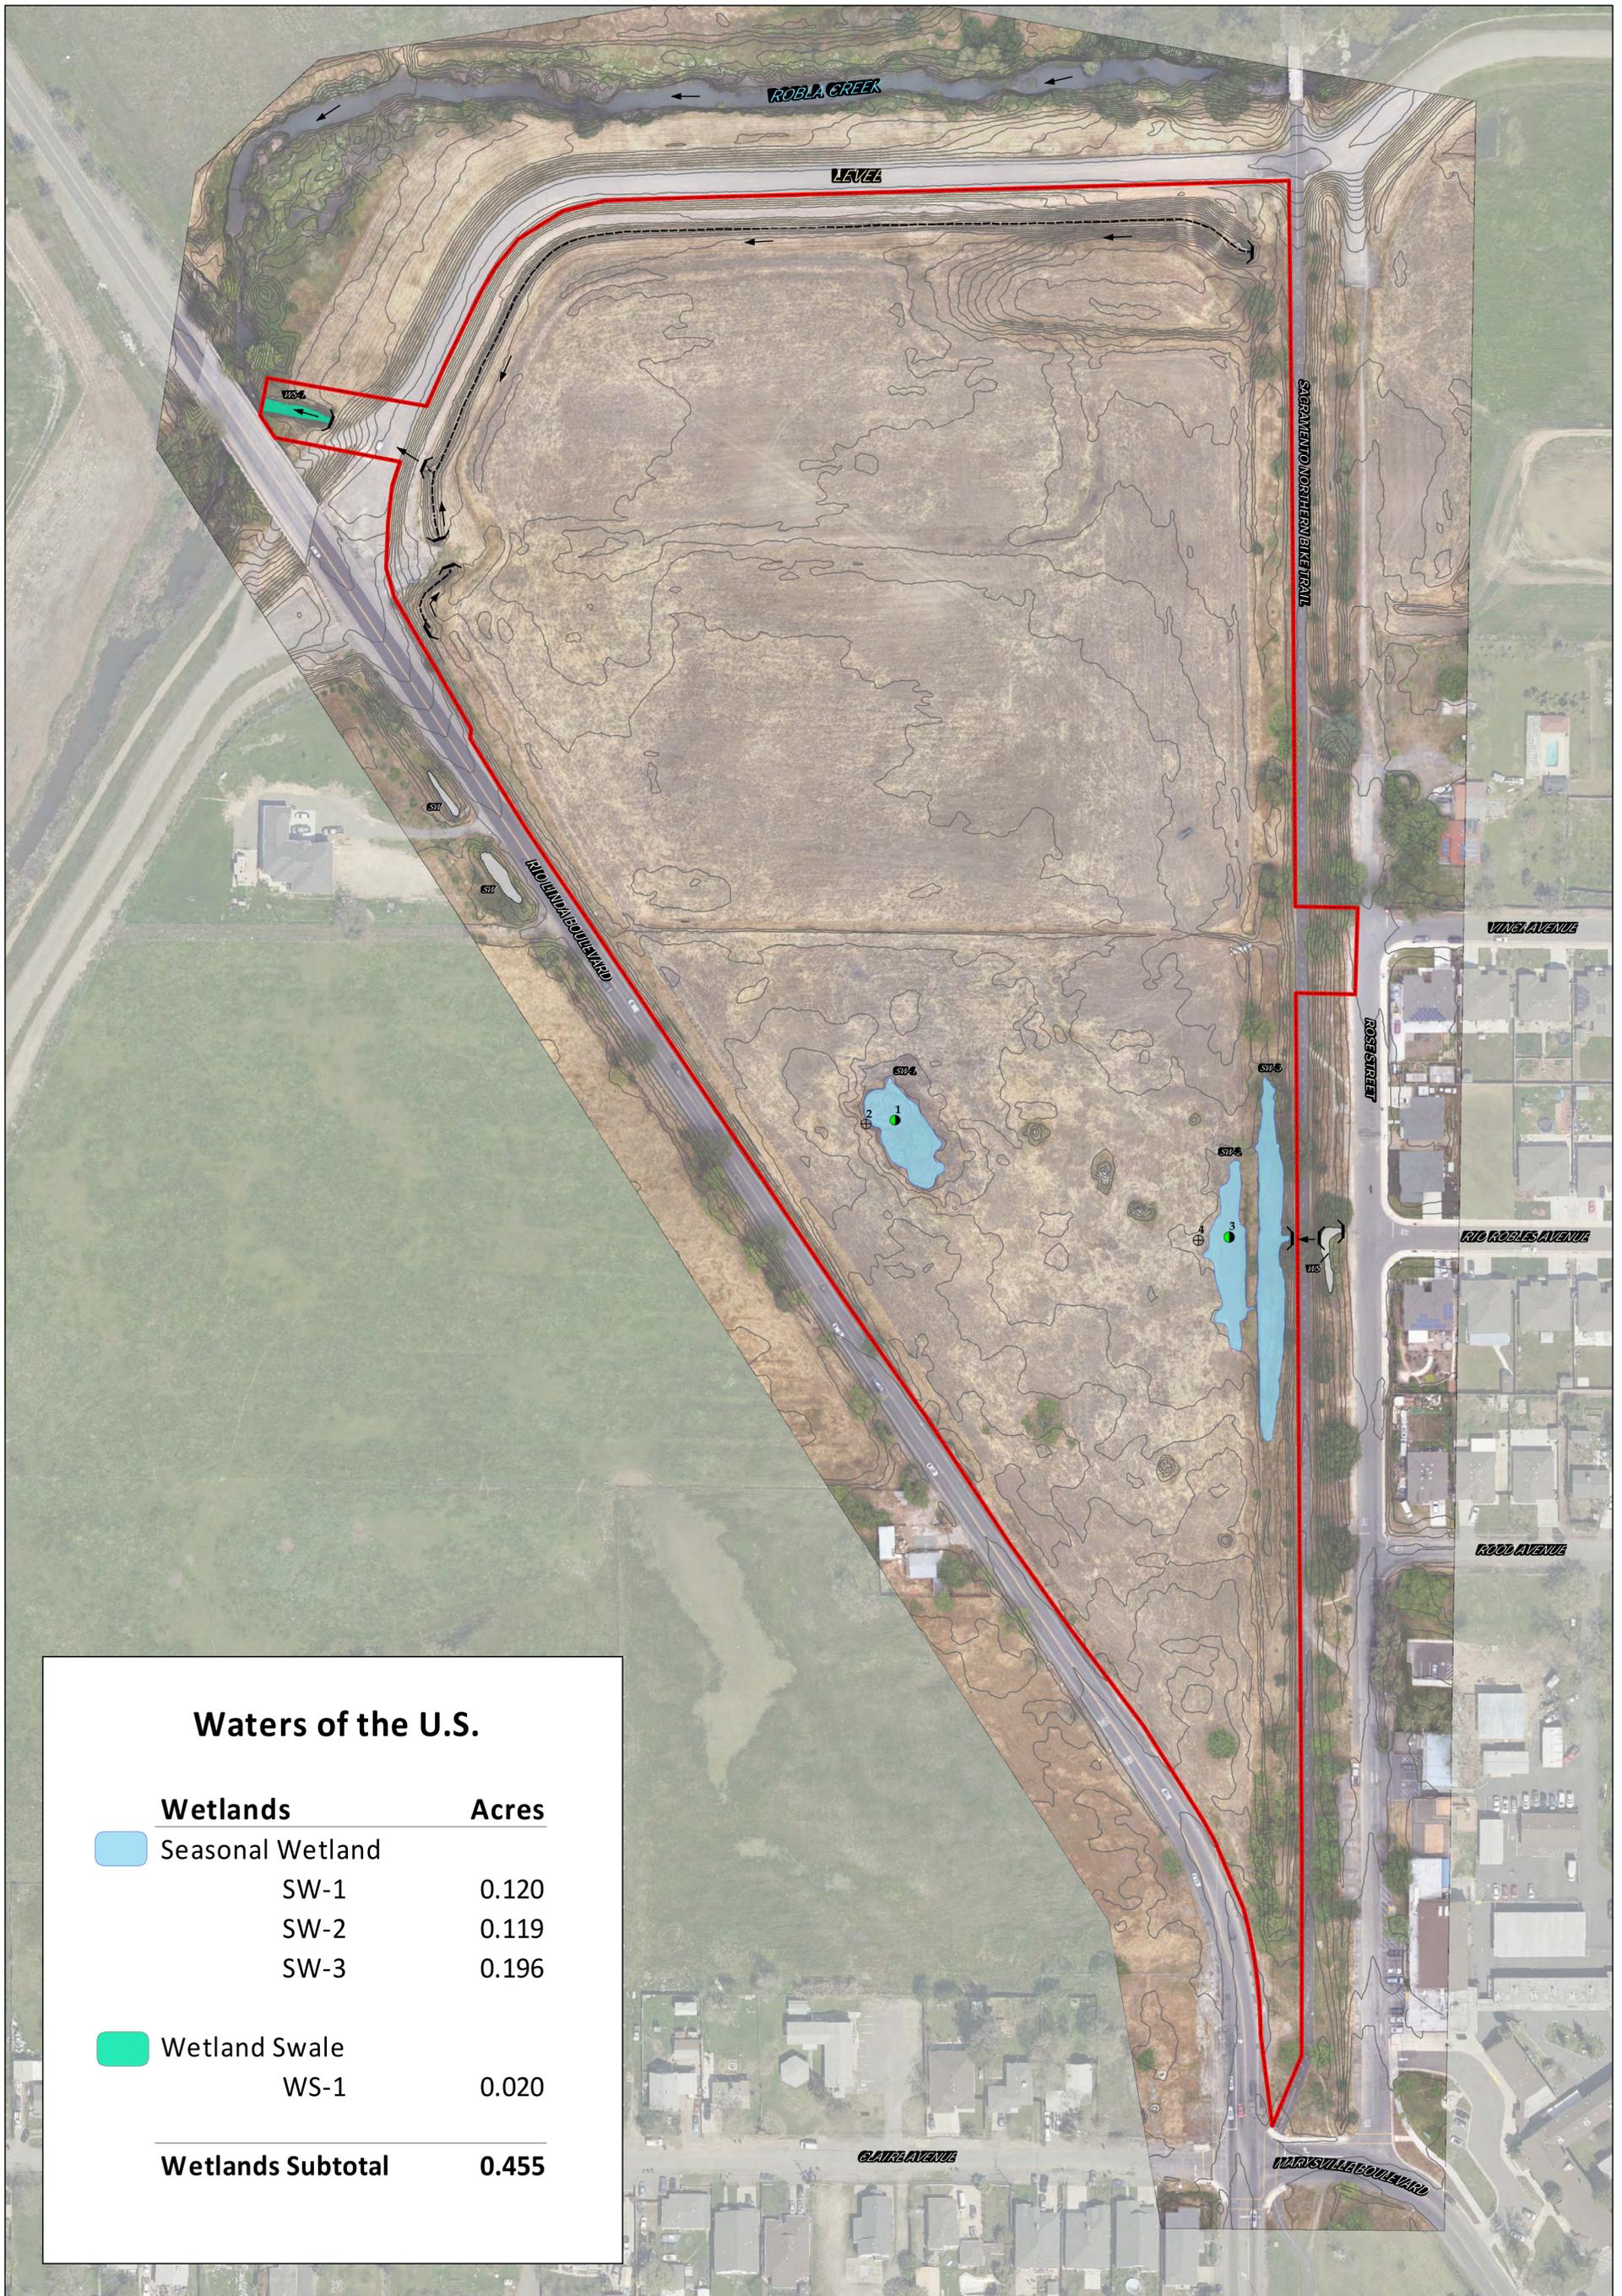
Figure 5

Wetlands	Acres
■ Seasonal Wetland	
SW-1	0.120
SW-2	0.119
SW-3	0.196
■ Wetland Swale	
WS-1	0.020
Wetlands Subtotal	0.455

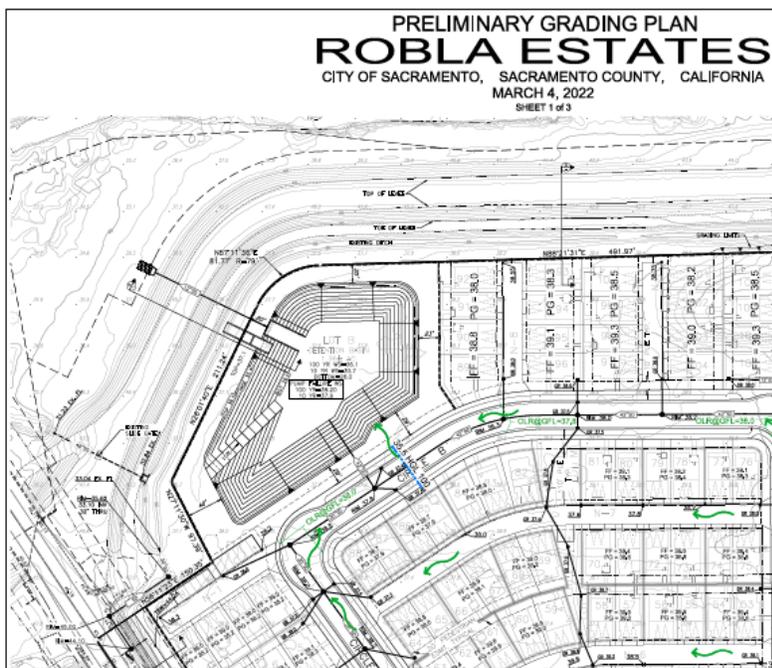
The location of the proposed outfall is on the water side of the Robla Creek levee as shown in the exhibit below.

The outfall is the overflow for the project detention basin. The outfall is piped through the levee and discharges at the tow of the levee into rock energy dissipaters. Water sheetflows from that location towards Robla Creek.

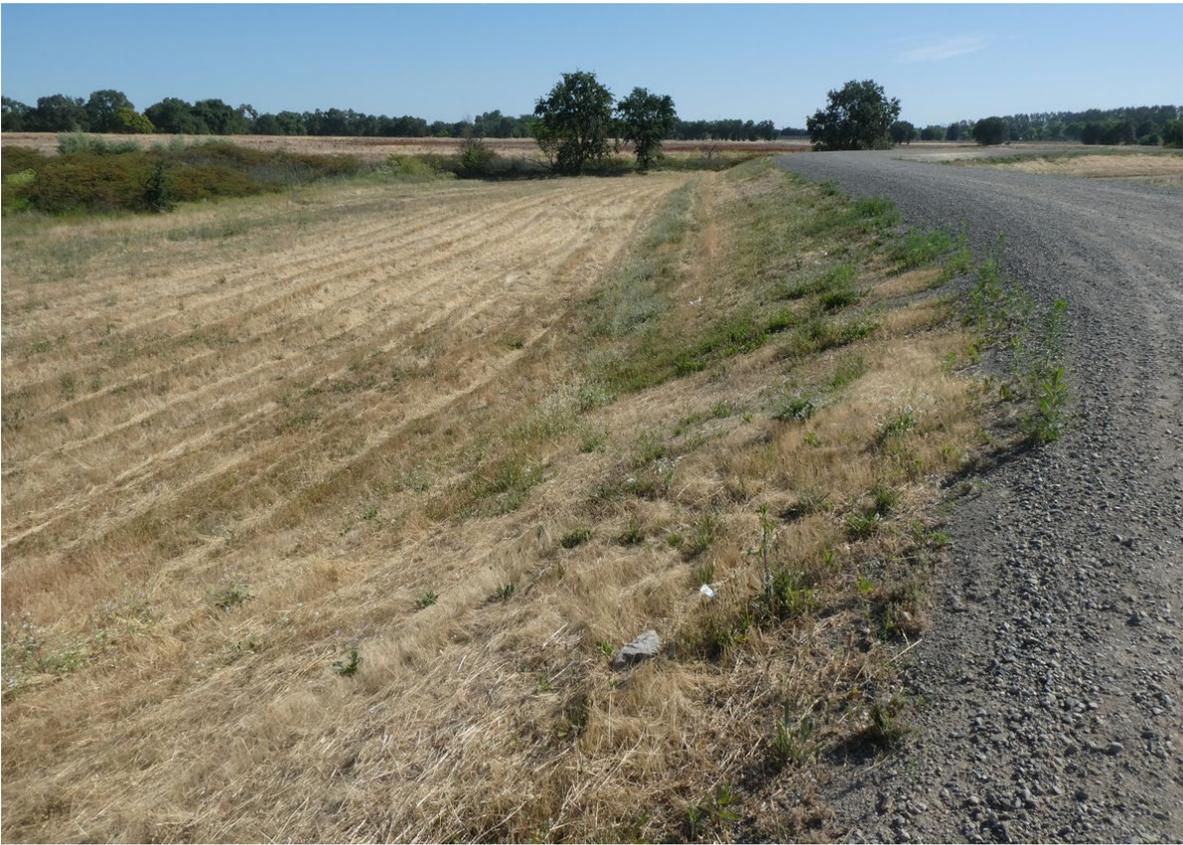
Looking northeast over outfall location.

The outfall location is situated in an upland annual grassland habitat dominated by weedy grass and forb species including ripgut grass, soft chess, Bermudagrass, broadleaf filaree, chicory, and winter vetch (scientific names provide in original report). The area from the top of the levee slope to the creek is a flood terrace but below the Ordinary High Water Mark (OHWM). The OHWM is the line at the edge of a waterway that defines the limit of federal (Corps of Engineers) jurisdiction. Along Robla Creek, the OHWM is much nearer the active channel and more than 50 feet away from the outfall location.

In conclusion, the proposed outfall location will not cause impacts to aquatic resources or special status plant or animal species but will require application of a Lake and Streambed Alteration Agreement from CDFW.

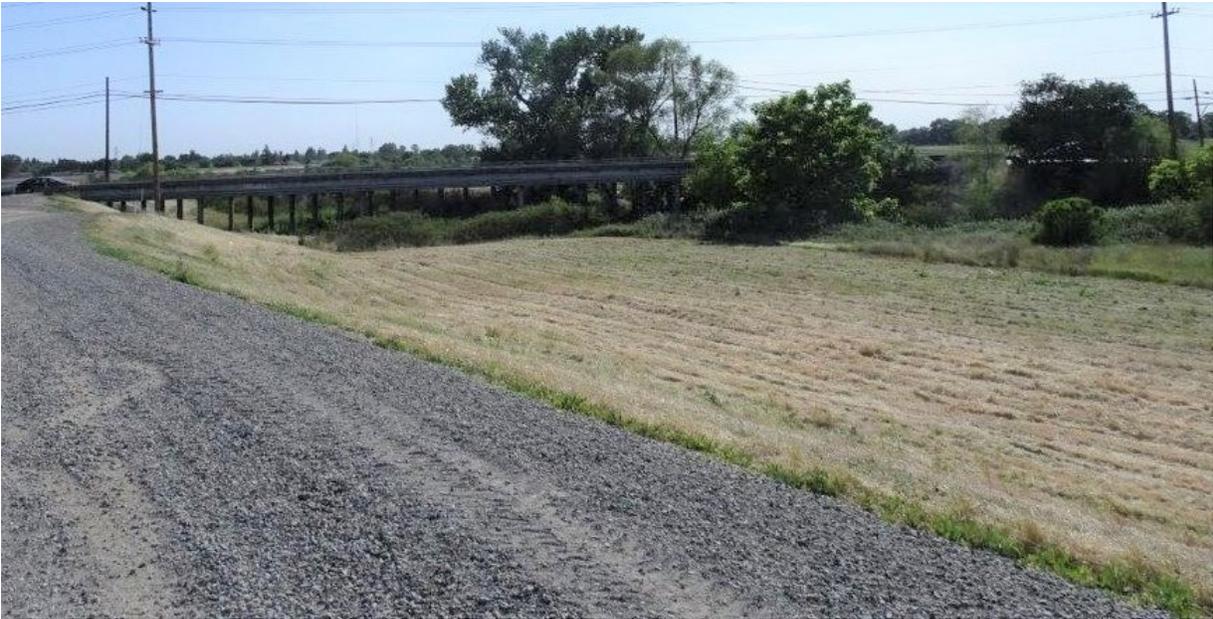
Looking west over outfall location and Rio Linda Boulevard bridge over Robla Creek.
