DRAFT
Aquatic Resources
Delineation Report

Stone Beetland

City of Sacramento, Sacramento County, California

January 2021

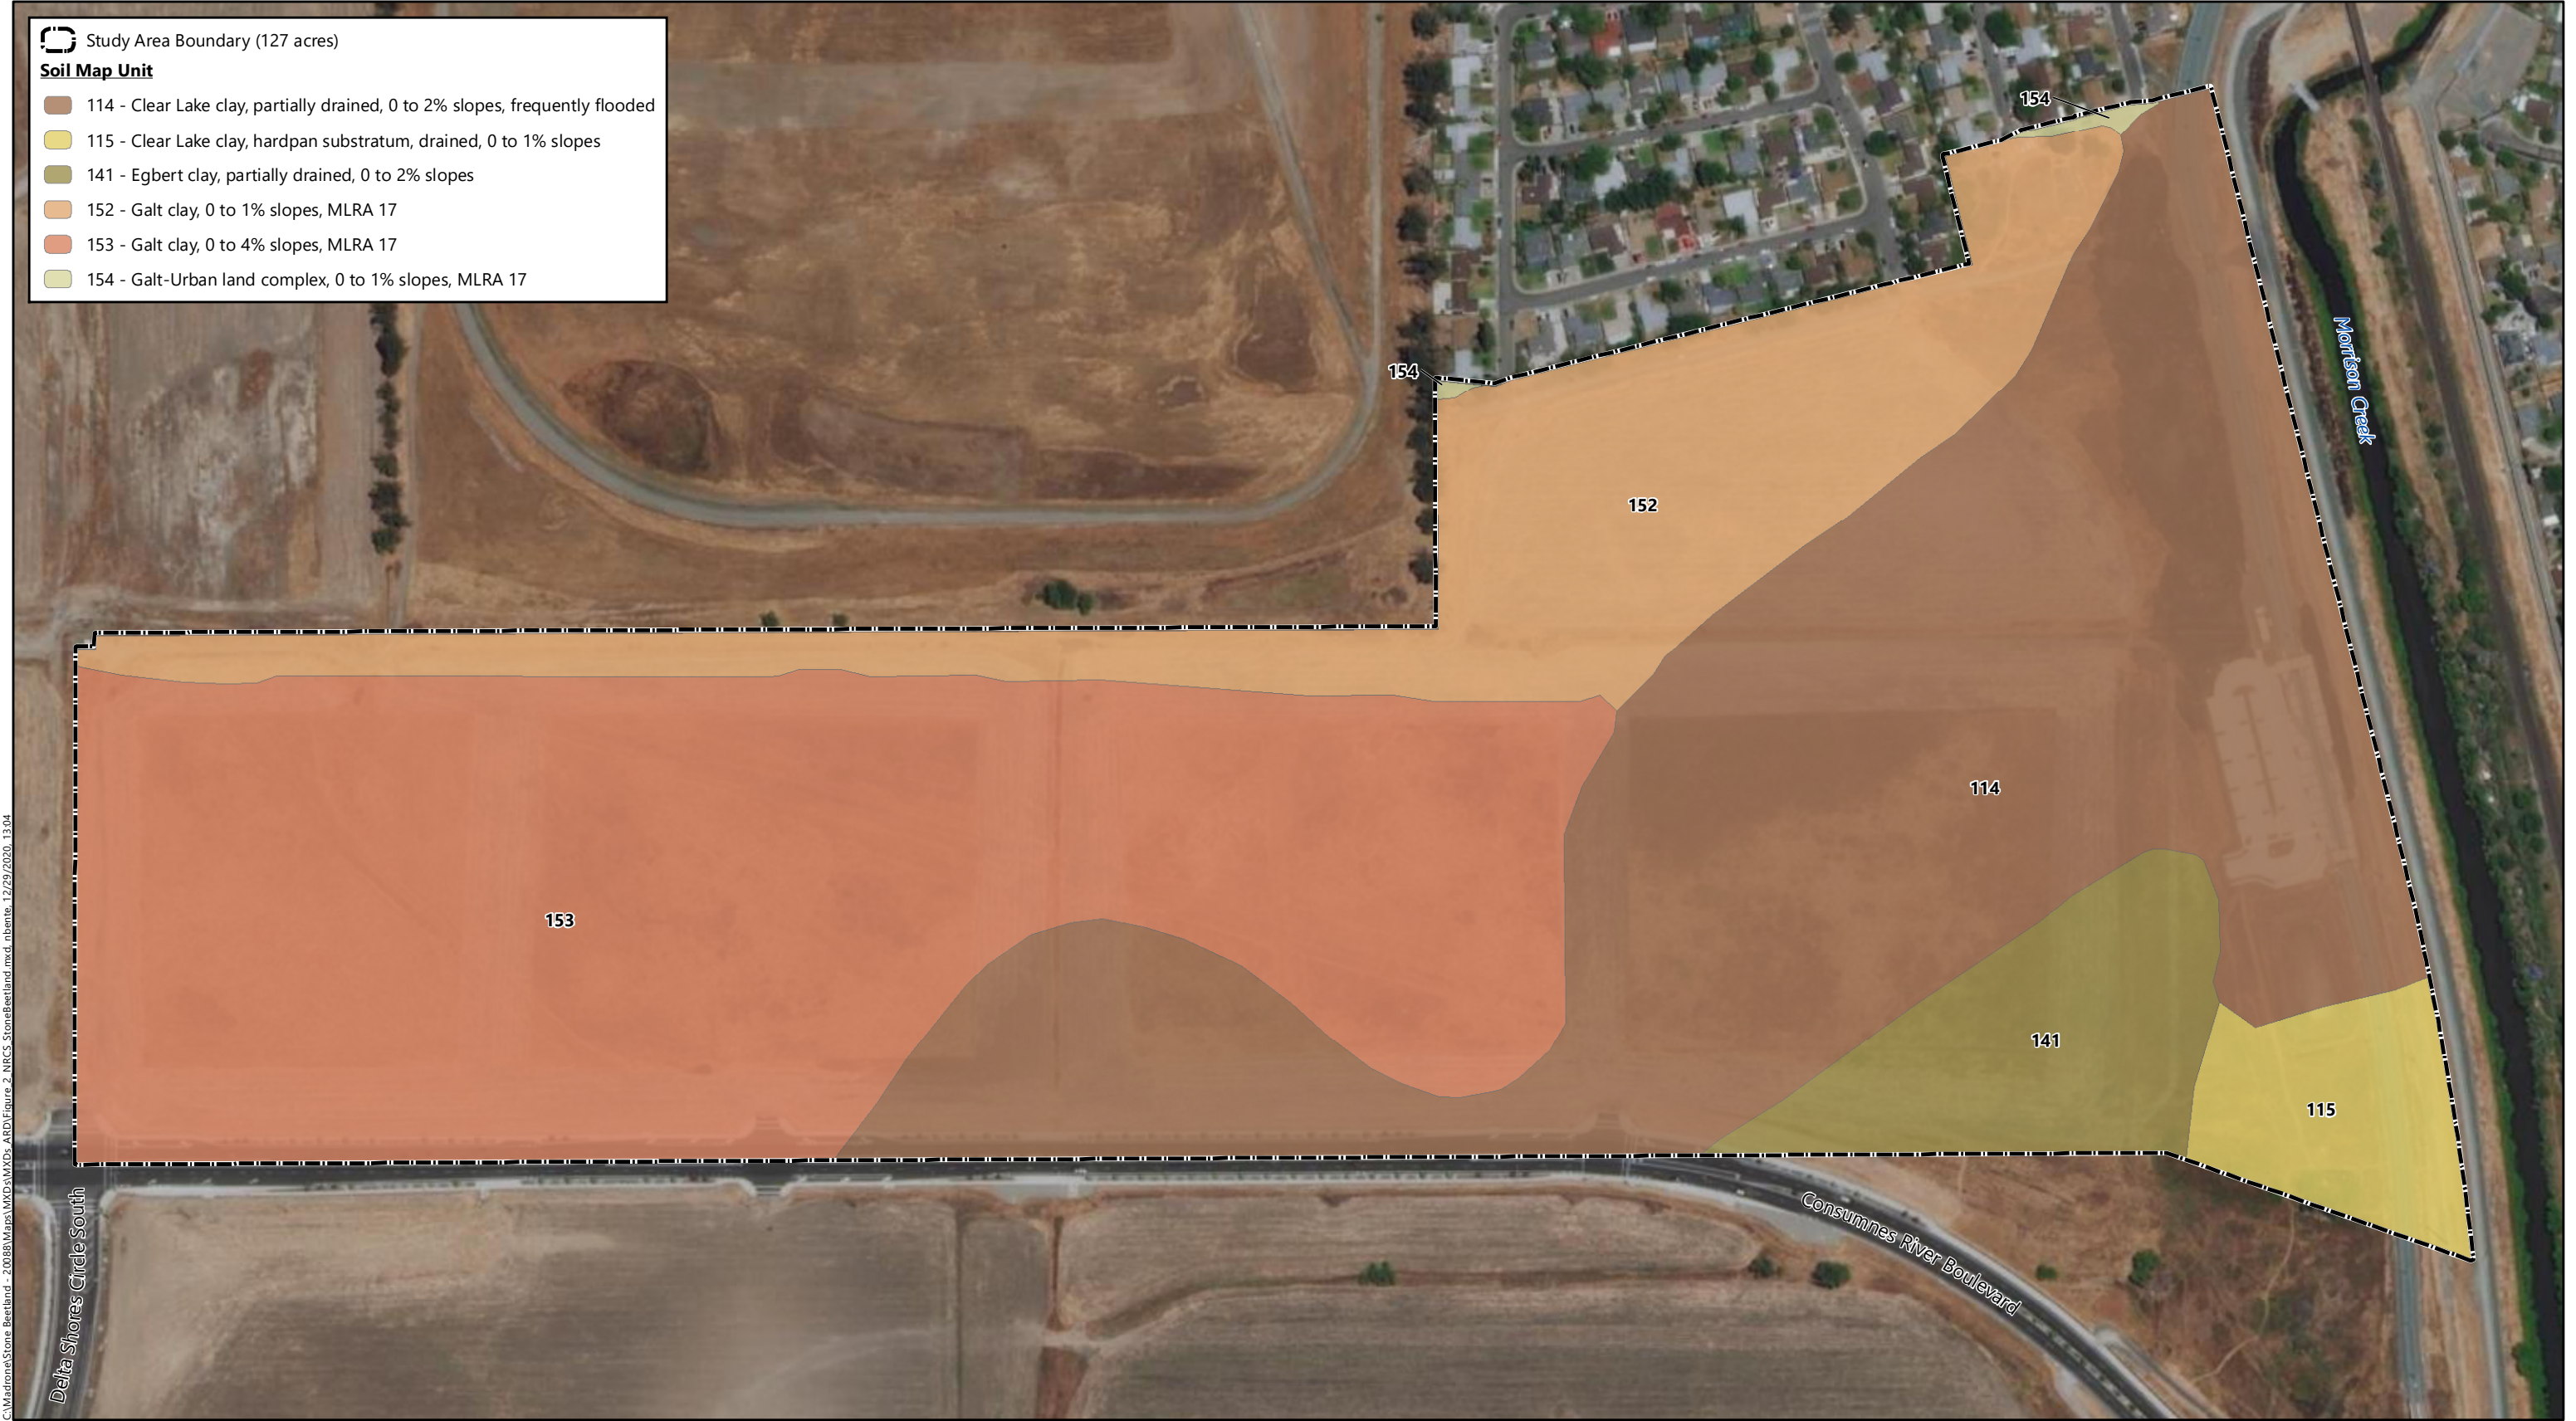
Figure 2. Natural Resources Conservation Service Soils

154 - Galt-Urban land complex, 0 to 1% slopes, MLRA 17

The NRCS has mapped the six soil units listed below within the Study Area (Figure 2) (NRCS 2020):

1. Clear Lake clay, partially drained, 0 to 2% slopes, frequently flooded (114) – the Clear Lake component and the Dierssen and Egbert inclusions are classified as hydric. This soil map unit is non-saline to slightly saline; and the pH ranges from slightly acid to moderately alkaline within the upper portion of the root zone.

2. Clear Lake clay, hardpan substratum, drained, 0 to 1% slopes (115) – the Clear Lake component and the Cosumnes inclusion are classified as hydric. This soil map unit is non-saline to very slightly saline; and the pH ranges from slightly acid to moderately alkaline within the upper portion of the root zone.

3. Egbert clay, partially drained, 0 to 2% slopes (141) - the Egbert component and the Clear Lake, Gazwell, Laugenour, Scribner, and Valpac inclusions are classified as hydric. This soil map unit is non-saline to very slightly saline; and the pH ranges from slightly acid to slightly alkaline within the upper portion of the root zone.

4. Galt clay, 0 to 1% slopes, MLRA 17 (152) – the Galt component and the Clear Lake inclusion are classified as hydric. This soil map unit is non-saline; and the pH ranges from slightly acid to neutral within the upper portion of the root zone.

5. Galt clay, 0 to 4% slopes, MLRA 17 (153) – the Galt component and the Clear Lake inclusion are within the root zone. classified as hydric. This soil map unit is non-saline; and the pH ranges from slightly acid to neutral within the upper portion of the root zone.

6. Galt-Urban land complex, 0 to 1% slopes, MLRA 17 (154) – the Galt component and the Clear Lake and Egbert inclusions are classified as hydric. This soil map unit is non-saline; and the pH ranges from slightly acid to neutral within the upper portion of the root zone.

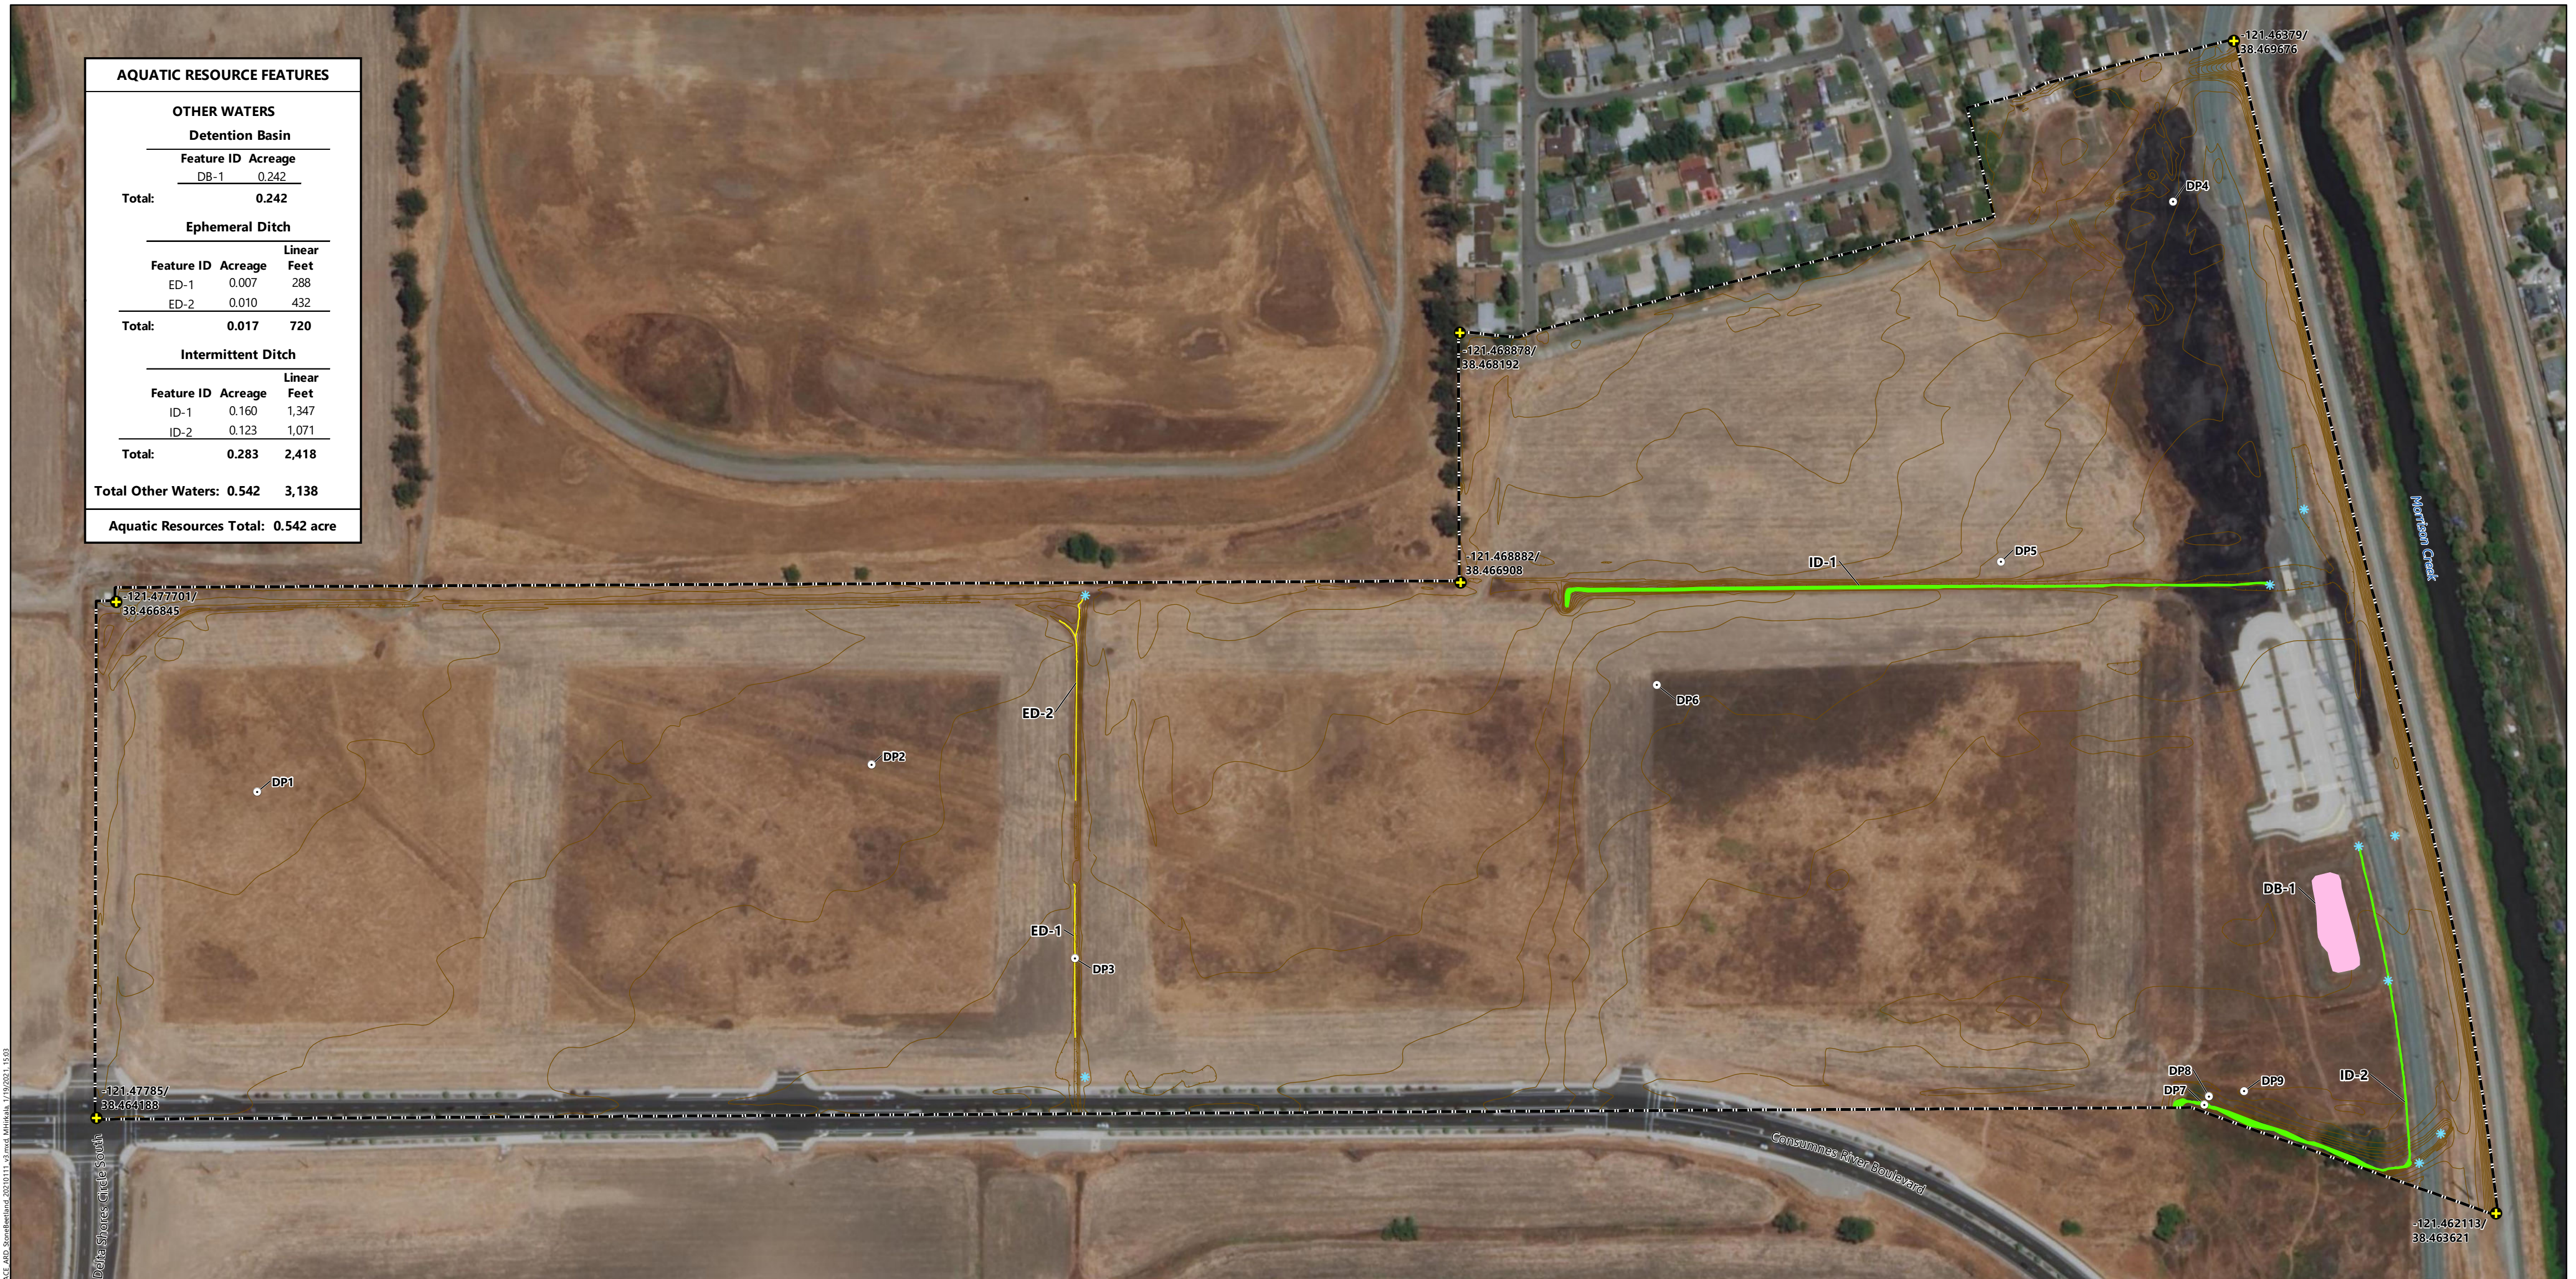
Aquatic Resources Delineation – Stone Beetland

AQUATIC RESOURCE FEATURES			
OTHER WATERS			
Detention Basin			
Feature ID	Acree		
DB-1	0.242		
Total:	0.242		
Ephemeral Ditch			
Feature ID	Acree	Linear Feet	
ED-1	0.007	288	
ED-2	0.010	432	
Total:	0.017	720	
Intermittent Ditch			
Feature ID	Acree	Linear Feet	
ID-1	0.160	1,347	
ID-2	0.123	1,071	
Total:	0.283	2,418	
Total Other Waters: 0.542 3,138			
Aquatic Resources Total: 0.542 acre

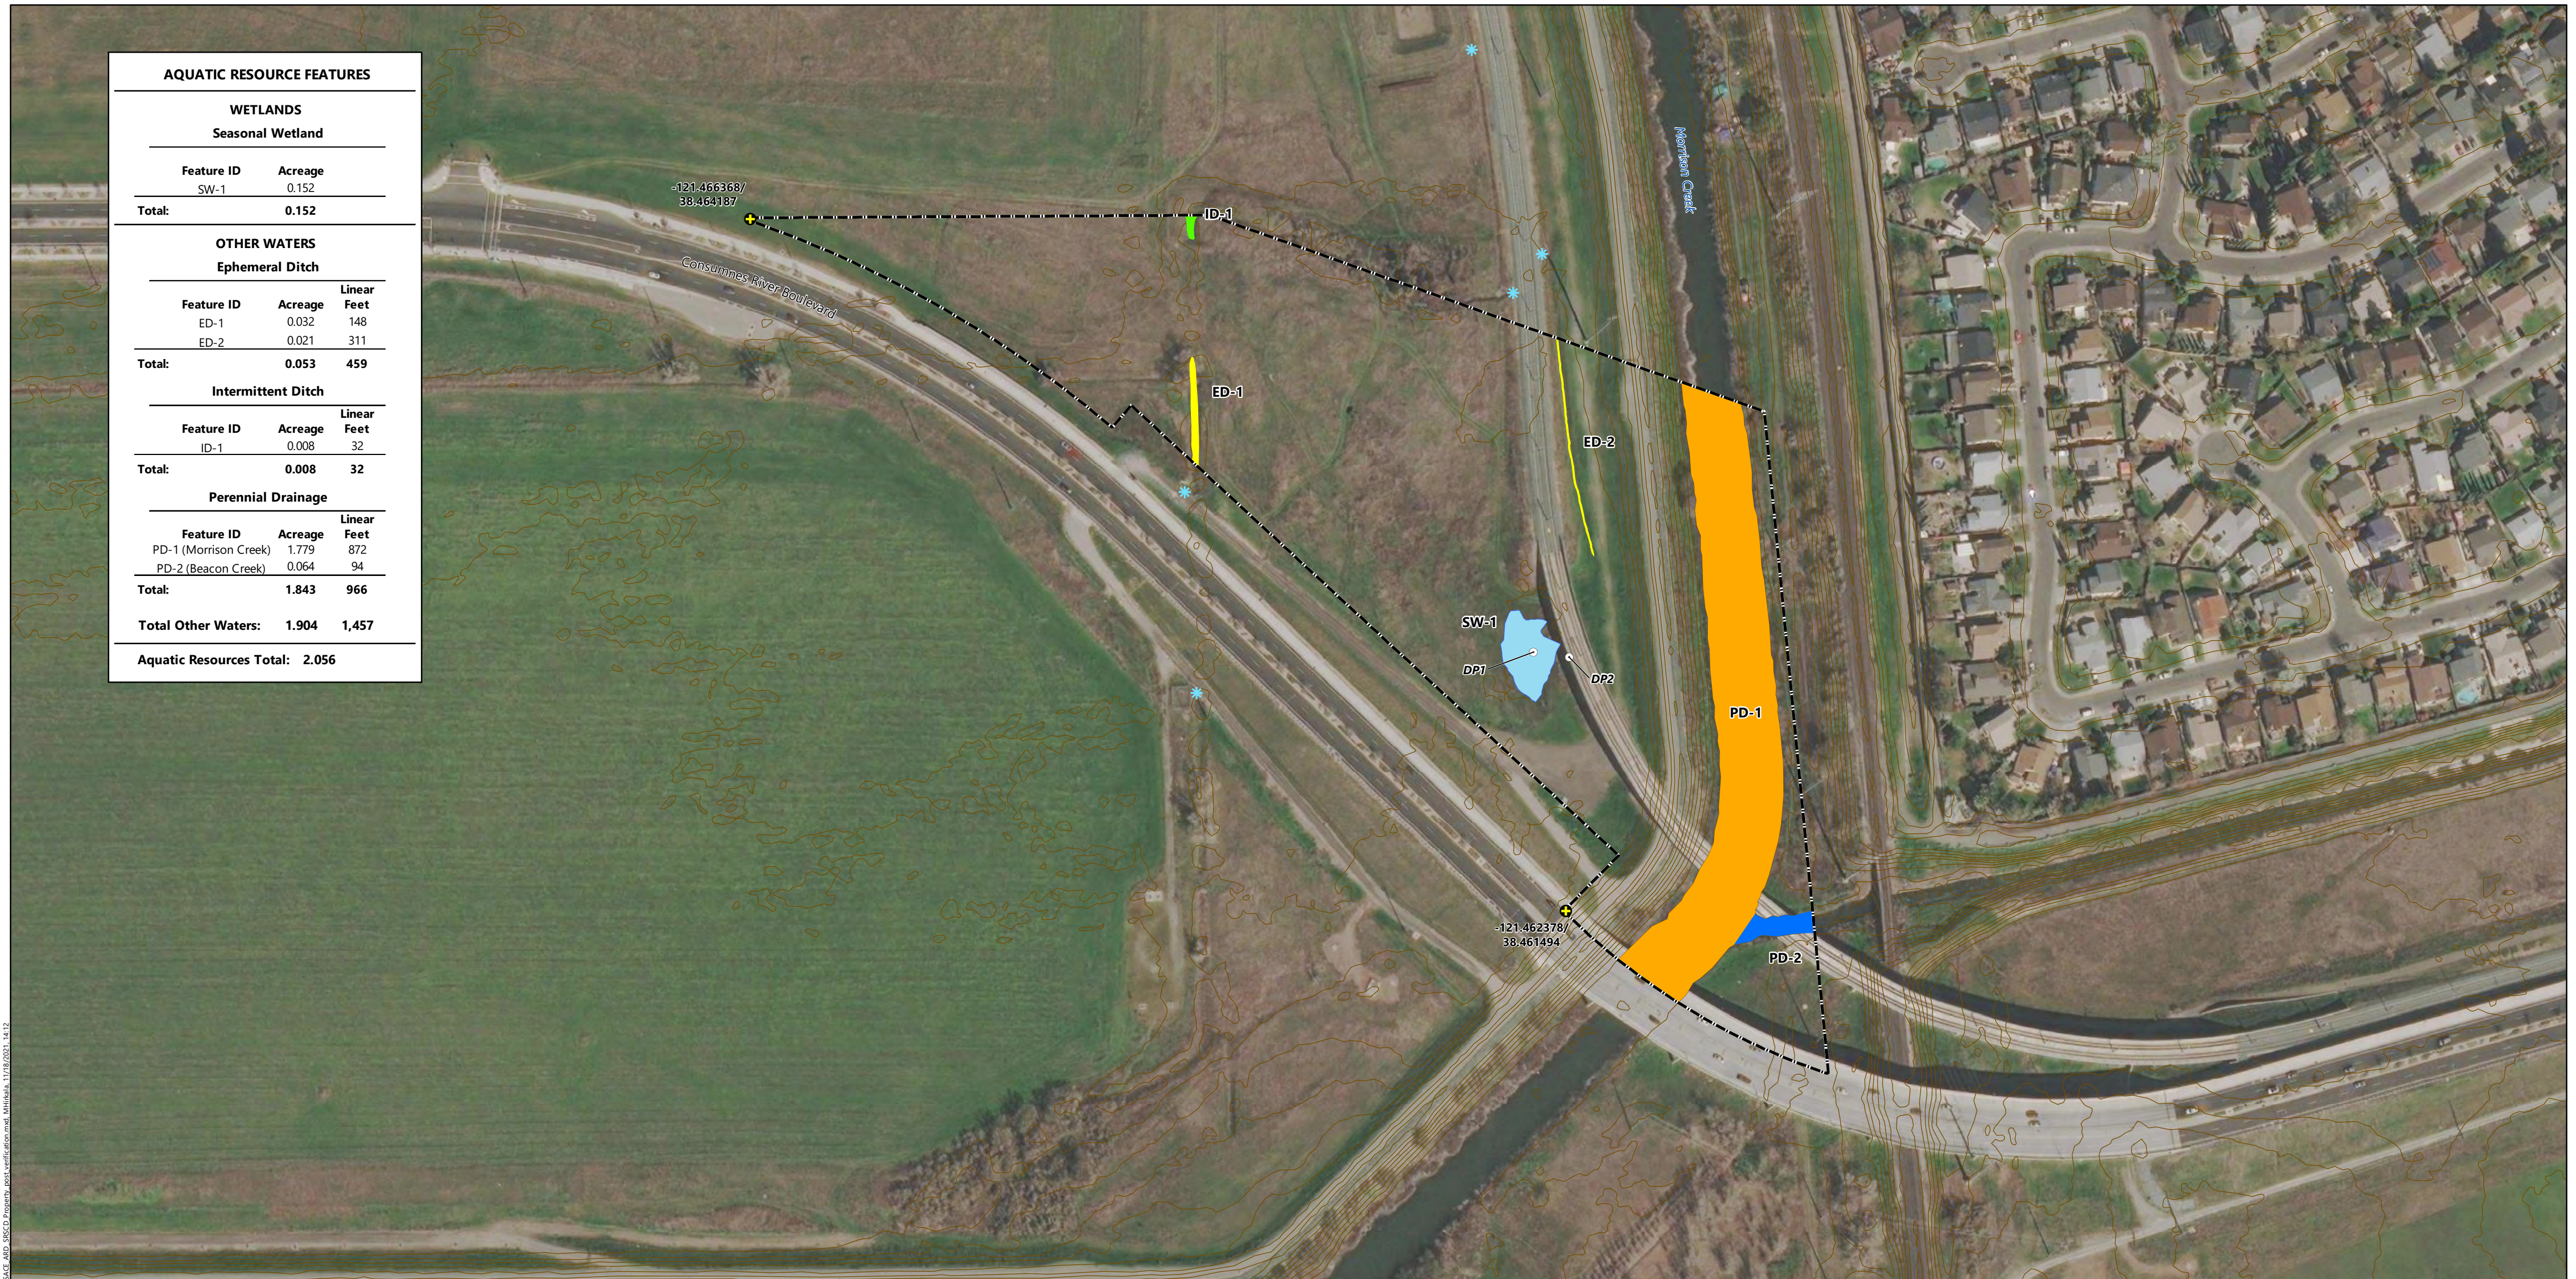
AQUATIC RESOURCE FEATURES			
WETLANDS			
Seasonal Wetland			
Feature ID	Acreage		
SW-1	0.152		
Total:	0.152		
OTHER WATERS			
Ephemeral Ditch			
Feature ID	Acreage	Linear Feet	
ED-1	0.032	148	
ED-2	0.021	311	
Total:	0.053	459	
Intermittent Ditch			
Feature ID	Acreage	Linear Feet	
ID-1	0.008	32	
Total:	0.008	32	
Perennial Drainage			
Feature ID	Acreage	Linear Feet	
PD-1 (Morrison Creek)	1.779	872	
PD-2 (Beacon Creek)	0.064	94	
Total:	1.843	966	
Total Other Waters:	1.904	1,457	
Aquatic Resources Total:	2.056
