# **PHASE I ENVIRONMENTAL SITE ASSESSMENT**

**PHASE 1 ENVIRONMENTAL SITE ASSESSMENT**

Capital Station 65  
424 N. 7<sup>th</sup> Street  
Sacramento, CA 95814

May 2006

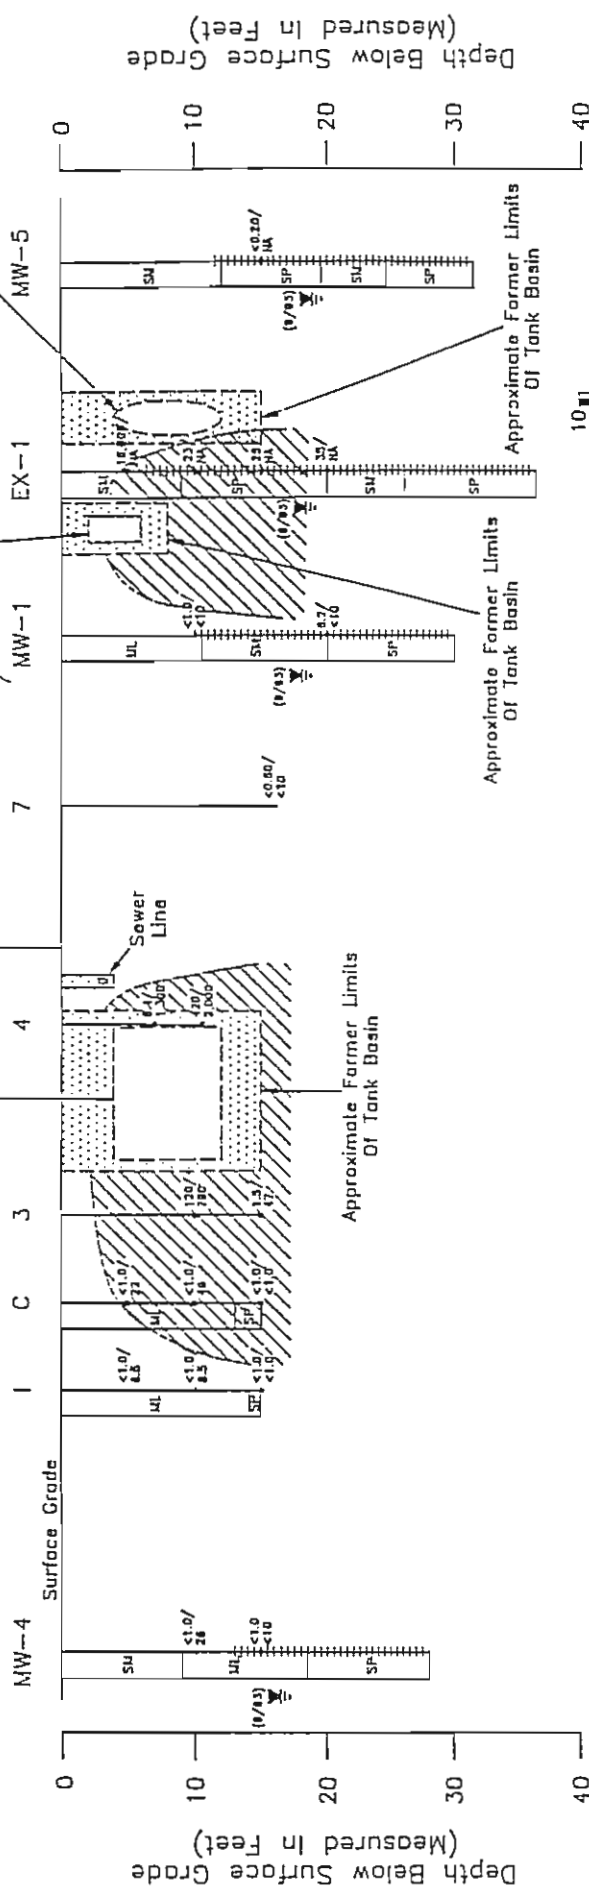
FIGURE 13  
GEOLOGIC CROSS-SECTION B-B'

Approximate Former Location Of  
8,000-Gallon Gasoline  
Underground Storage Tank

Inferred Area Of Soil Containing Petroleum Hydrocarbons At Concentrations Exceeding 10 mg/Kg

SIERRA QUALITY CANNERS  
428 NORTH 7TH STREET  
SACRAMENTO, CALIFORNIA

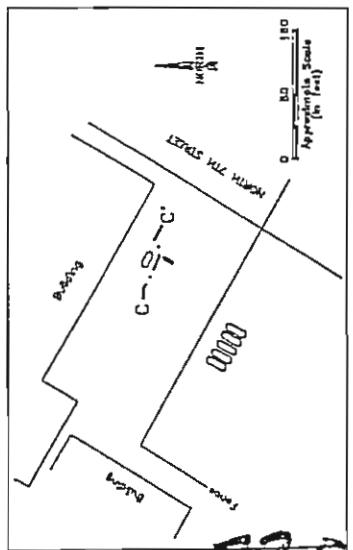
FIGURE 14  
GEOLOGIC CROSS-SECTION C-C'  
SIERRA QUALITY CHAINERS  
420 NORTH 7TH STREET  
SACRAMENTO, CALIFORNIA

Inferred Area Of Soil Containing Petroleum Hydrocarbons At Concentrations Exceeding 10 mg/kg

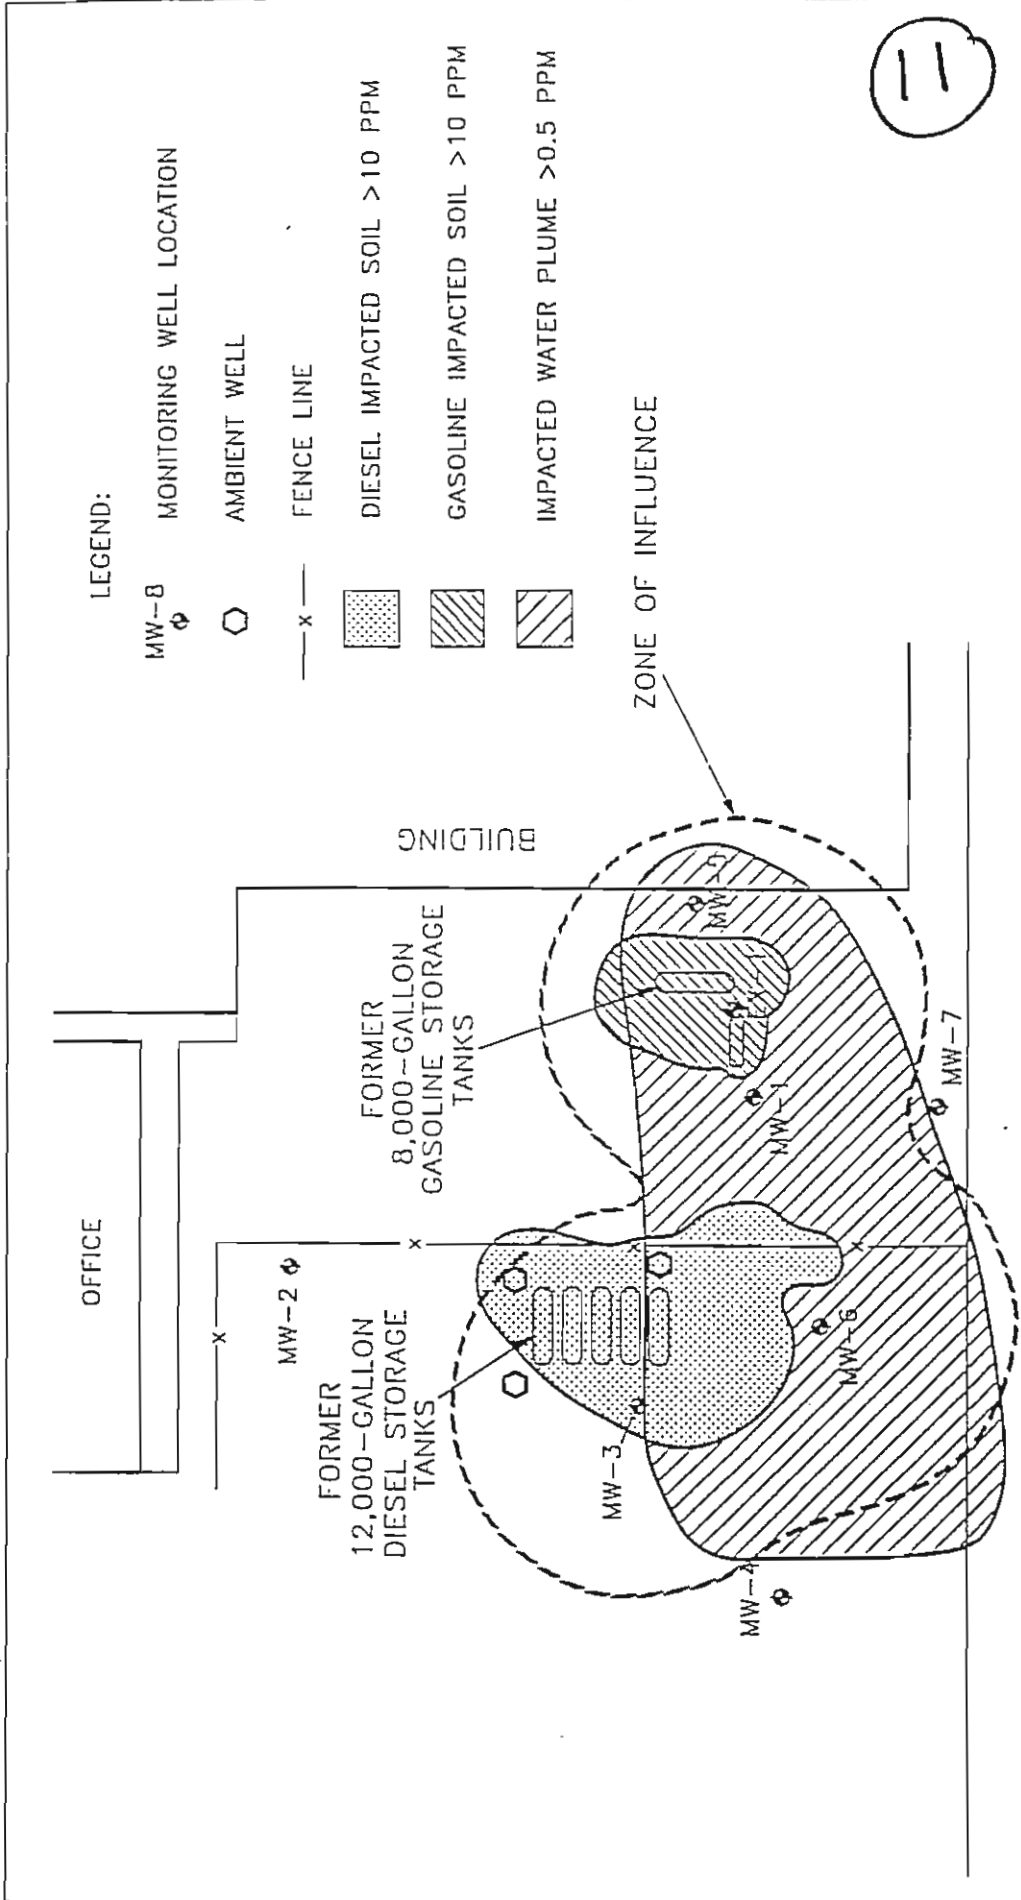
- MW-8  $\phi$  MONITORING WELL LOCATION
- $\circ$  AMBIENT WELL
- x— FENCE LINE
- [Stippled Box] DIESEL IMPACTED SOIL >10 PPM
- [Diagonal Lines Box] GASOLINE IMPACTED SOIL >10 PPM
- [Cross-hatched Box] IMPACTED WATER PLUME >0.5 PPM
