Two Rivers Trail Phase II: Project Comments

RE: Supplemental Comments on the Draft Environmental Impact Report for the Two Rivers Trail - Phase II Project

The Technical and Resource Advisory Committee (TRAC), as part of the Lower American River Task Force's (LARTF) Bank Protection Working Group (BPWG), presents this summary report and its attachments to document for the United States Army Corps of Engineers (USACE) the process, considerations, deliberations, and recommendations for Tier 1 and Tier 2 bank protection sites identified in Subreach 2 of the Lower American River (LAR). The comprehensive and collaborative process has resulted in recommended bank protection conceptual designs for a total of ten segments in Subreach 2. The 10% conceptual designs presented later in this document have been substantially vetted and considered through extensive discussion, analysis, and refinement. The TRAC members support the conceptual designs presented herein as a means to achieve the intended goals of managing flood risk along LAR, while adhering to key regulations influencing bank protection design (e.g. Endangered Species Act, Wild and Scenic Rivers Act, American River Parkway Plan, etc

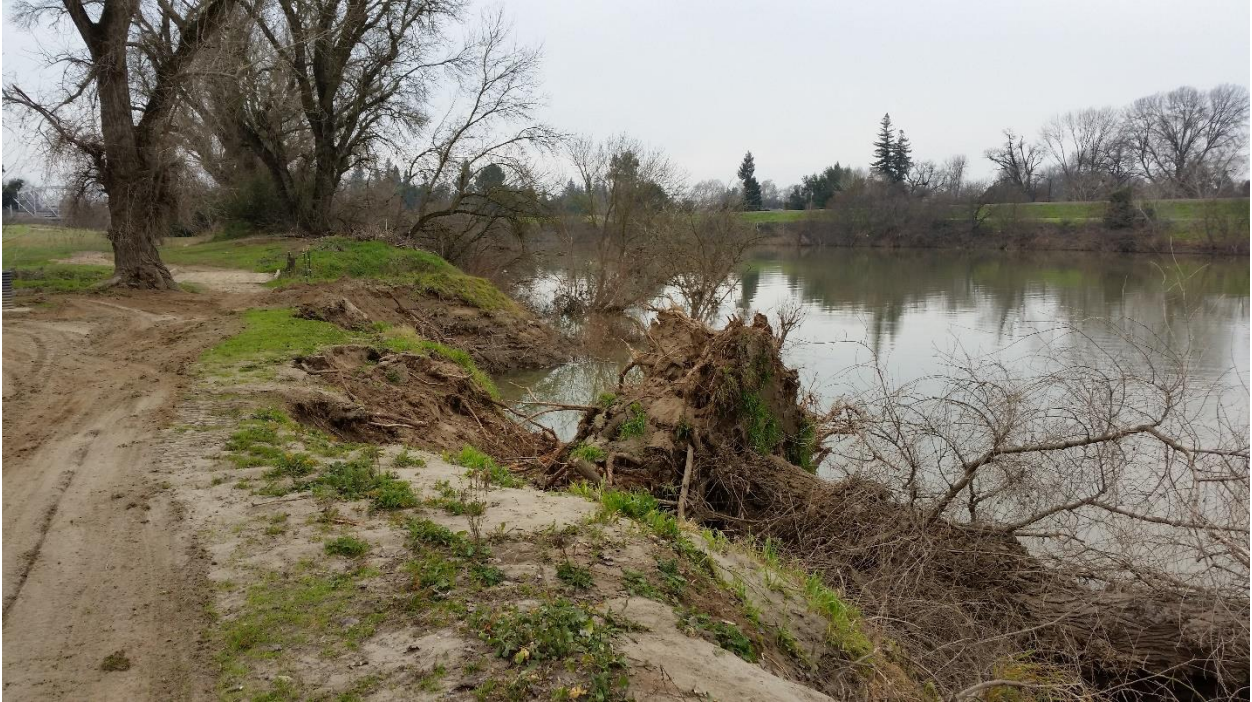
Figure 7. Example of Recent Bank Erosion and Limited Tree Cover Protecting Steep Erodible Banks on LAR at RM 6.0 Right Bank on Campus Commons Golf Course

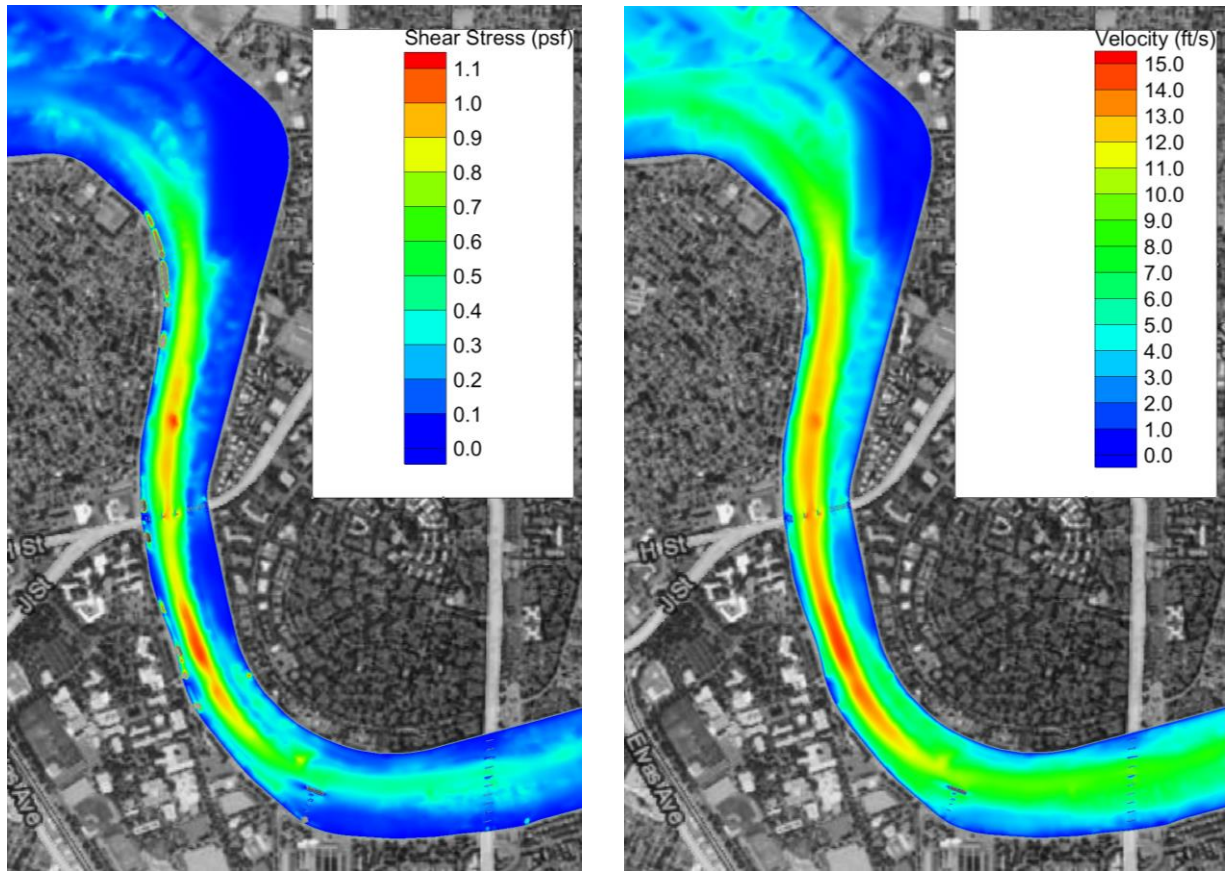
Figure 8 shows the model results for velocity and shear stress throughout Subreach 2 at a flow of 160,000 cfs. In-channel velocities exceed 10 feet per second (ft/s) from the Fairbairn intake downstream to Paradise Bend. Peak shear stresses are about 1.1 pounds per square foot (psf), with typical values between 0.5 and 1.0 psf instream, and less than 0.1 psf in the overbank area.

Figure 8. Subreach 2 Model Results for Shear Stress (left) and Velocity (right) during a Constant Discharge of 160,000 cfs

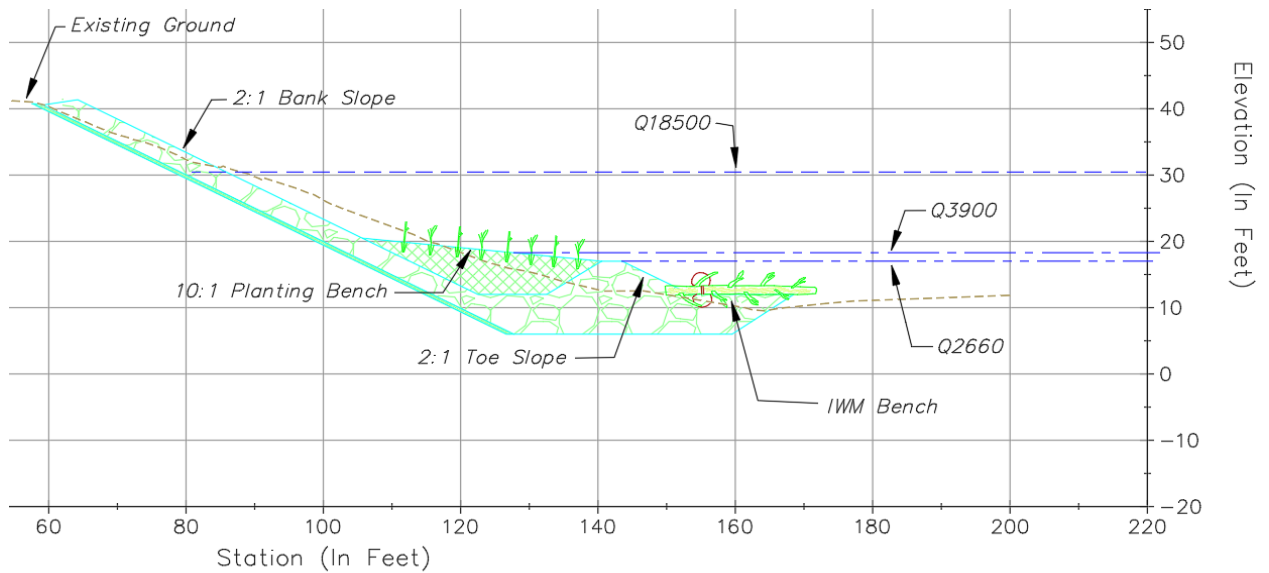
The base design was the initial concept presented- consisting of a rocked upper bank sloping down to a planting bench with an instream woody material bench on a launchable toe (Figure 16). This design addresses toe erosion as well as fluvial erosion of the upper bank. The planting bench will be varied in elevation and horizontal distance out into the water to provide diverse conditions of habitat. The design has a planting bench width of about 25 feet which is consistent with the planting bench width of modern revetment designs in Subreach 2.

Figure 16. Typical Cross Section of the Tier 1 Base Design with Labels Showing Average Summer/Fall (2,660 cfs), Average Winter/Spring (3,900 cfs), and 2-Year Storm Event (18,500 cfs) Water Levels

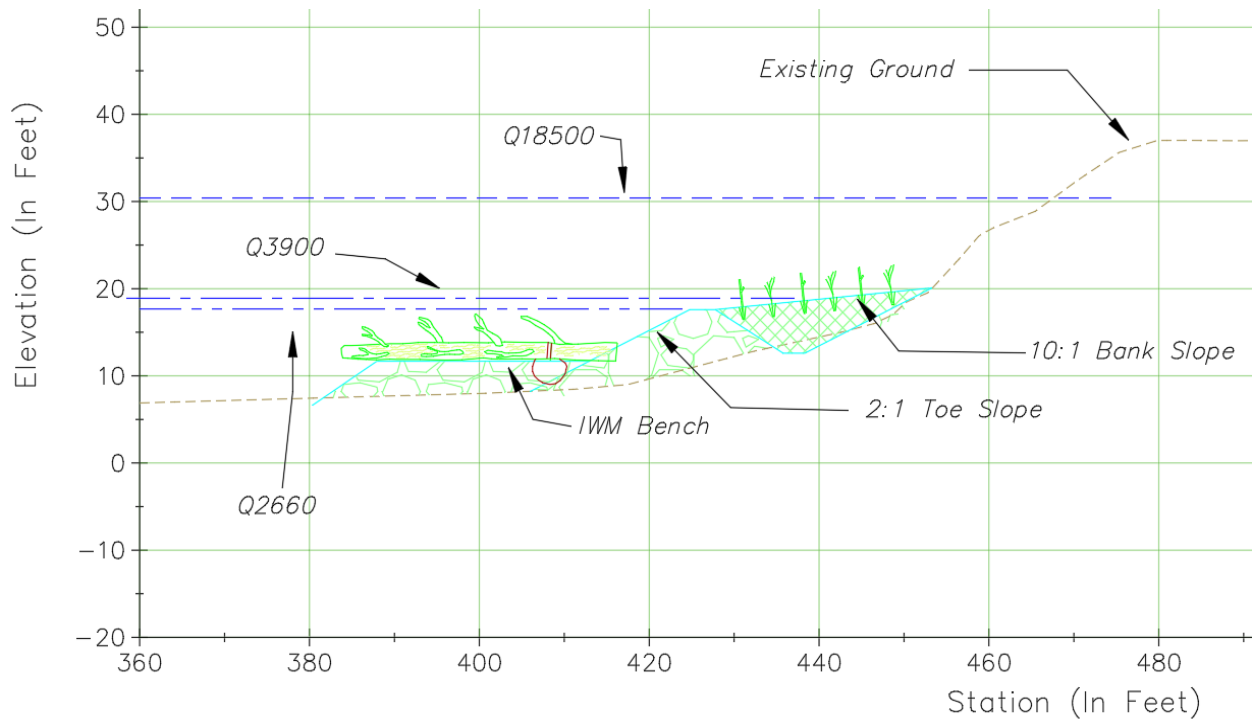
This design protects the bank toe while keeping the upper bank natural. A planting bench with an instream woody material bench on a launchable rock toe prevents toe erosion (Figure 21).

Figure 21. Typical Cross Section of the Tier 2 Small Bench With Toe Design With Labels Showing Average Summer/Fall (2,660 cfs), Average Winter/Spring (3,900 cfs), and 2-Year Storm Event (18,500 cfs) Water Levels

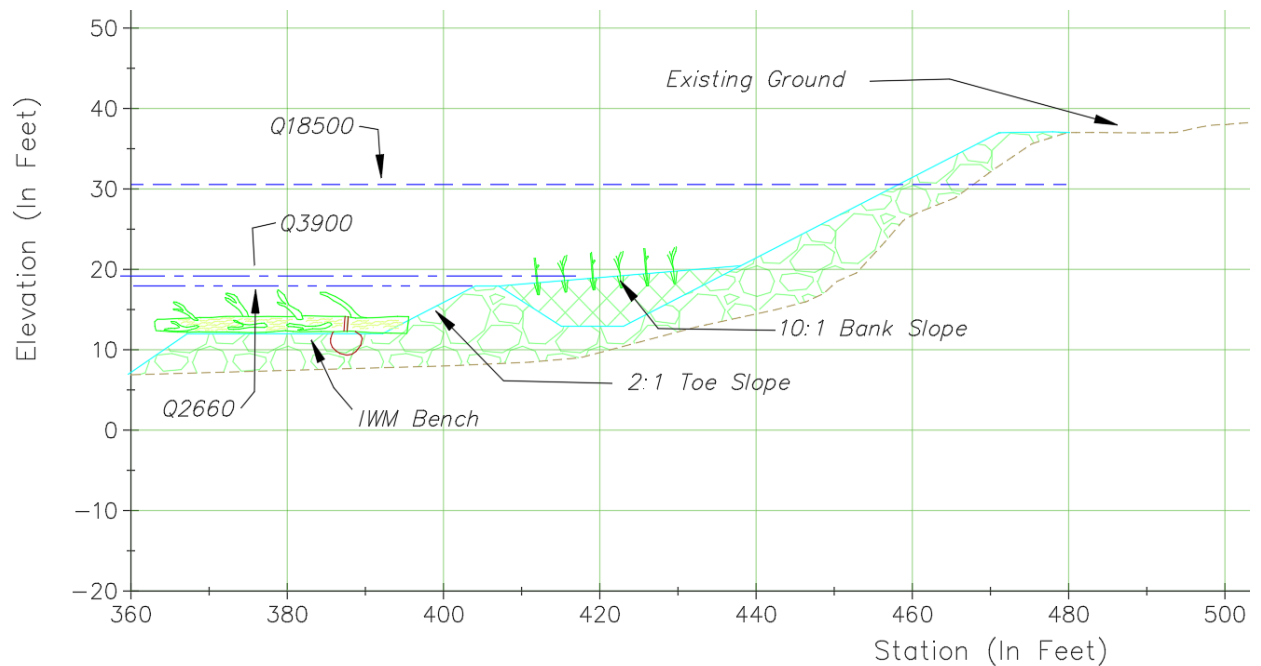
This is the maximum design concept, fully protecting the bank toe and upper bank. There is a rocked upper bank sloping down to a planting bench with an instream woody material bench on a launchable toe. This design, like the Tier 1 Full Fill design, does not cut into the existing bank (Figure 22).

Figure 22. Typical Cross Section of the Tier 2 Full Fill Design with Labels Showing Average Summer/Fall (2,660 cfs), Average Winter/Spring (3,900 cfs), and 2-Year Storm Event (18,500 cfs) Water Levels

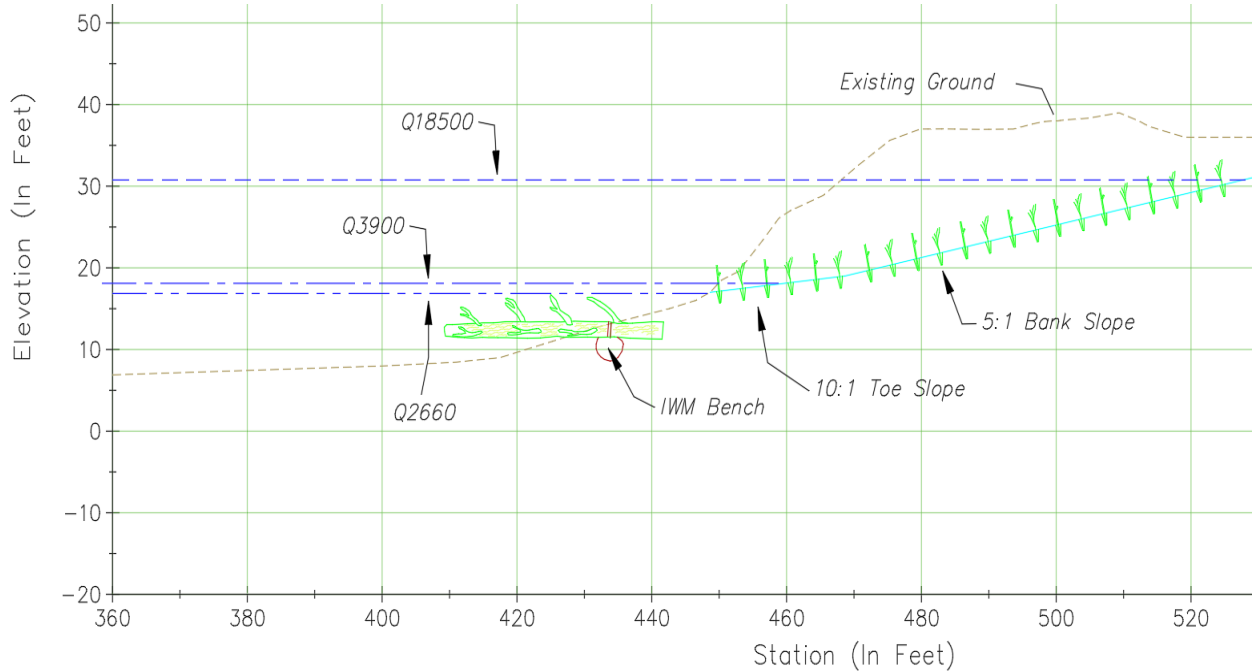
This design treats the process instead of the symptoms by sloping back the bank to prevent larger bank failures. The existing ground is cut back at two different slopes to facilitate vegetation growth (Figure 23). By accelerating the natural channel adjustment processes, this conceptual design shapes the bank to a more stable geometry.

Figure 23. Typical Cross Section of the Tier 2 Cut Bank Design with Labels Showing Average Summer/Fall (2,660 cfs), Average Winter/Spring (3,900 cfs), and 2-Year Storm Event (18,500 cfs) Water Levels

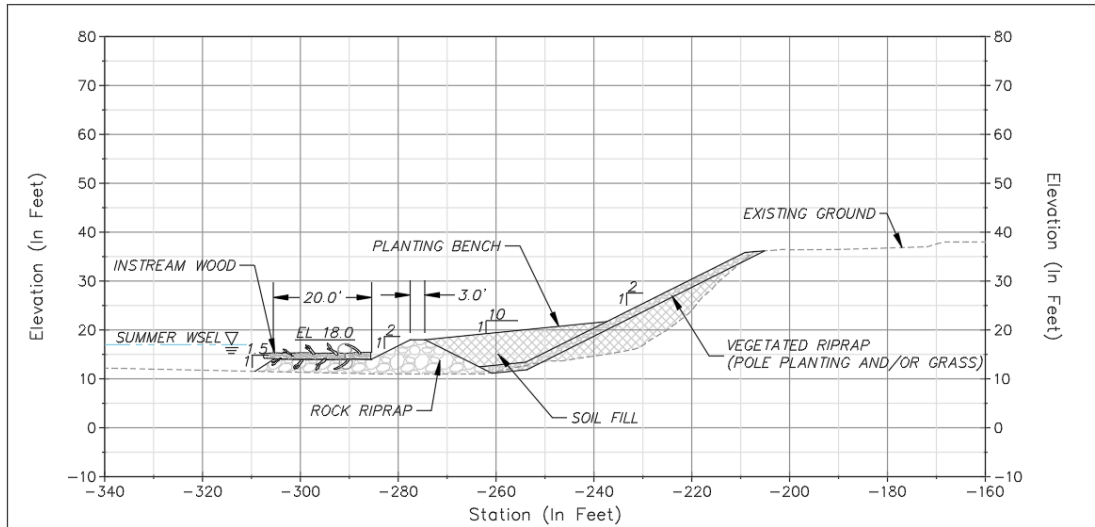
Figure 28 shows the typical cross-section of this design. The planting bench will vary in width up to 40 feet throughout the design with variable elevations between 1 and 3 feet above the summer water level. The planting bench will be planted with native riparian plants. The planting bench will be located outside of the ETL-1110-2-583 vegetation free zone and will not require a variance. The waterside toe of the design will have instream woody material placed at or below the summer water level along 40% or more of the bank toe.

Figure 28. Typical section with planting bench as Repair Site 2-2
