Raley Boulevard Truck Service and Parking Facility Project

Aquatic Resources Delineation Report

May 2024 | 08951.00001.001

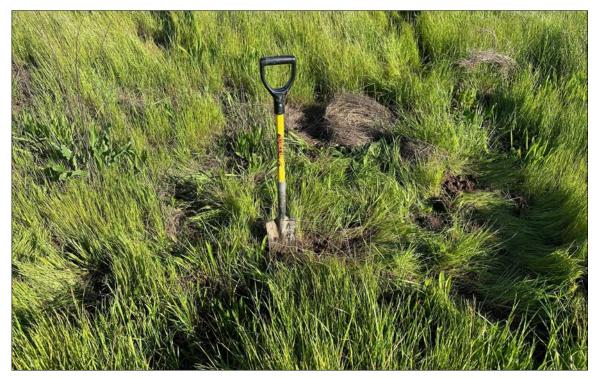
Photo 1. Representative view of low terrace floodplain (TF)-1 looking north. Note that the shovel is at the data point (TF)-1 location. Photo taken 3/26/24.

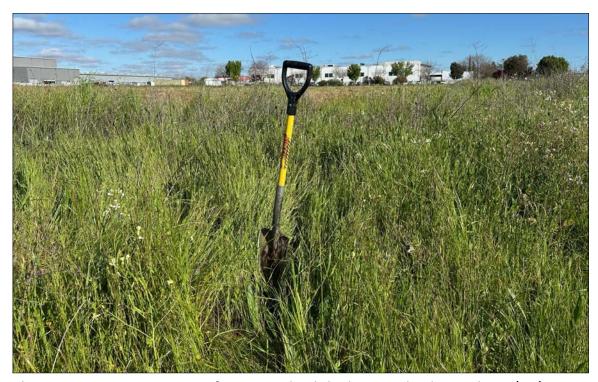
Photo 2. Representative view of DP-2 in uplands looking north. Photo taken 3/26/24.

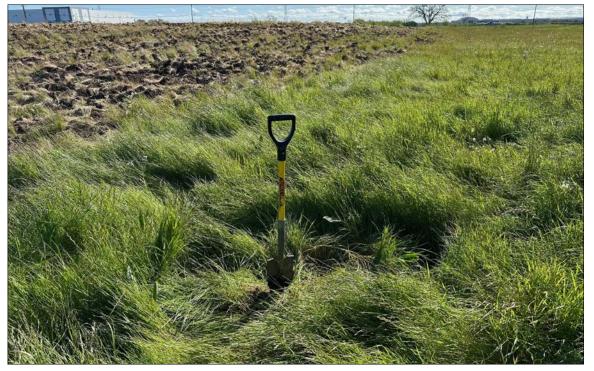
Photo 3. Representative view of DP-3 in a low terrace area that was indicative of upland habitat, looking northeast. Photo taken 3/26/24.

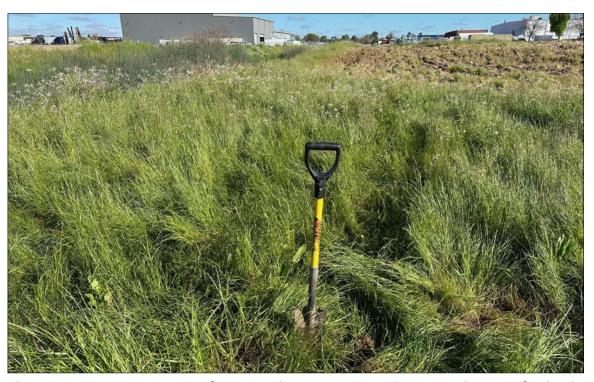
Photo 4. Representative view of DP-4 in a low terrace area that was indicative of upland habitat, looking north. Photo taken 3/26/24.

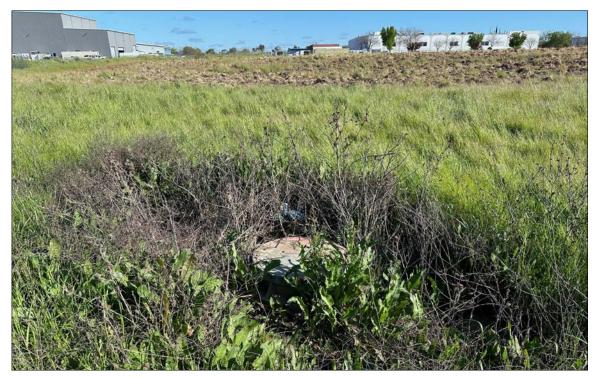
Photo 5. Vertical drain observed just outside of the Study Area near DP-3 and DP-4, looking north. Photo taken 3/26/24.

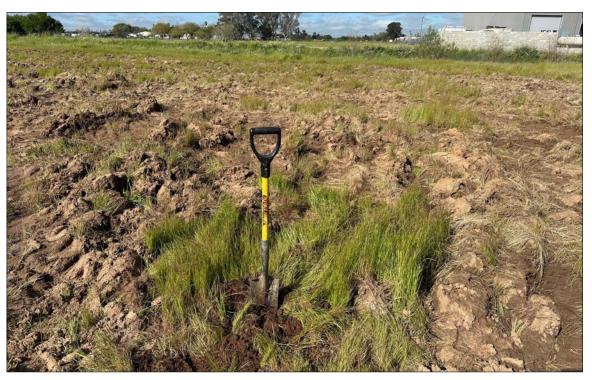
Photo 6. Representative view of DP-5 in a recently disked area indicative of upland habitat, looking west. Photo taken 3/26/24.

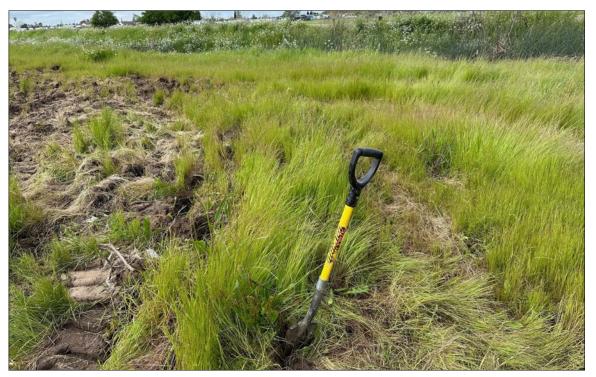
Photo 7. Representative view of DP-6 on border of disked area near Magpie Creek, looking southwest. Photo taken 3/26/24.

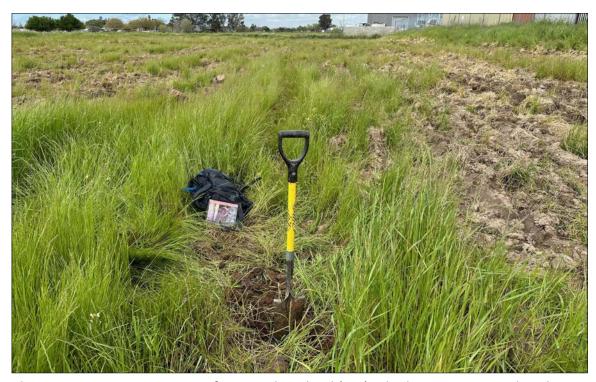
Photo 8. Representative view of seasonal wetland (SW)-1 looking west. Note that the shovel is at the data point DP-7 location. Photo taken 3/26/24.

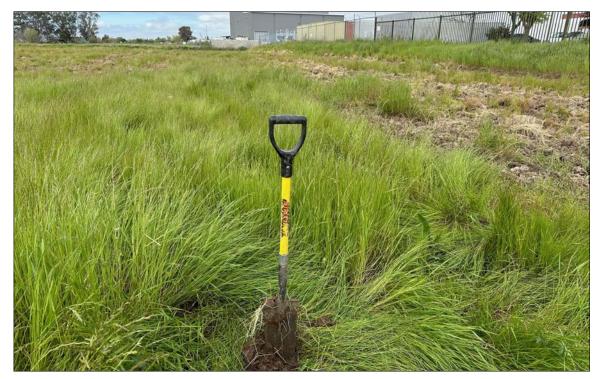
Photo 9. Representative view of DP-8 in upland habitat adjacent to SW-1 looking west. Photo taken 3/26/24.

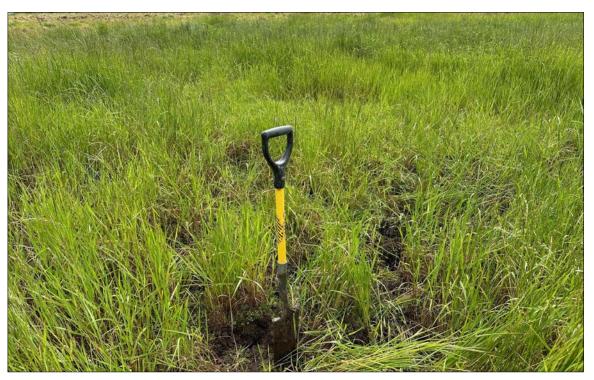
Photo 10. Representative view of SW-2 looking east. Note that the shovel is at the data point DP-9 location. Photo taken 3/26/24.

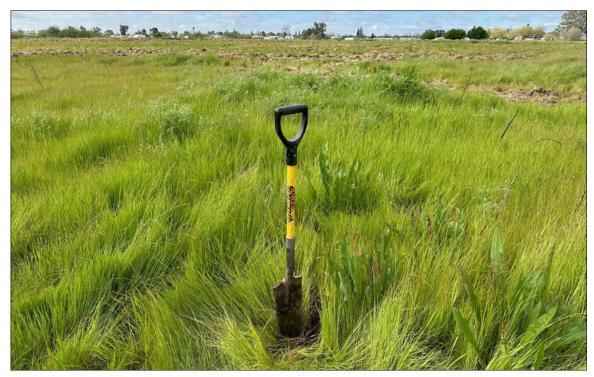
Photo 11. Representative view of DP-10 in upland habitat adjacent to SW-2 looking southwest. Photo taken 3/26/24.

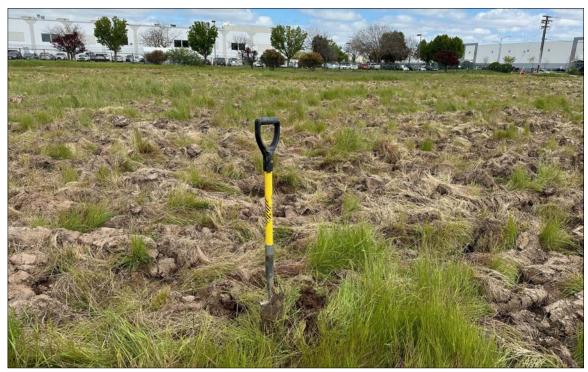
Photo 12. Representative view of DP-11 in a recently disked area indicative of upland habitat, looking west. Photo taken 3/26/24.
