# **Aquatic Resources Delineation Report**

Meadowview 102

City of Sacramento,  
Sacramento County, California

September 2024

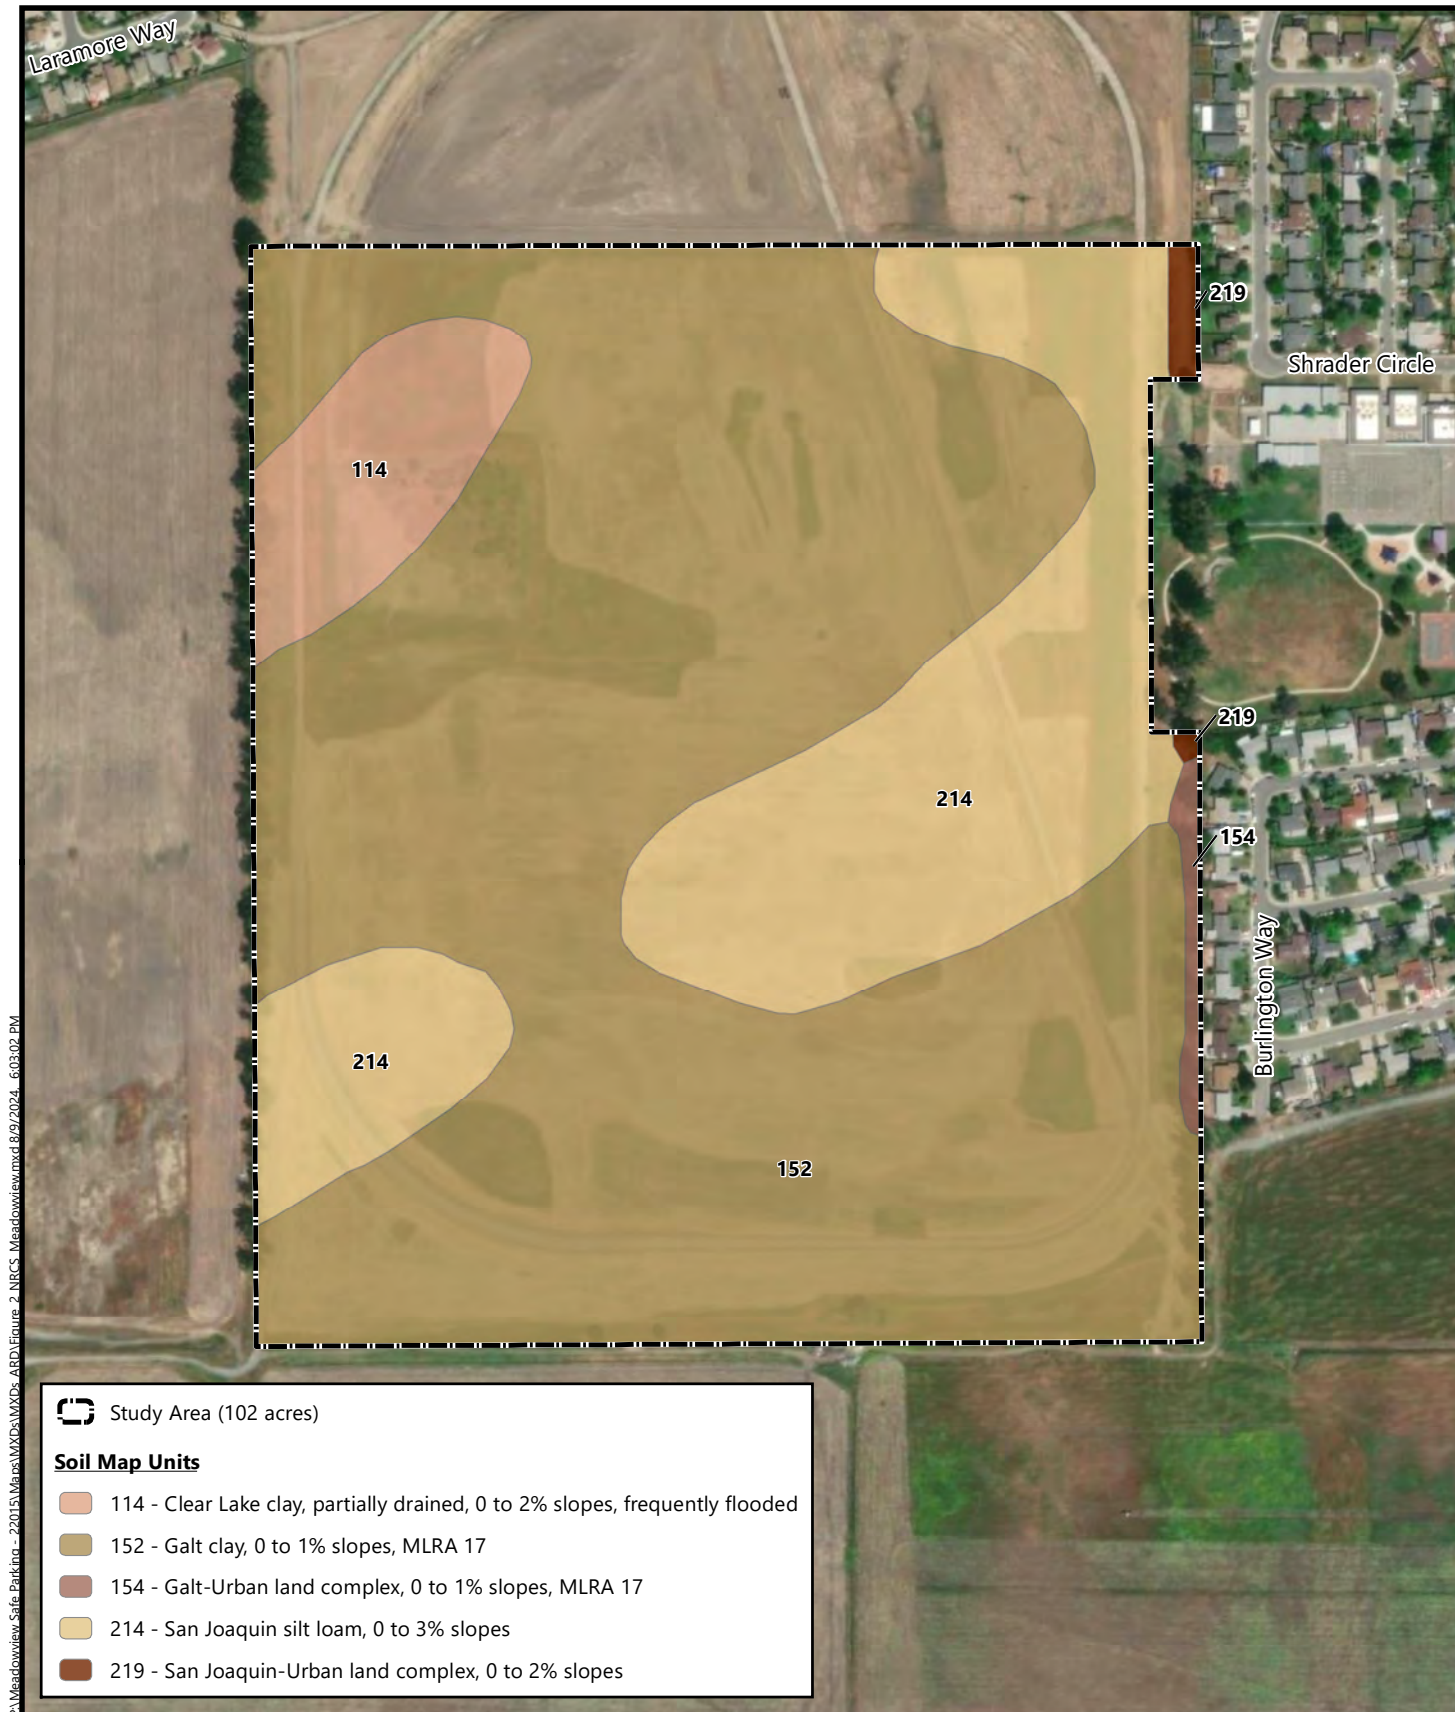
**Figure 2**  
**Natural Resources Conservation**  
**Service Soils**

According to the Natural Resources Conservation Service (NRCS) Soil Survey Database (NRCS 2024), five soil mapping units occur within the Study Area (**Figure 2**):

- Clear Lake clay, partially drained, 0 to 2% slopes, frequently flooded (114) – the Clear Lake component and the Dierssen and Egbert inclusions are classified as hydric. This soil map unit is non-saline to slightly saline; and the pH ranges from slightly acid to moderately alkaline within the upper portion of the root zone.

- Galt clay, 0 to 1% slopes, MLRA 17 (152) – the Galt component and the Clear Lake inclusion are classified as hydric. This soil map unit is non-saline; and the pH ranges from slightly acid to neutral within the upper portion of the root zone.

- Galt-Urban land complex, 0 to 1% slopes, MLRA 17 (154) – the Galt component and the Clear Lake and Egbert inclusions are classified as hydric. This soil map unit is non-saline; and the pH ranges from slightly acid to neutral within the upper portion of the root zone. . This soil is known to support duripan vernal pools.

- San Joaquin silt loam, 0 to 3% slopes, MLRA 17 (214) – the Galt inclusion is classified as hydric in depressions. This soil map unit is non-saline; and the pH ranges from slightly acid to neutral within the upper portion of the root zone.

- San Joaquin- Urban land complex, 0 to 2% slopes, MLRA 17 (219) – the Galt inclusions are classified as hydric on terraces. This soil map unit is non-saline; and the pH ranges from slightly acid to neutral within the upper portion of the root zone.

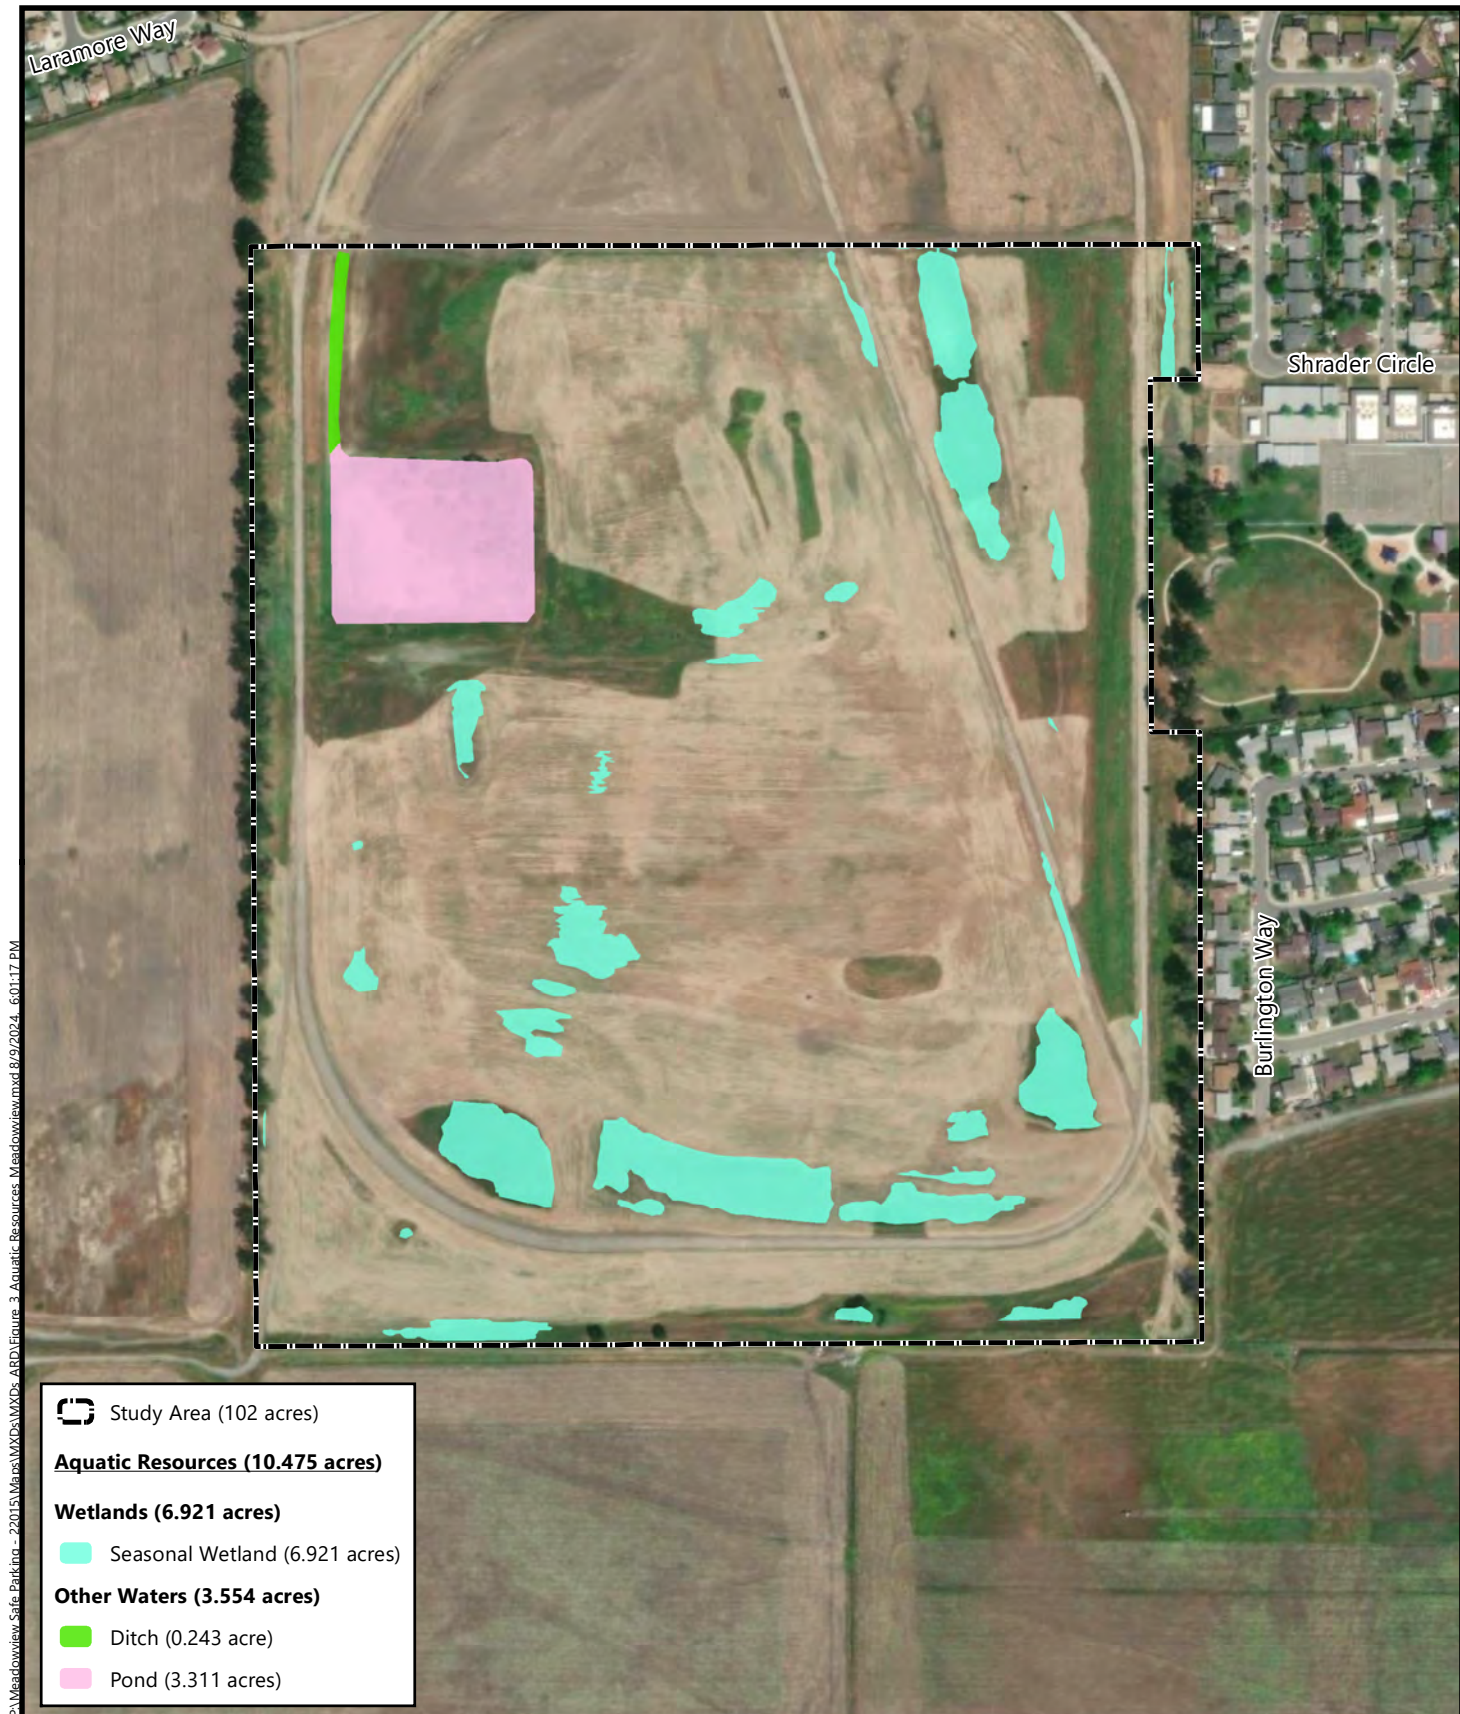
**Figure 3**  
**Aquatic Resources**

A total of approximately 10.475 acres of aquatic resources were delineated within the Study Area, including approximately 6.921 acres of wetlands and 3.554 acres of other waters. Seasonal wetlands, a constructed pond, and a ditch were delineated within the Study Area. The aquatic resources found on-site and their acreages are summarized in **Table 1** below.

Data sheets are included in **Attachment A**. Maps of the aquatic resources within the Study Area are included as **Figure 3** and **Attachment B**, and a list of the plant species observed in the Study Area with their wetland indicator status is included in **Attachment C**. GIS Shapefiles and the *Aquatic Resources Excel Spreadsheet* for the aquatic resources shown on **Figure 3** and **Attachment B** will be digitally transmitted with this document when it is submitted. Each of the feature types are described below.

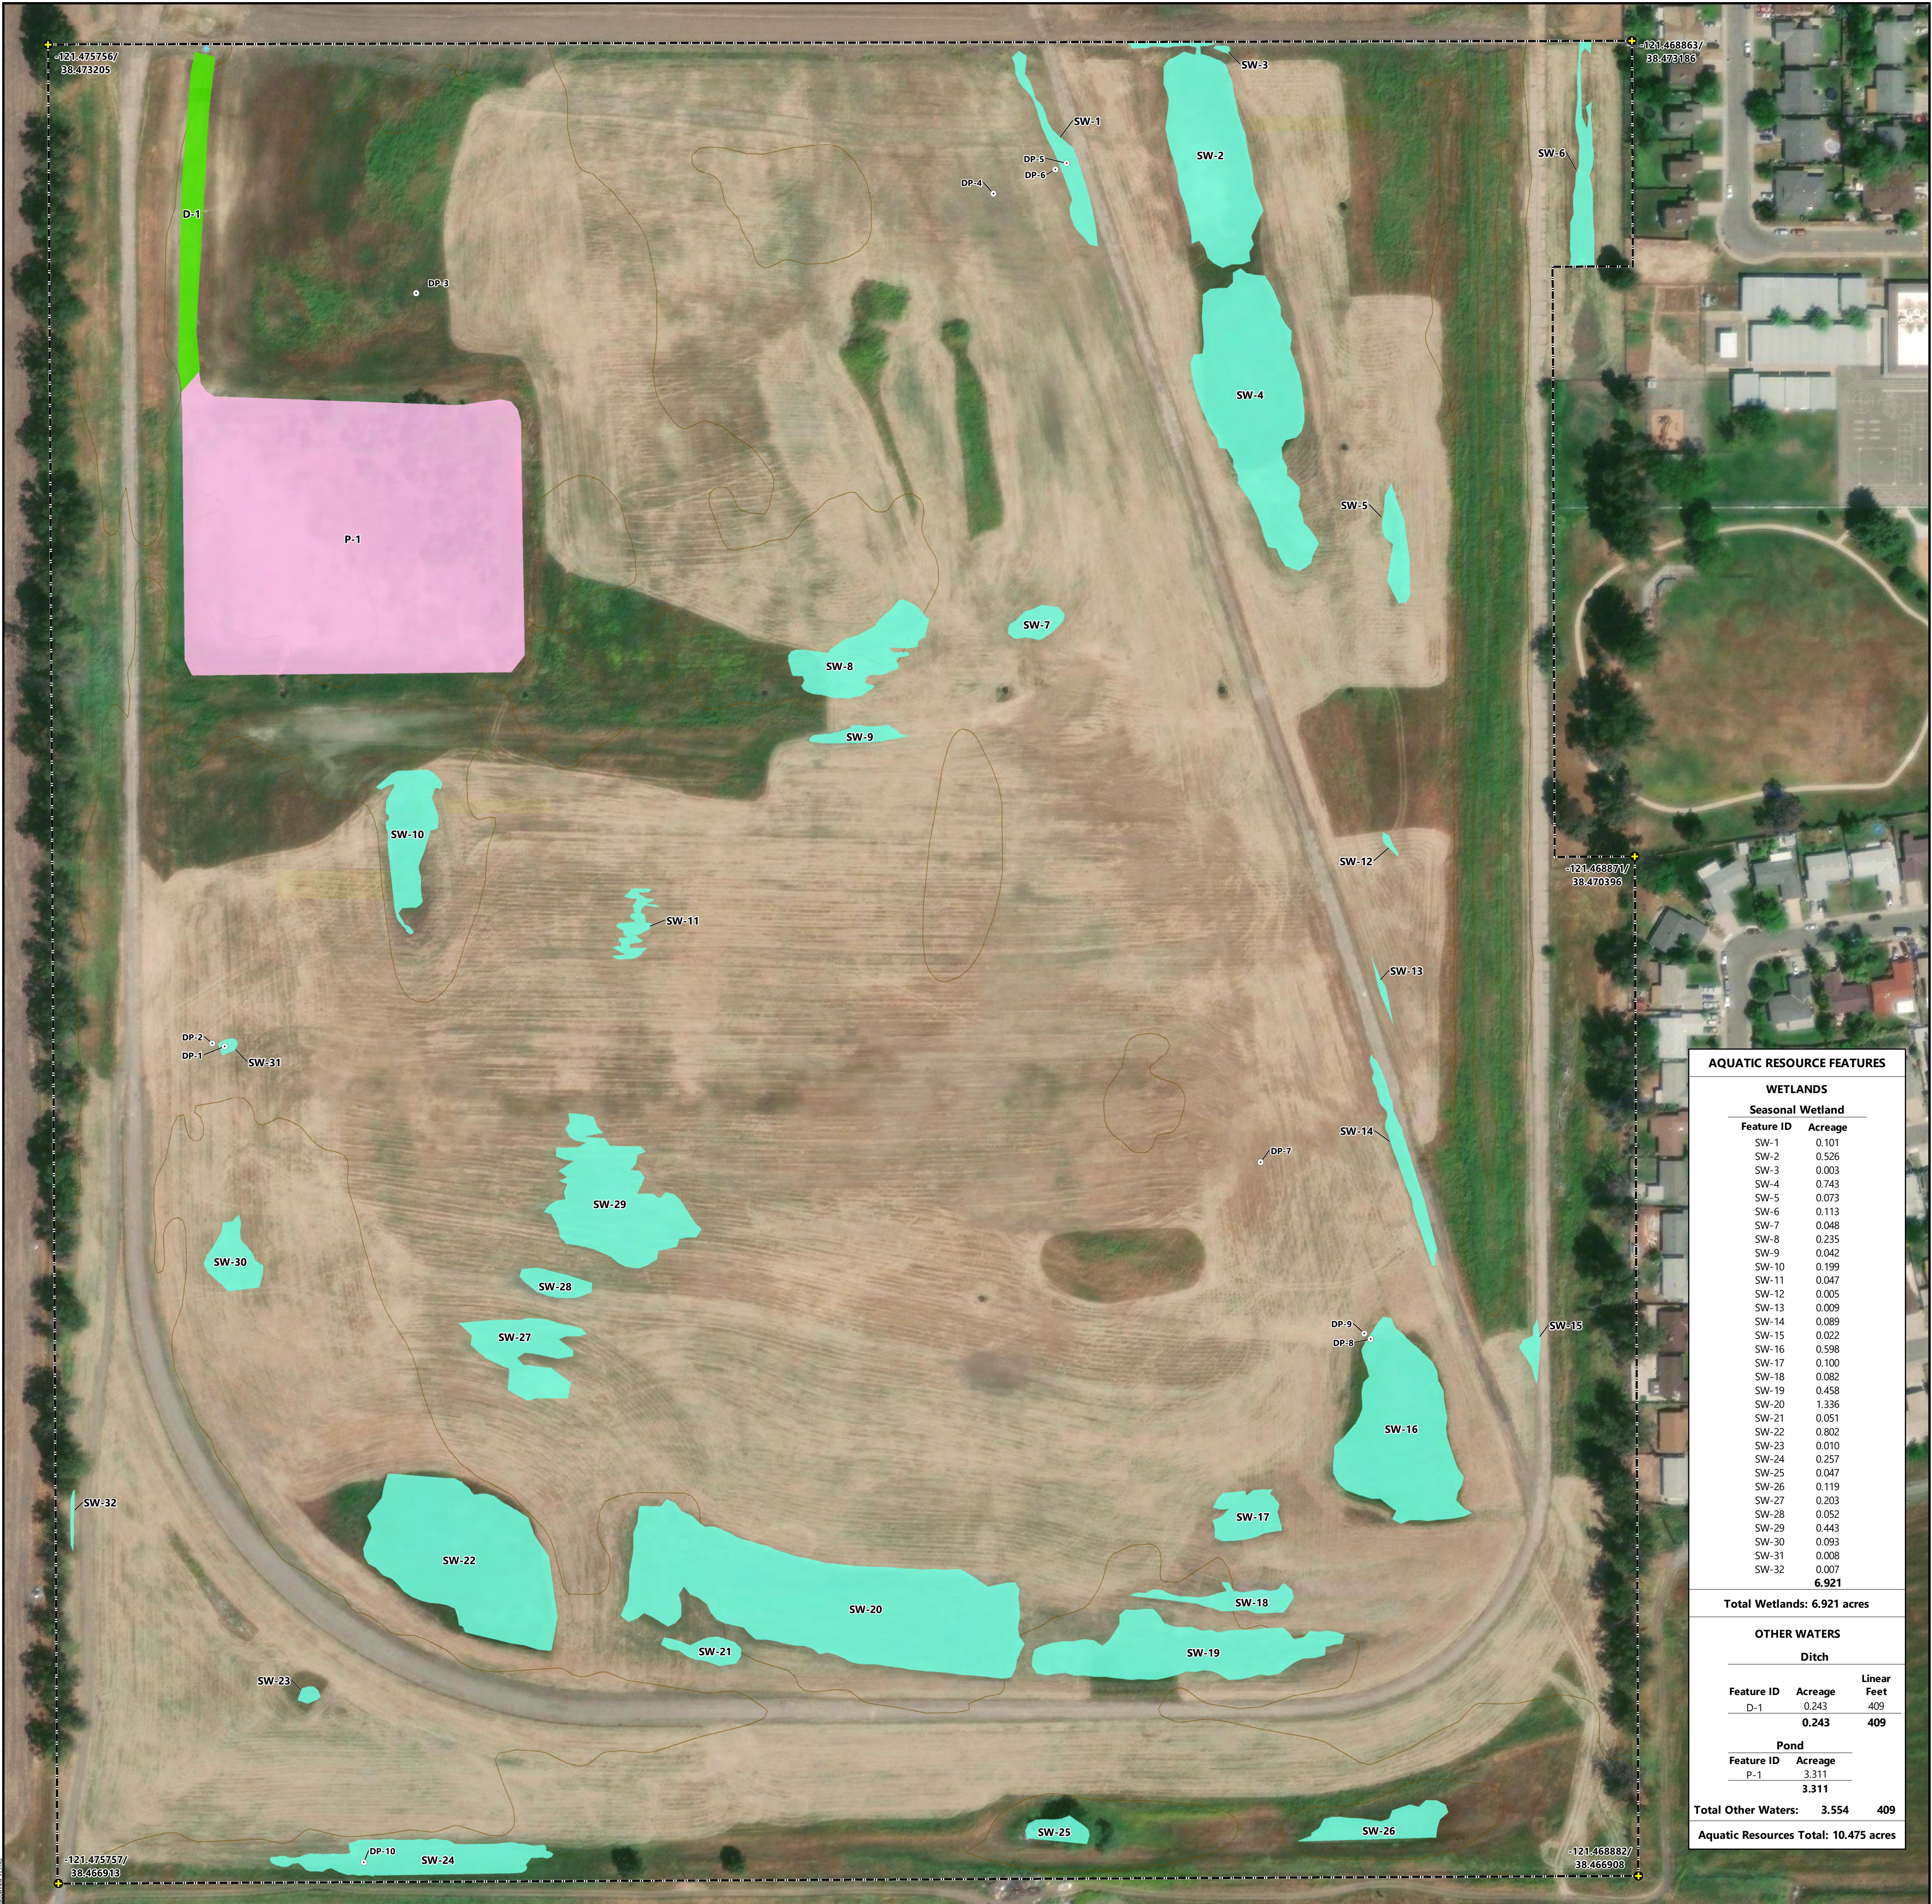
## **Aquatic Resources Delineation Map**

The 10.475 acres of aquatic resources mapped on the site appear to have no connection to any other Waters of the U.S. and therefore do not appear to be subject to USACE jurisdiction. As such, the applicant is requesting an Approved Jurisdictional Determination for the Aquatic Resources Delineation Map of the Study Area (**Attachment B**). A JD request form is attached in **Attachment D**.
