CITY OF SACRAMENTO VISION ZERO SCHOOL SAFETY STUDY

- **Vision Zero School Safety Study** – This project, which is the focus of this report, documents conditions for students who walk, bike, take transit or private vehicle at 20 schools across Sacramento. The assessments of these conditions reflect the social, built and natural environments that affect the ability and desire of students to walk, bike and take transit to school. This study results in short-, medium- and long-term recommendations for the 20 identified schools to improve safety conditions for children walking or biking to school, and which include signage, pavement marking, traffic calming and operational improvements along roadways within school zones.

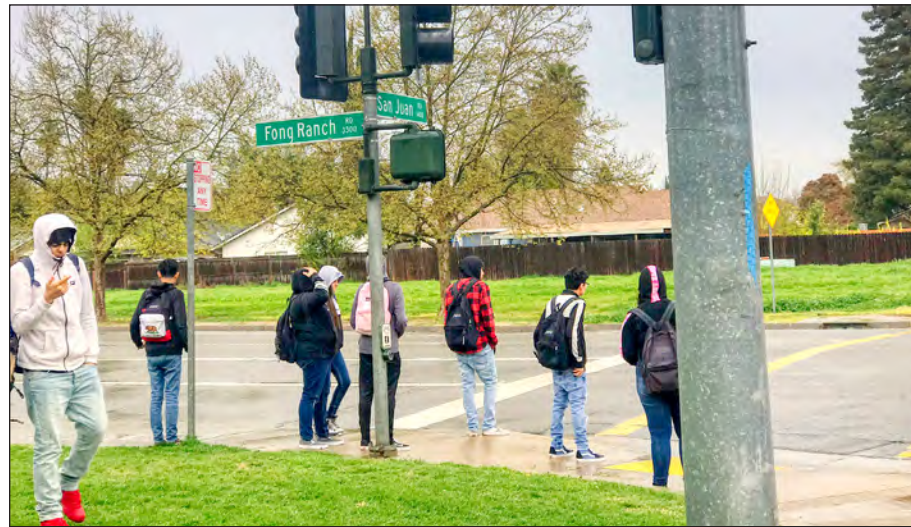
The intersection of Fong Ranch Road and San Juan Road is located near the main school entrance and many students cross the intersection before and after school.

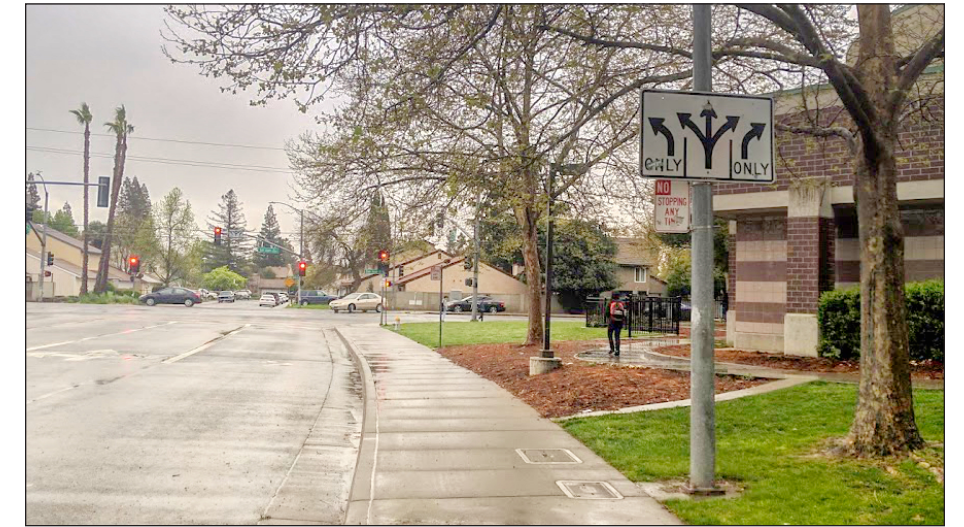
The configuration of the Fong Ranch Road and San Juan Road intersection has two right-turn lanes, which can result in potential conflict with pedestrians crossing the western and northern crosswalks.

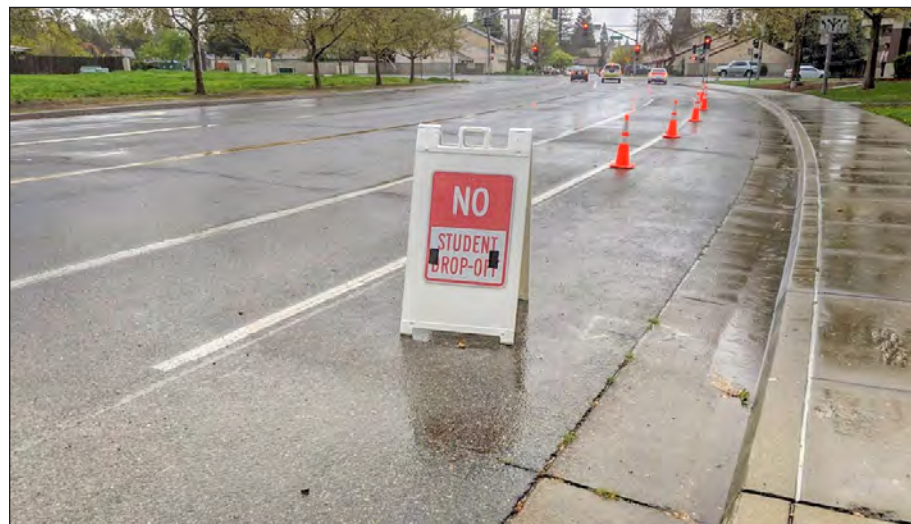
Natomas High staff routinely set up cones and signage to discourage student drop-off on Fong Ranch Road near the northern leg of the Fong Ranch Road / San Juan Road major intersection.

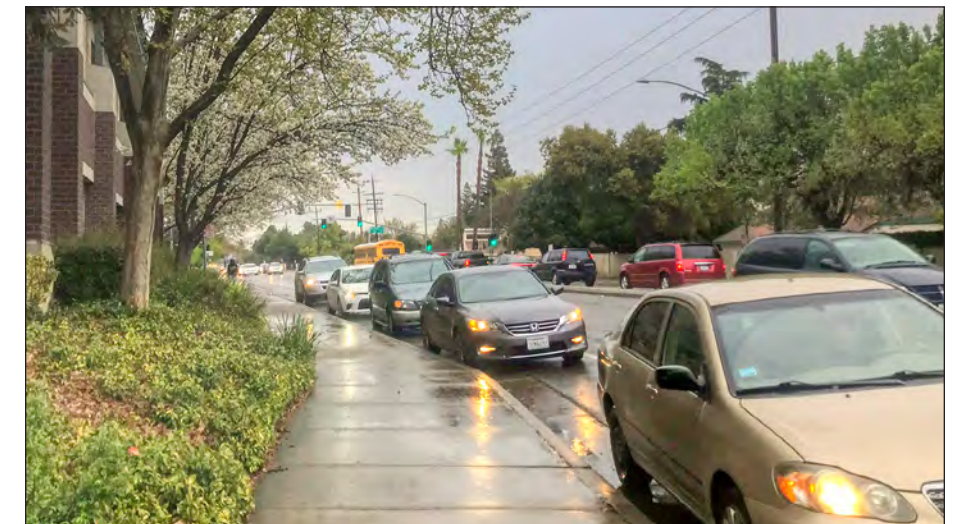
Drivers were observed queuing in the bicycle lane on San Juan Road during the afternoon pick-up period.

LOCATION	OBSERVATION	RECOMMENDATIONS	IMPLEMENTATION			RESPONSIBILITY
			Short	Medium	Long	
B San Juan Road	B1 Parents were observed using the westbound bicycle lane on San Juan Road as a loading zone when picking up students.	<ul style="list-style-type: none"> Stripe red curb along existing 100' of curb west of the intersection on the north side of San Juan Road to discourage using the existing curb space as a loading zone – B1 	✓			Department of Public Works
	B2 Vehicles were observed parked in the eastbound bicycle lane, obstructing bicycle path of travel.	<ul style="list-style-type: none"> Replace the existing “No Parking” sign on the north side of San Juan Road with a “No Stopping Any Time” sign to discourage using the existing curb space as a loading zone. This recommendation is consistent with Sacramento City Codes – B1 	✓			Department of Public Works
	B3 School administration reports that students exiting school from the side gate on San Juan Road tend to jay-walk across San Juan Road.	<ul style="list-style-type: none"> Consider installing delineators (e.g., Safe-Hit posts) to reinforce parking prohibitions in the bike lanes, approximately 100' west of Fong Ranch Road. Per Caltrans standards, a two foot buffer would be included. The street widths are to remain a minimum of 10 feet, per City Standards – B1, B2 	✓			Department of Public Works

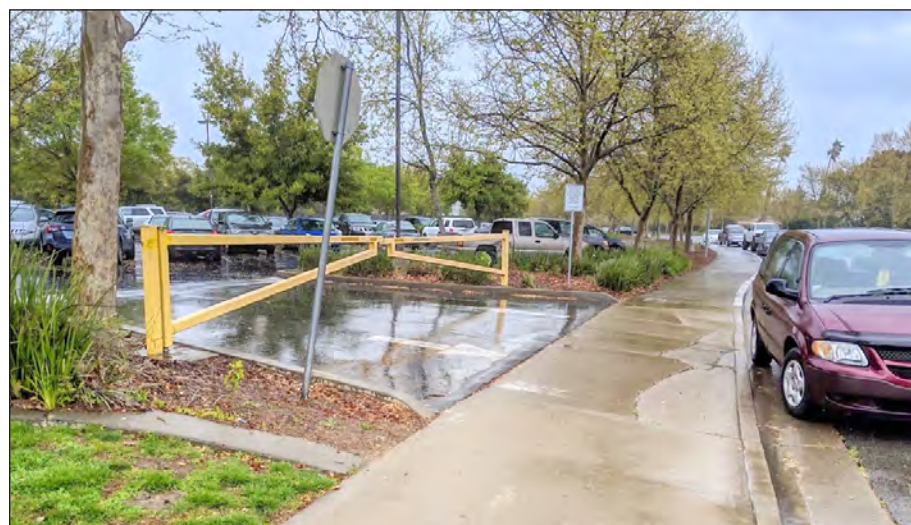
Driveway entrance gate remains closed before the afternoon bell to discourage vehicle queuing inside the parking lot.

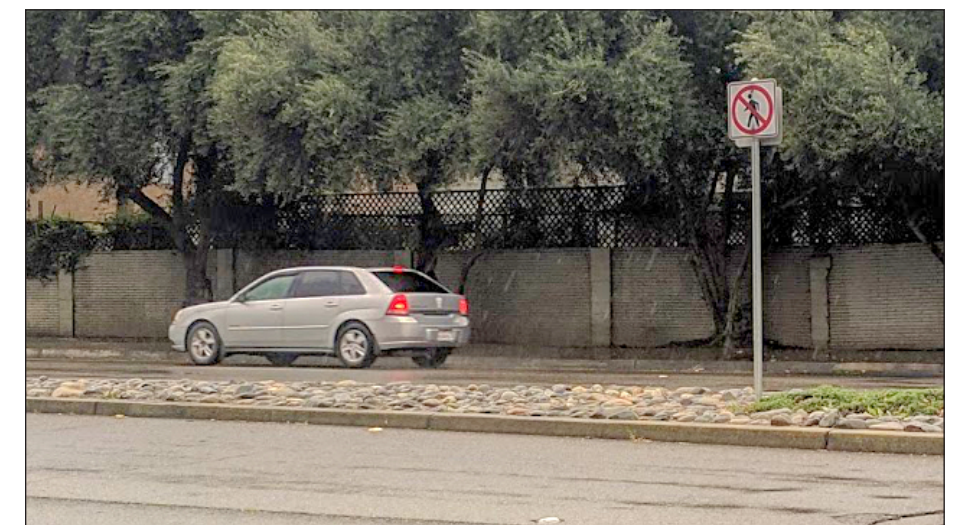
Signs along San Juan Road are posted to discourage jaywalking across the five lane street. The nearest crosswalks from the side gate are about 500' in either direction.

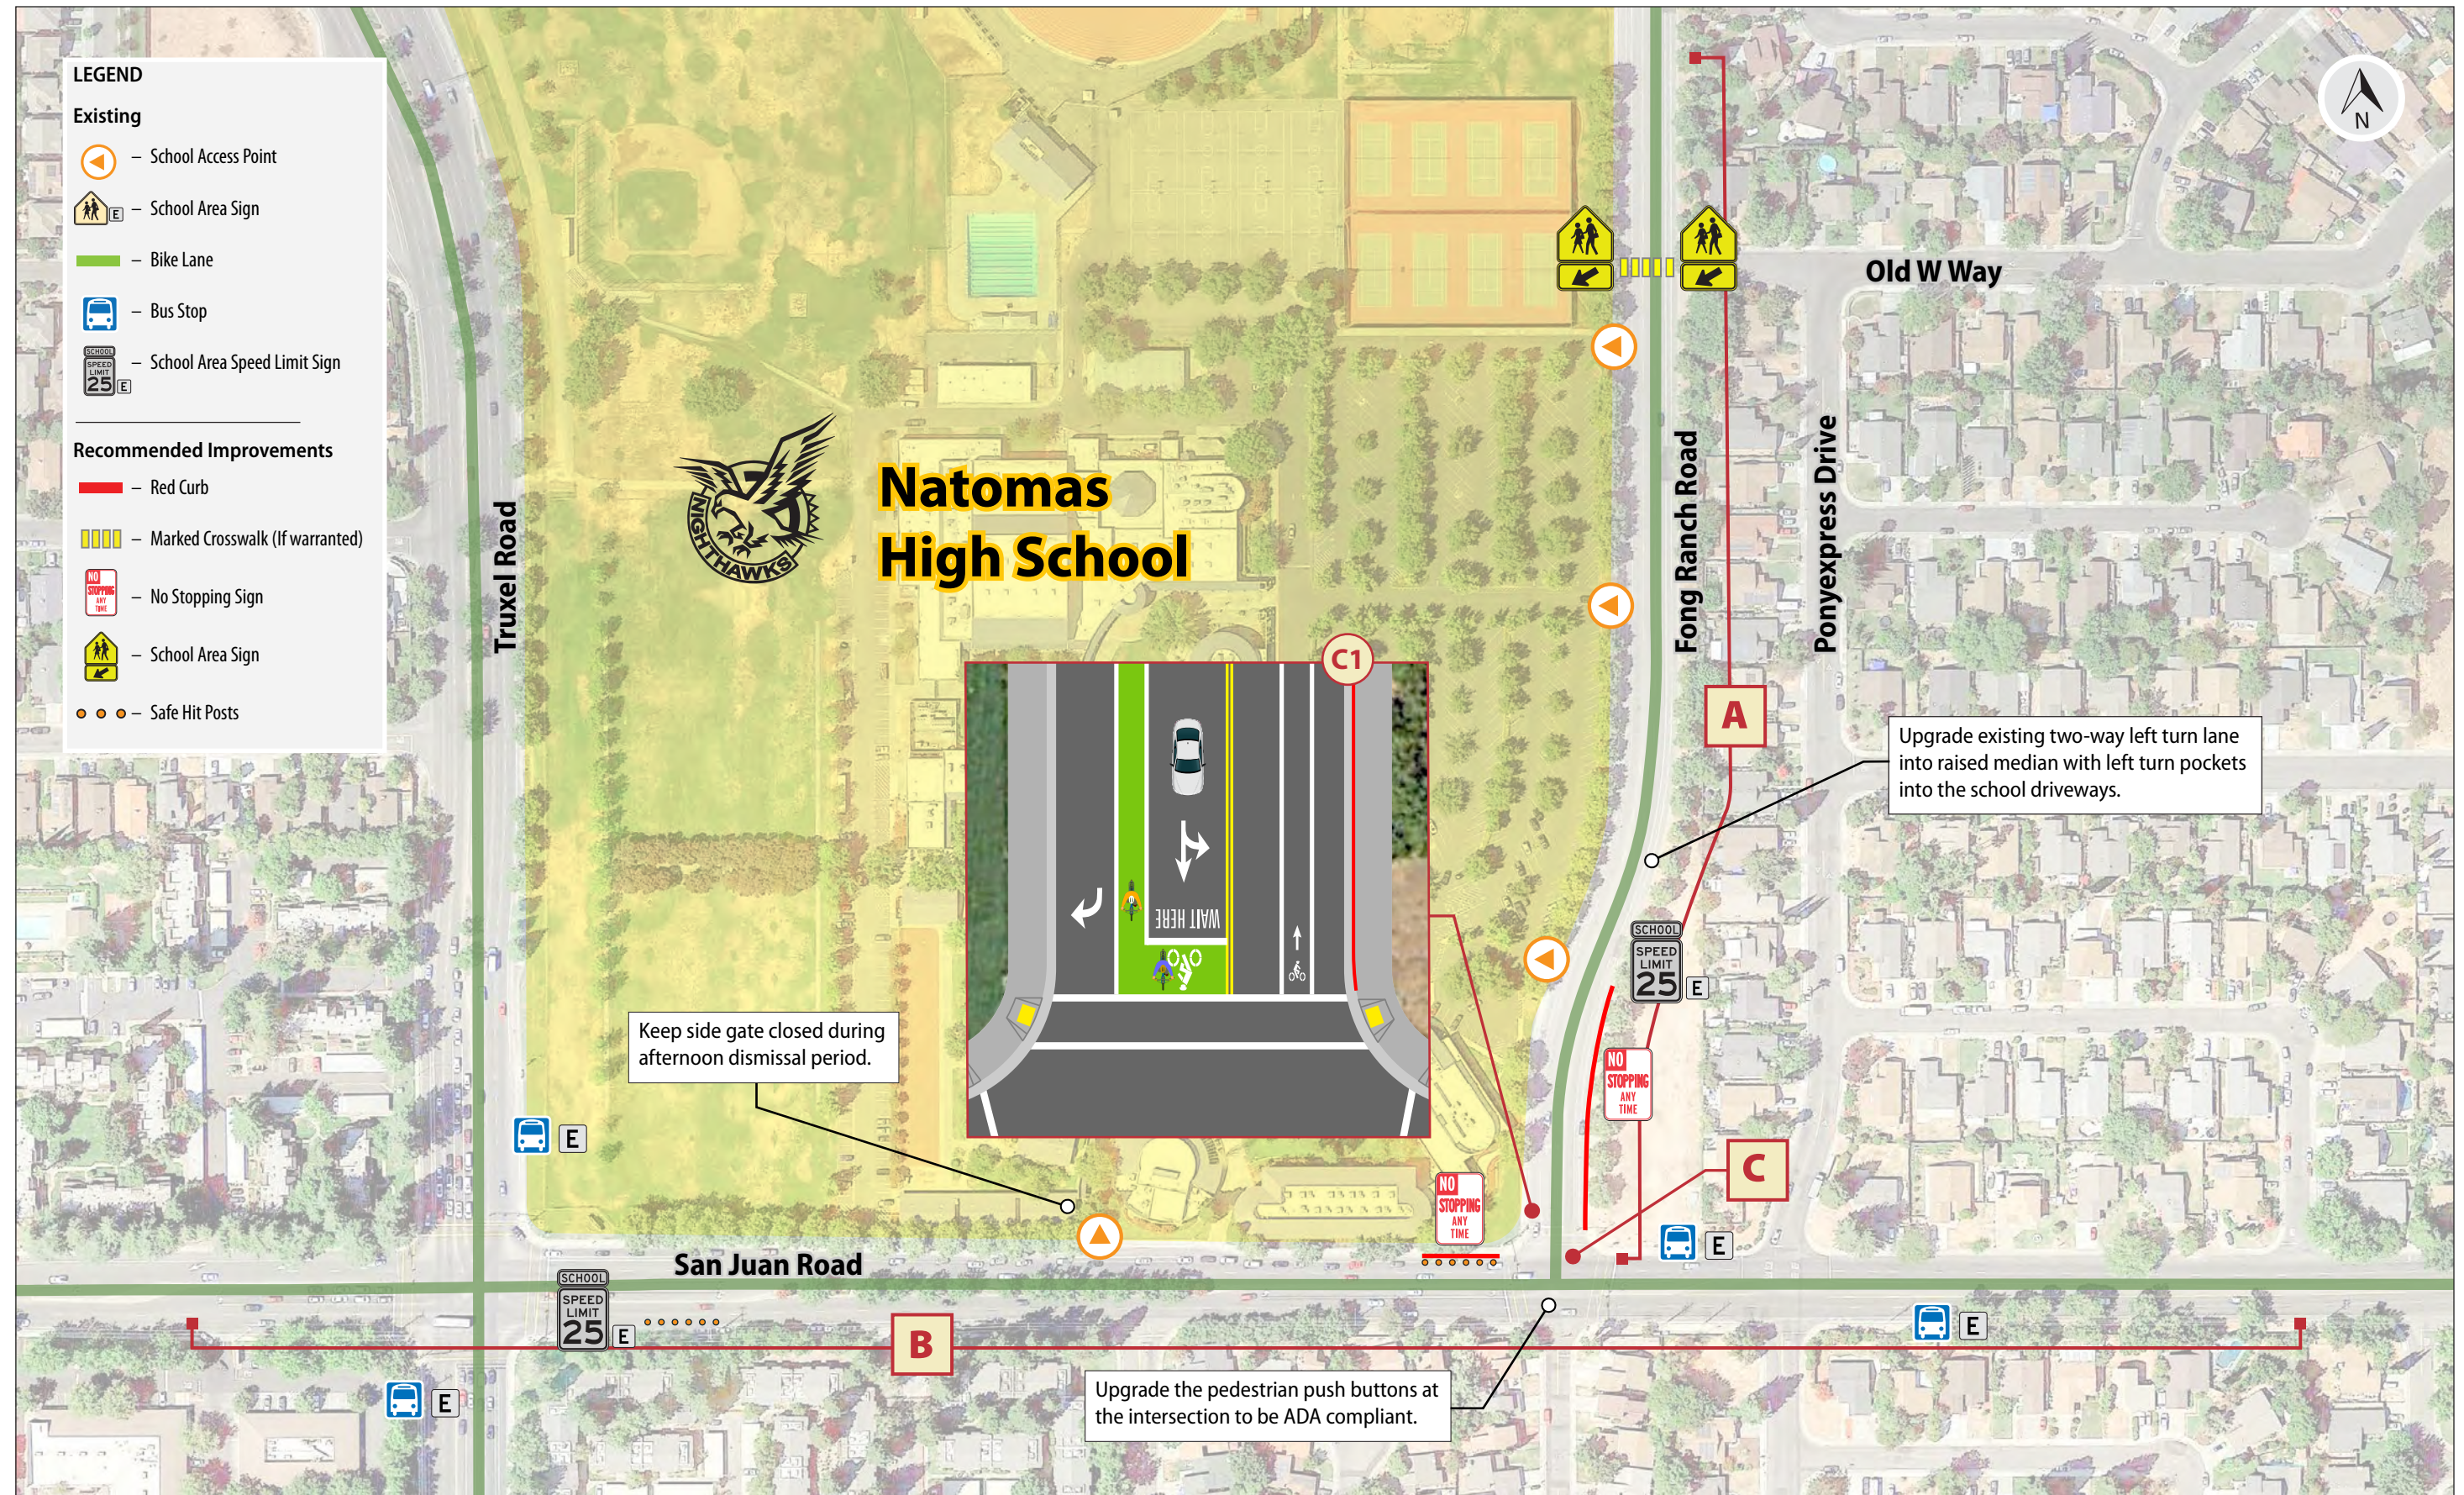
NATOMAS SCHOOL, 3301 FONG RANCH ROAD, SACRAMENTO

LOCATION	OBSERVATION	RECOMMENDATIONS	IMPLEMENTATION			RESPONSIBILITY
			Short	Medium	Long	
A. Fong Ranch Road	A1 Vehicles were observed using the No Parking zone on the east side of Fong Ranch Road as a loading zone.	• Stripe red curb along existing No Parking zone, approximately 280' north of the intersection, to discourage using the existing curb space as a loading zone – A1	✓			Department of Public Works
	A2 Students were observed jay-walking across Fong Ranch Road at Old W Drive.	• Replace the existing “No Parking” sign with a “No Stopping Any Time” to discourage using the existing curb space as a loading zone. This recommendation is consistent with Sacramento City Codes – A1	✓			Department of Public Works
	A3 School administrators report frequent U-turns along Fong Ranch Road during drop-off and pick-up periods.	• Evaluate appropriateness for a new marked crossing with ADA compliant curb ramps and appropriate driveway clearances across Fong Ranch Road at Old W Drive. Include school Assembly B crosswalk signage at the new crosswalk * – A2	✓			Department of Public Works

<ul style="list-style-type: none"> Provide targeted parking enforcement related to illegal parking in the bike lane on the south side of San Juan Road – B2 	✓			Department of Public Works
		<ul style="list-style-type: none"> Keep side gate closed during afternoon dismissal period – B3 	✓			Natomas High School
C Fong Ranch Road and San Juan Road Intersection	C1 The southbound approach on Fong Ranch Road at the intersection with San Juan Road has two right-turn lanes.	<ul style="list-style-type: none"> Review the feasibility of modifying the lane configuration on the southbound leg of the intersection to remove the dual right-turn lane. Consider providing a bike box ahead of the left-through lane – C1 		✓		Department of Public Works
	C2 Pedestrian push buttons at this intersection are not ADA-compliant.	<ul style="list-style-type: none"> Upgrade the pedestrian push buttons at the intersection to be ADA-compliant – C2 		✓		Department of Public Works

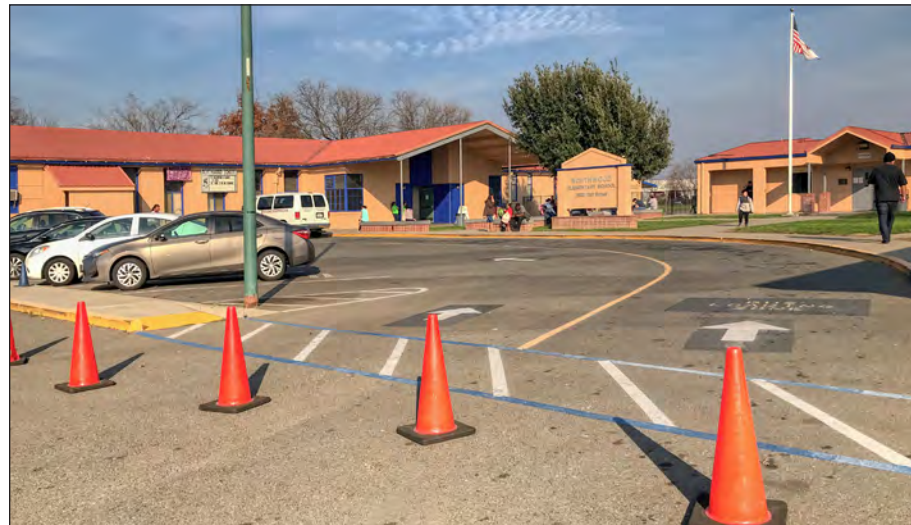
Northwood staff cone off the front of the loading loop to reserve spaces for buses.

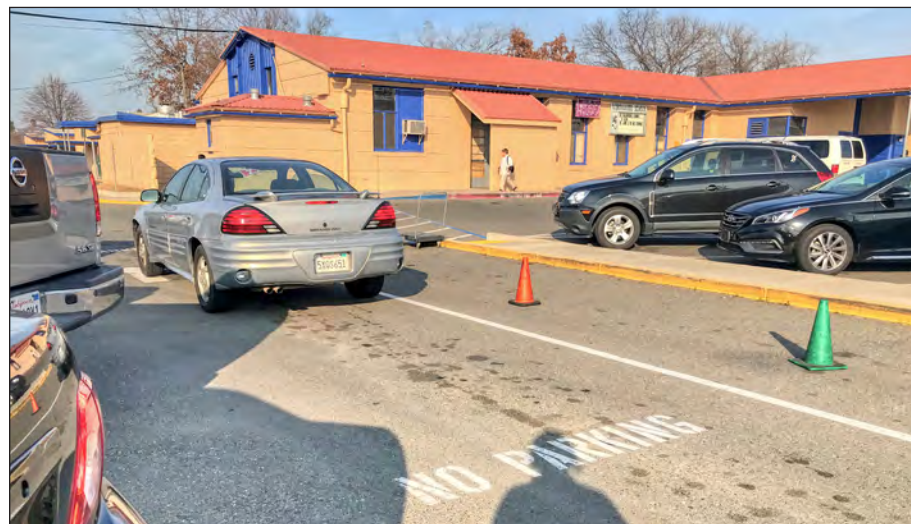
Drivers occasionally park their vehicles in no parking zones to pick-up students from school.

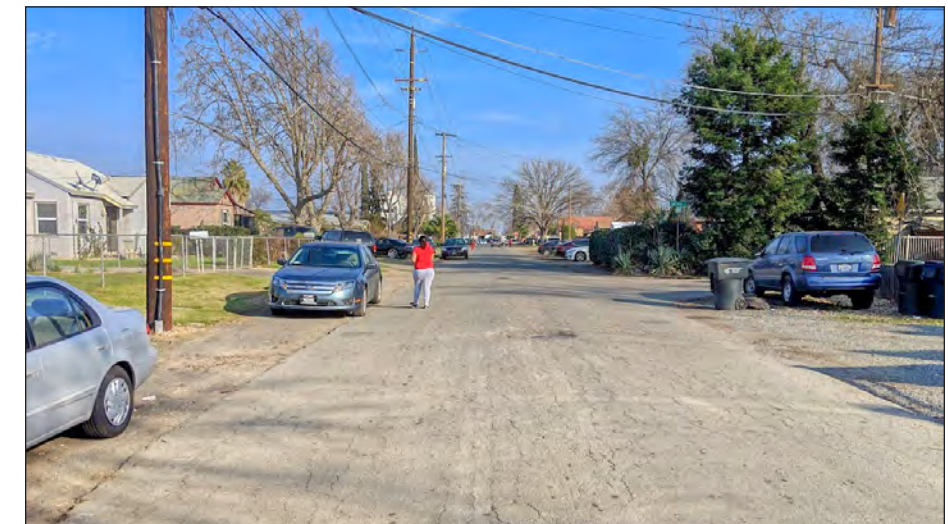
Many streets in the vicinity of the school lack sidewalks and roadway markings.

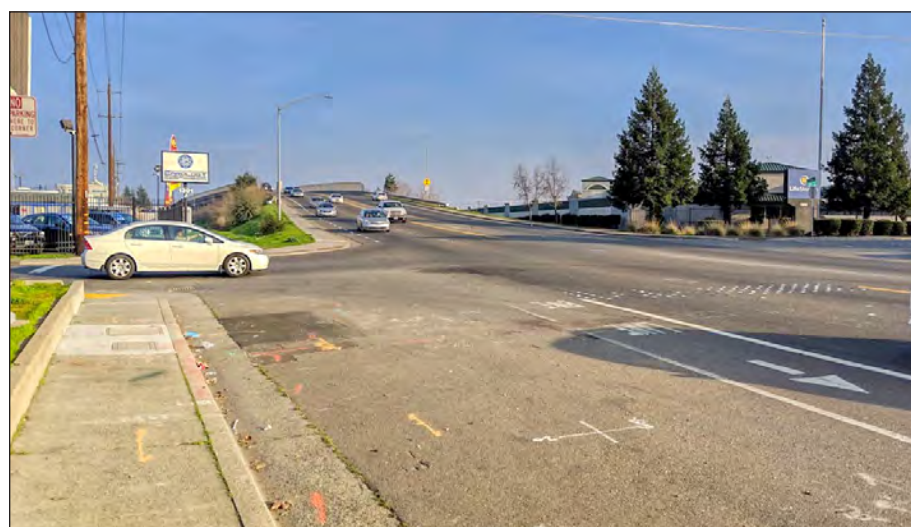
El Camino Avenue is a wide multi-lane arterial; high speeds were reported by school representatives.

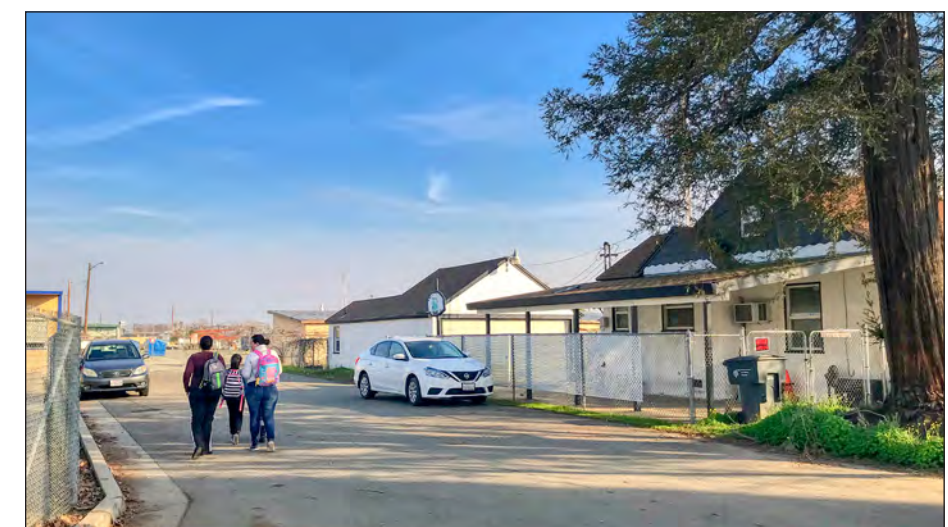
Some parents use the alley south of the school as a parking space during pick-up time.

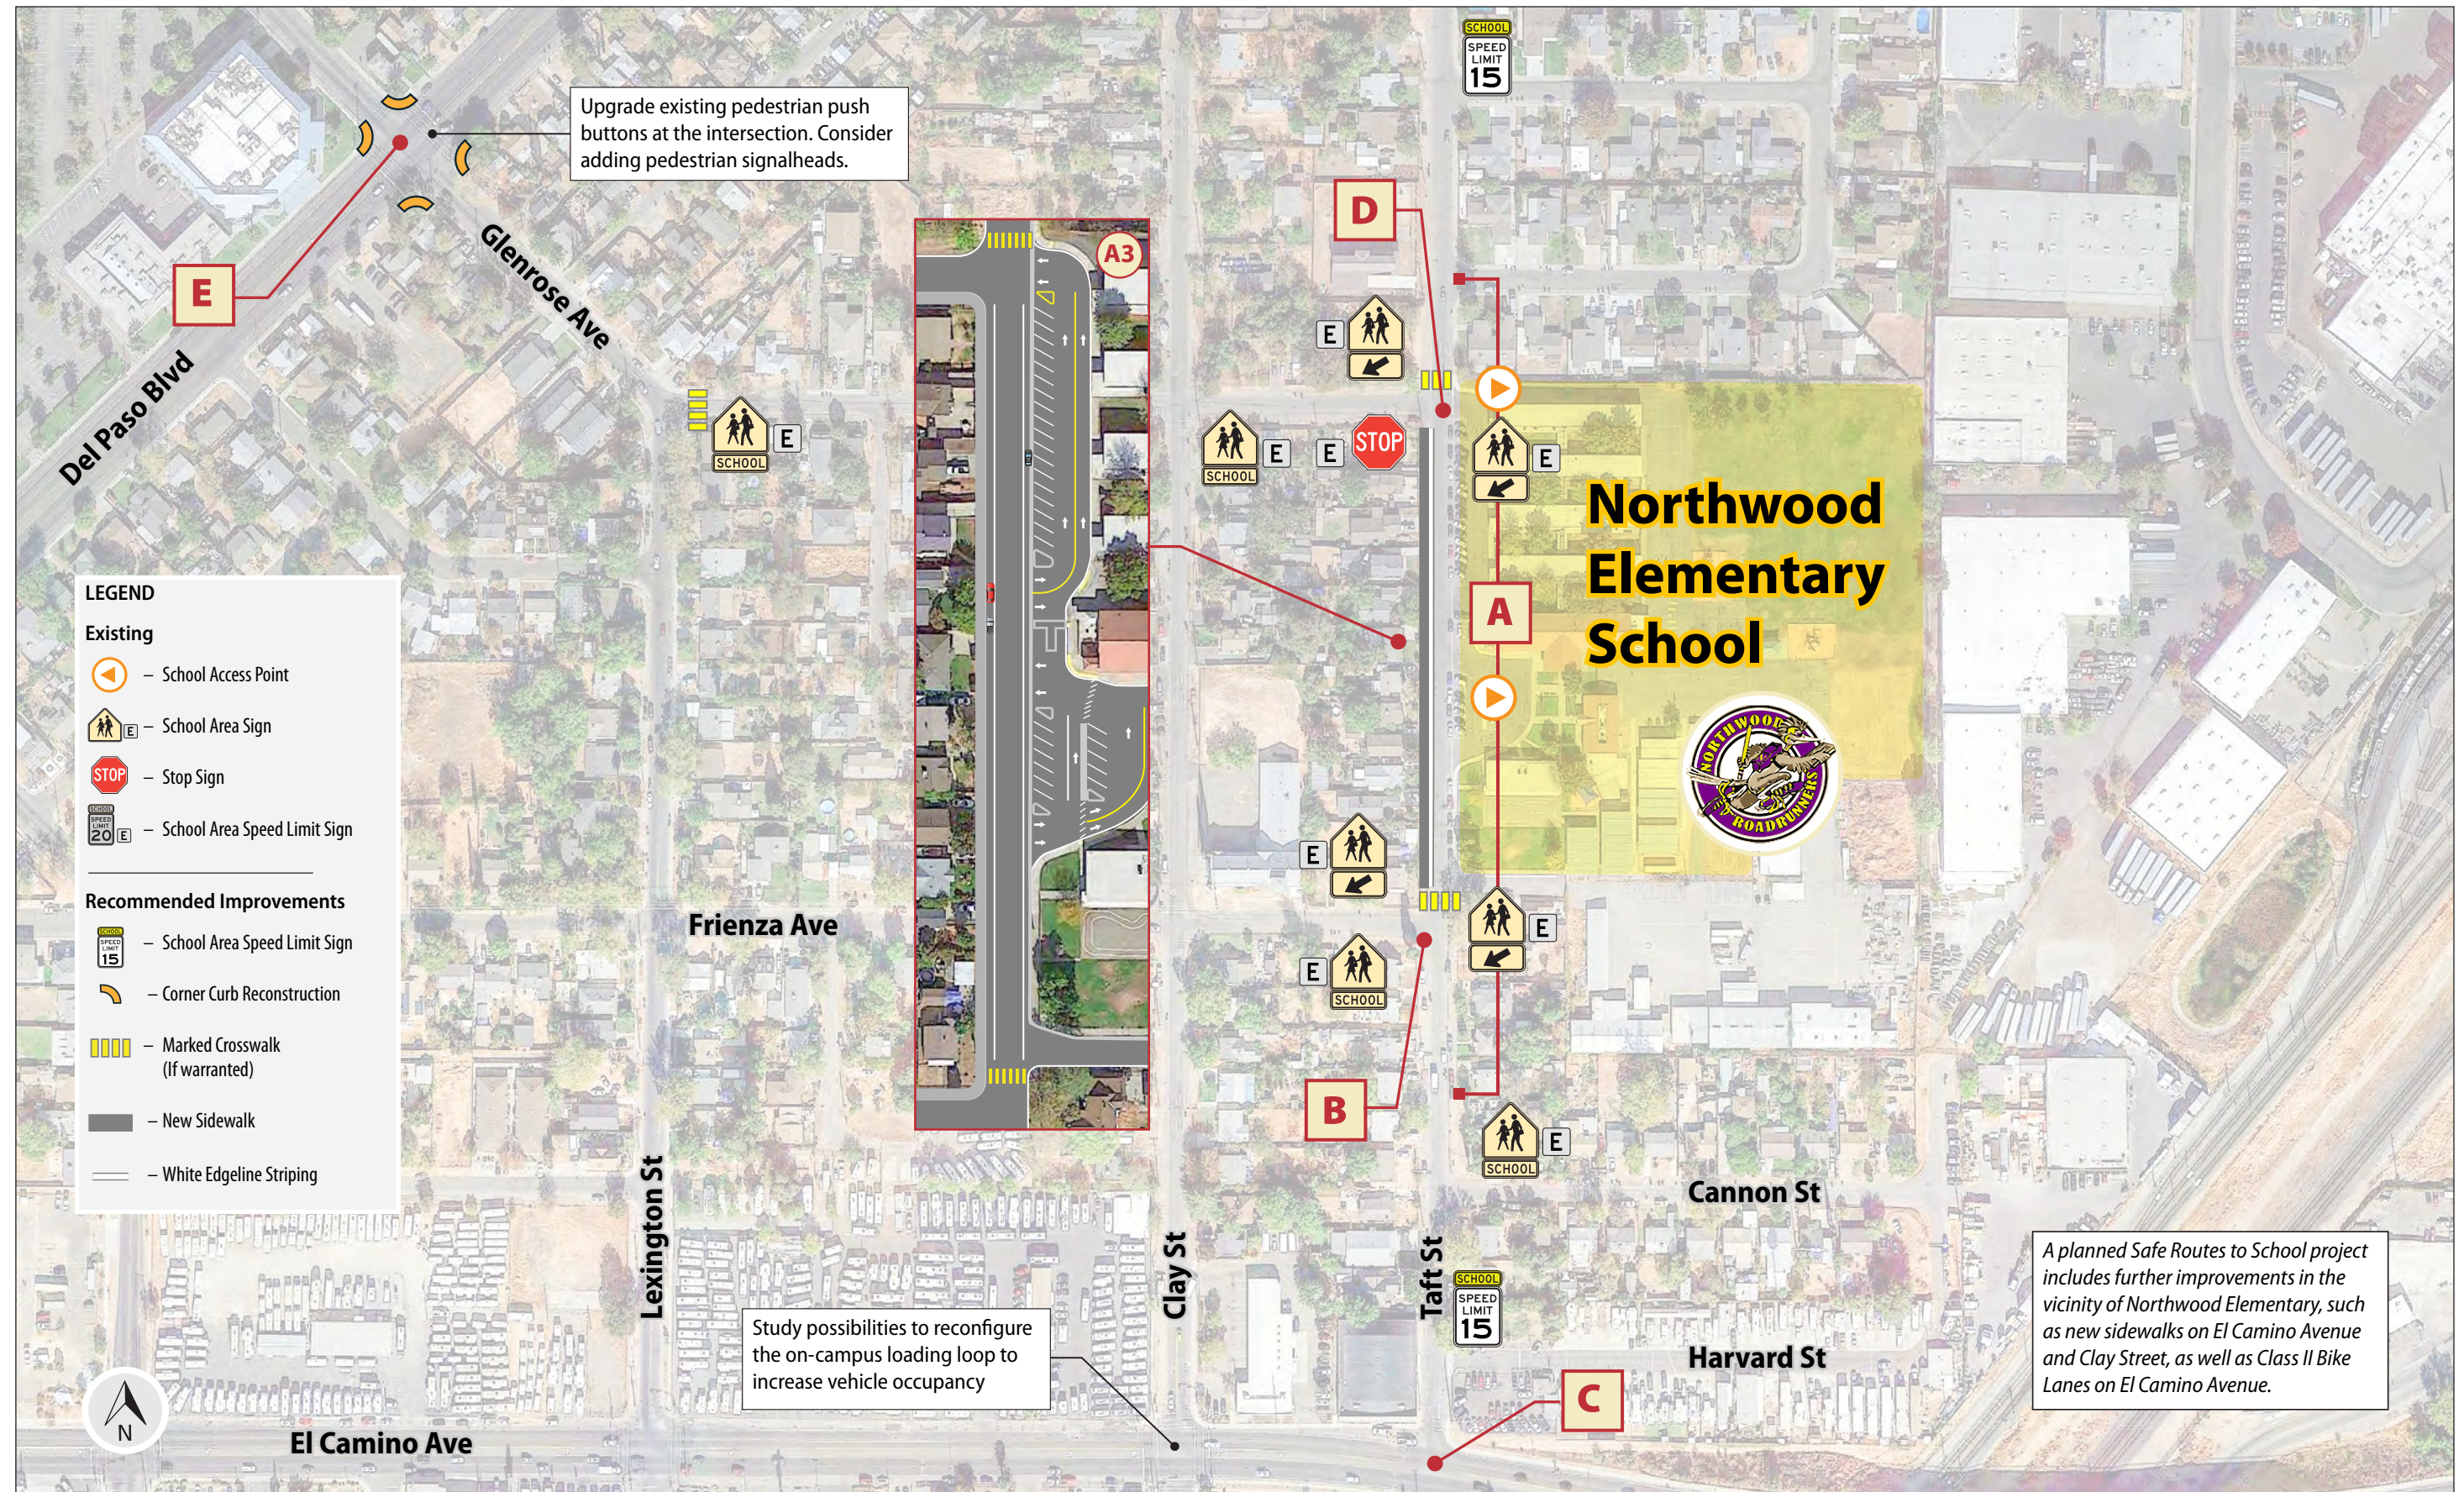
NORTHWOOD ELEMENTARY SCHOOL, 2630 TAFT STREET, SACRAMENTO

LOCATION	OBSERVATION	RECOMMENDATIONS	IMPLEMENTATION			RESPONSIBILITY
			Short	Medium	Long	
A. Taft Street	A1 Taft Street lacks curb and gutter on the west side. Edge line better channelizes parked vehicles.	<ul style="list-style-type: none"> • Install right edge line striping uniformly on both sides of Taft Street between Frienza Avenue and Glenrose Avenue to channelize parked vehicles. – A1 • As part of city-wide school area speed reduction program, provide 15 MPH school area speed limit signs along Taft Street between Shobar and Cannon – A2 • Construct sidewalks with curb and gutter, initially along the west side of Taft Street between Glenrose Avenue and Frienza Avenue – A3 • After potential long-term implementation of sidewalks, consider provision of park and walk strategy * – A4, A5, A6 	✓			Department of Public Works
	A2 Taft Street is a qualifying street in the City of Sacramento’s school area speed reduction program.		✓			Department of Public Works

A3 Currently the west side lacks any sidewalks.					
	A4 On-campus parking lots and loading loops are congested during pick-up and drop-off times, resulting on vehicle backups onto Taft Street.				✓	Department of Public Works
	A5 Vehicles were observed double parking along Taft Street.				✓	Northwood Elementary
	A6 Parents often ignore the parking lot procedures by moving traffic cones and idling in the bus-only zone.

C. El Camino Avenue and Taft Street Intersection	C1 High volume of students observed crossing at this uncontrolled unmarked crossing.	• Educate students on recommended travel patterns with a preferred walking route map and school reminders. Encourage students to cross Taft Street at Clay Street, a signalized intersection with a marked crosswalk. – C1, C2	✓			Northwood Elementary School
	C2 School administrators report speeding vehicles and lack of yield compliance to pedestrians crossing Taft Street.

D. Taft Street and Glenrose Avenue Intersection	D1 High volume of students observed crossing at this location and continuing to Del Paso Boulevard. This intersection has no traffic controls at any approach.	• Evaluate appropriateness for a new stop control on the minor approach (Glenrose Avenue). Include stop bar, stop stencil and stop sign – D1	✓			Department of Public Works

LOCATION	OBSERVATION	RECOMMENDATIONS	IMPLEMENTATION			RESPONSIBILITY
			Short	Medium	Long	
E. Del Paso Boulevard and Eleanor Avenue Intersection	E1 Pedestrian push buttons are not ADA-complaint at northeast and southeast corners.	<ul style="list-style-type: none"> Upgrade existing pedestrian push buttons on the northeast and southeast corners to be ADA-complaint – E1 	✓			Department of Public Works
	E2 This intersection does not have pedestrian signals for the east and west crosswalks.	<ul style="list-style-type: none"> Consider adding pedestrian signal heads to crosswalks crossing Eleanor and Glenrose – E2 		✓		Department of Public Works
	E3 All four corners of the intersection have large corner curb radii.	<ul style="list-style-type: none"> Consider reconstructing the corner curbs at all four corners to reduce corner curb radii, which will narrow the intersection approaches and slow turning traffic – E3 			✓	Department of Public Works

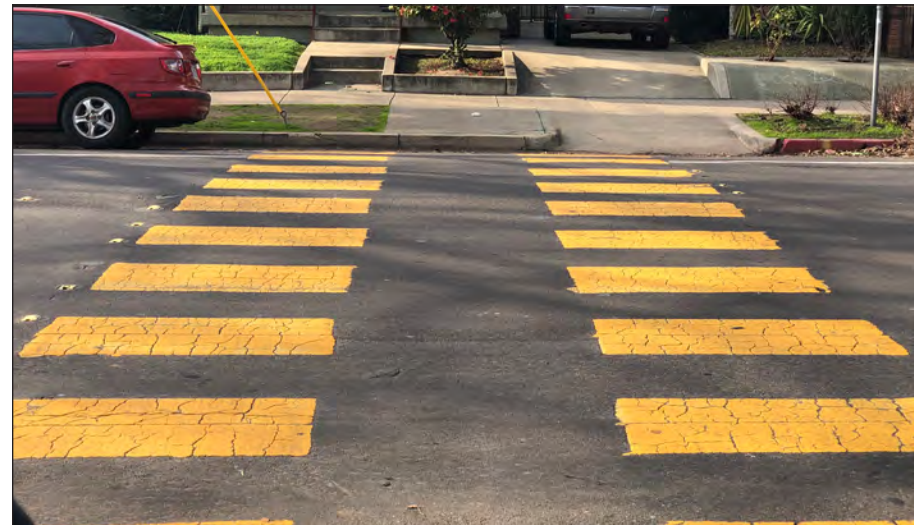
The east leg of the crosswalk at Alhambra Boulevard and I Street lacks an ADA-standard curb ramp and terminates at a residential driveway.

LOCATION	OBSERVATION	RECOMMENDATIONS	IMPLEMENTATION			RESPONSIBILITY
			Short	Medium	Long	
D. Alhambra Boulevard and I Street Intersection	D1 Many parents wait for students on the west side of Alhambra, resulting in a high number of crossings at the uncontrolled crosswalk.	<ul style="list-style-type: none"> Create a designated loading/unloading zone on the east side of Alhambra during pick-up and drop-off times to reduce the number of students crossing the street – D1, D2 	✓			Department of Public Works
	D2 A crossing guard assists students crossing to the west side of the street. School administrators report that yield compliance of pedestrians in the crosswalk by motorists is greatly reduced when the crossing guard is not present.	<ul style="list-style-type: none"> Install a minimum of 20' of red curb ahead of the northbound approach. Remove the parking space on the south side of the southbound approach to increase sight distance – D3 	✓			Department of Public Works

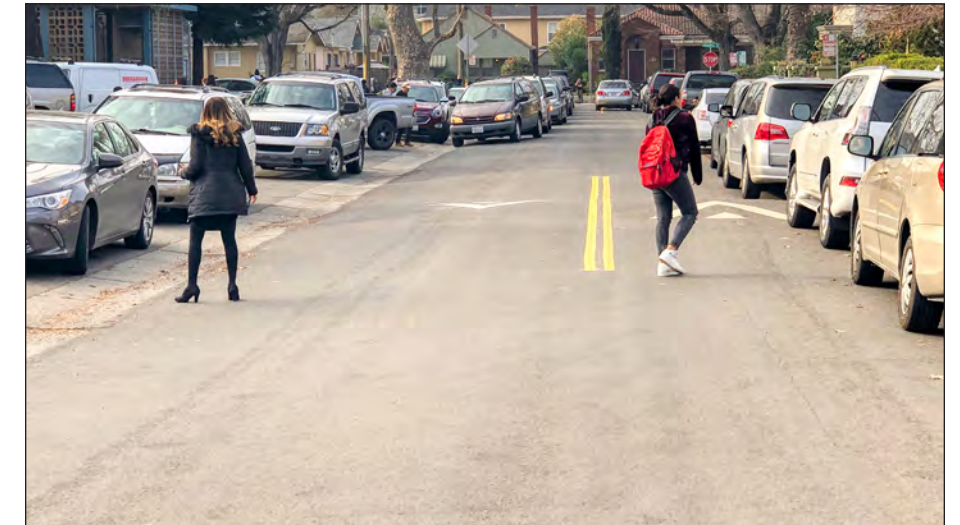
Students cross I Street at midblock locations.

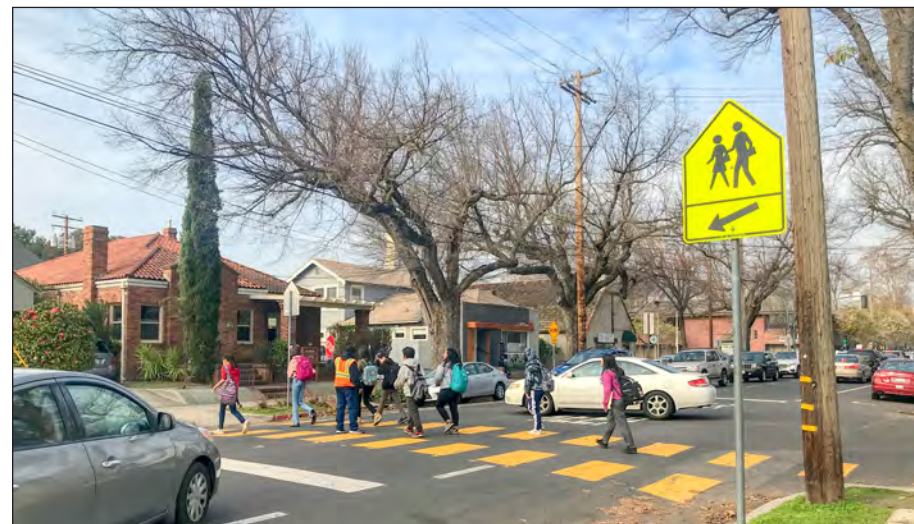
The uncontrolled marked crosswalk at Alhambra Boulevard and I Street was heavily used by students during the afternoon period. A volunteer crossing guard assists students at this location.

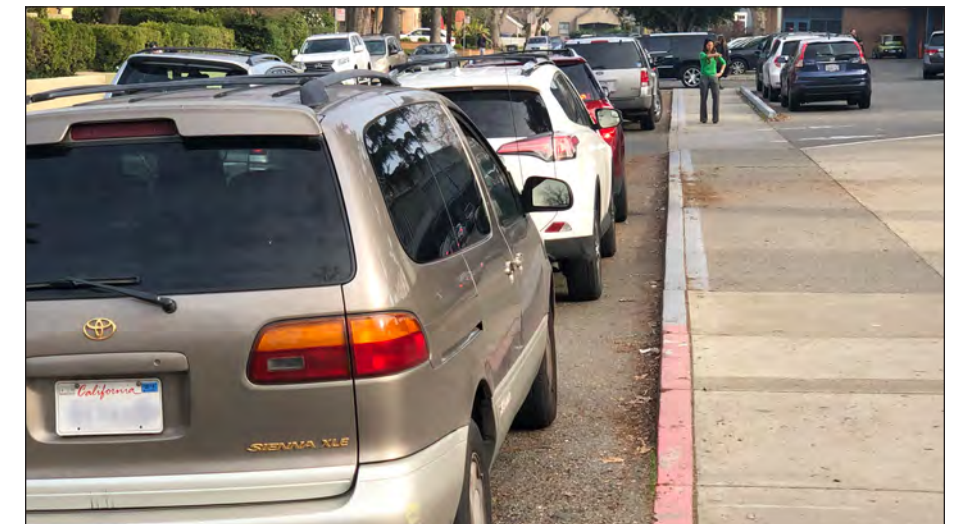
Drivers park in the white loading zone and the red No Parking zones before afternoon pick-up, with many of vehicles left unattended.

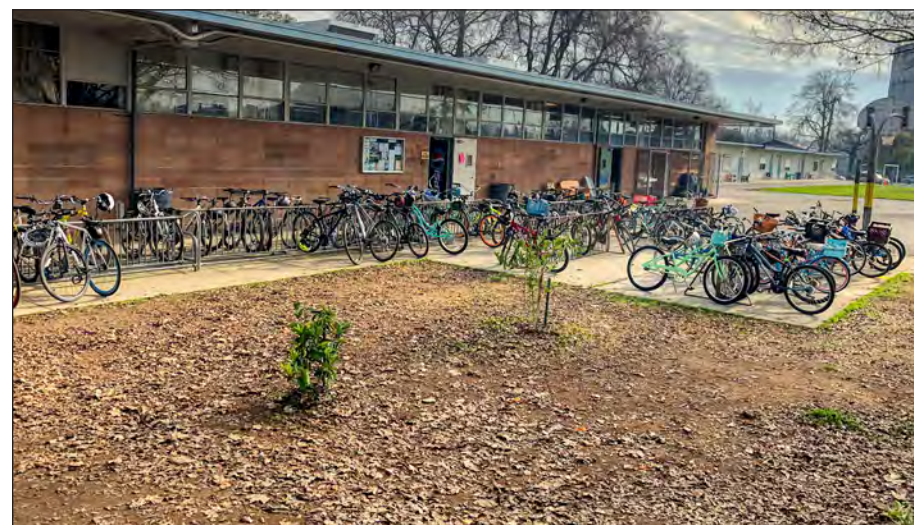
The on-campus bicycle racks were parked to near capacity with approximately 60 bikes.

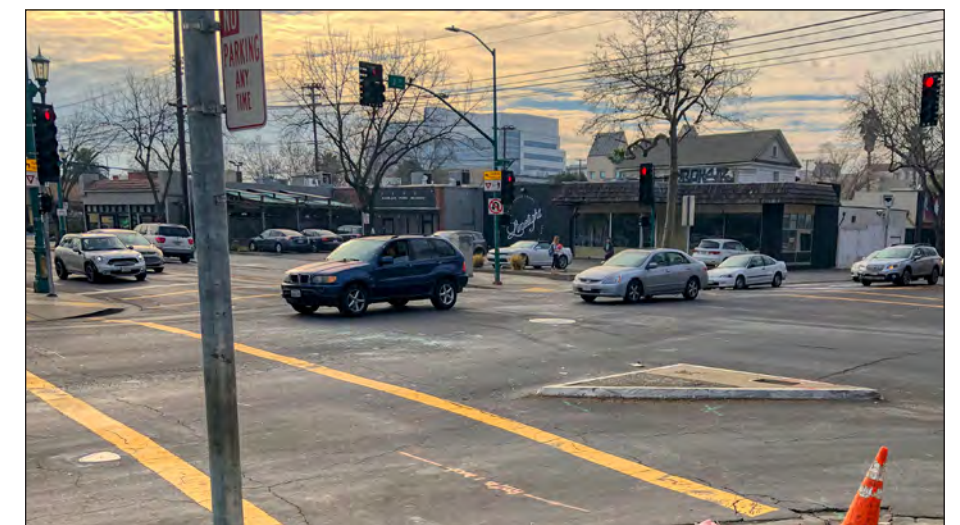
There is a raised triangular island at the Alhambra Boulevard and J Street intersection. Some motorists roll through the right turn at this approach, as well as causes a hindrance for bicycles.

E. Alhambra Boulevard and J Street Intersection	E1 There is a dedicated westbound right turn lane on J Street that leads to a right turn channel onto on Alhambra Boulevard. Some motorists roll through the right turn at this approach. Attendees noted that drivers oftentimes do not see pedestrians in the crosswalk traveling southbound.	<ul style="list-style-type: none"> Consider implementing no right turn on red restriction for vehicles turning right onto Alhambra from the slip lane – E1 Remove the raised triangular island and replace with striping for unobstructed bicycle travel – E1, E2 		✓		Department of Public Works
	E2 The concrete raised triangular island at the northeast corner disrupts the path of travel for northbound bicycles on Alhambra Boulevard.	<ul style="list-style-type: none"> Install a leading pedestrian interval (LPI) on all four legs of the crosswalk to reduce pedestrians exposure to conflicting vehicle traffic – E1 			✓	Department of Public Works

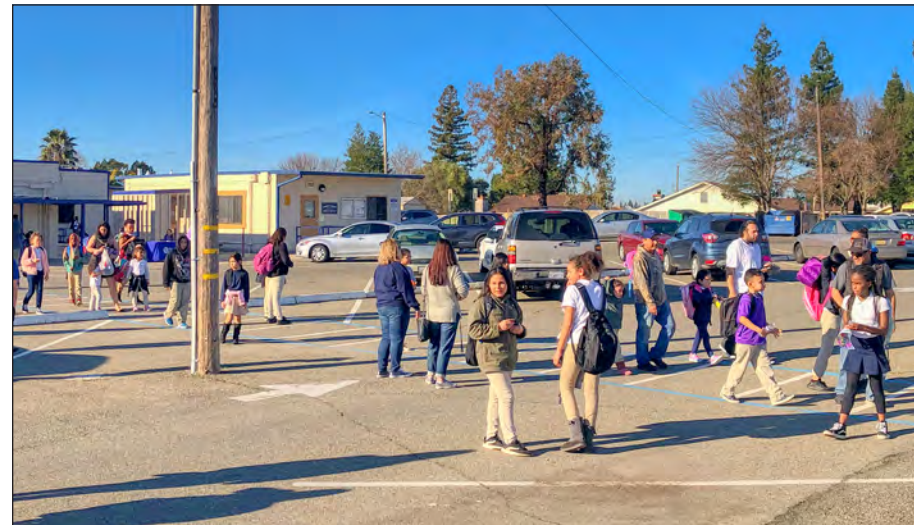
Students walking within, and outside of, the marked walkway that bisects Garden Valley Elementary School's parking lot.

LOCATION	OBSERVATION	RECOMMENDATIONS	IMPLEMENTATION			RESPONSIBILITY
			Short	Medium	Long	
A School parking lot	A1 Students heavily use lightly-marked crosswalk bisecting school's parking lot.	• Enhance crosswalk with high-visibility markings. Consider raising the crosswalk. – A1	✓			Twin Rivers Unified School District
	A2 Students need to walk above raised curb at end of parking lot's crosswalk where it meets the back of sidewalk at Larchwood Drive.	• Install an ADA-compliant curb ramp – A2		✓		Twin Rivers Unified School District
	A3 Parking lot is inaccessible to vehicles during school commute periods due to inefficient configuration for drop-off and pick-up operations.	• Evaluate alternative configuration modifications to the parking lot to potentially accommodate drop-off and pick-up – A3			✓	Twin Rivers Unified School District
B Larchwood Drive	B1 Some motorists wait to pick up students in yellow curb zones, others park immediately next to marked crosswalks.	• Install red curb at the bus stop with modified R26 (No Parking, Bus Loading Zone) sign – B1	✓			Department of Public Works

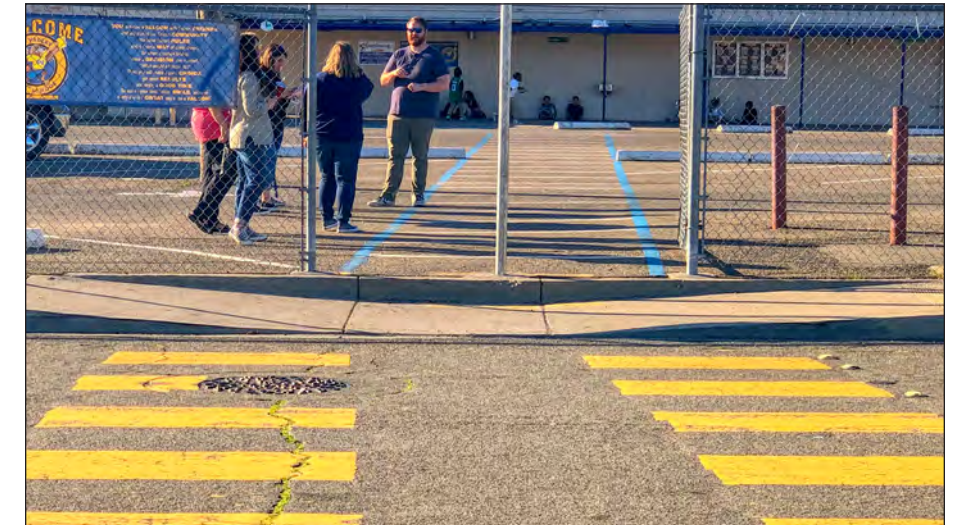
The transition between the internal walkway and the sidewalk along Larchwood Drive is separated by a raised curb, resulting in a non-ADA compliant route.

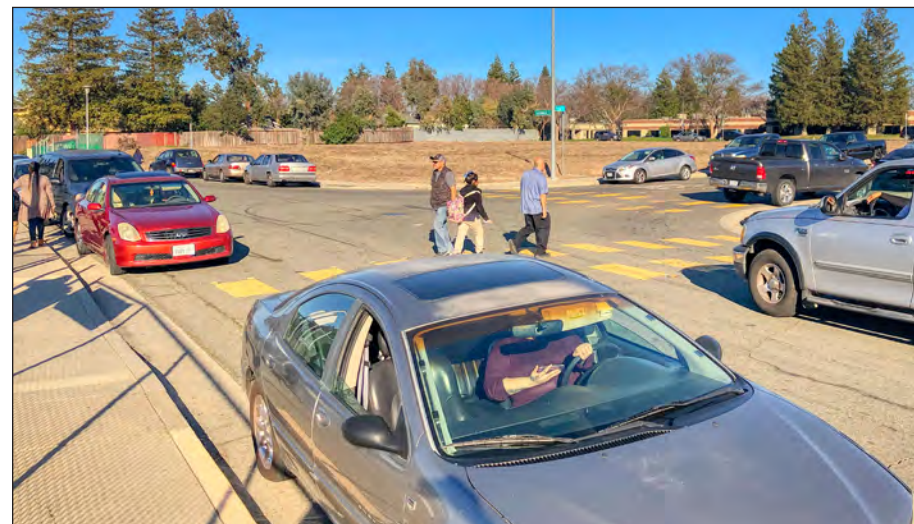
During school pick-up, vehicles are parked immediately adjacent to crosswalks, along crosswalks, and in yellow curb zones at the Larchmont Drive / Patio Avenue intersection.

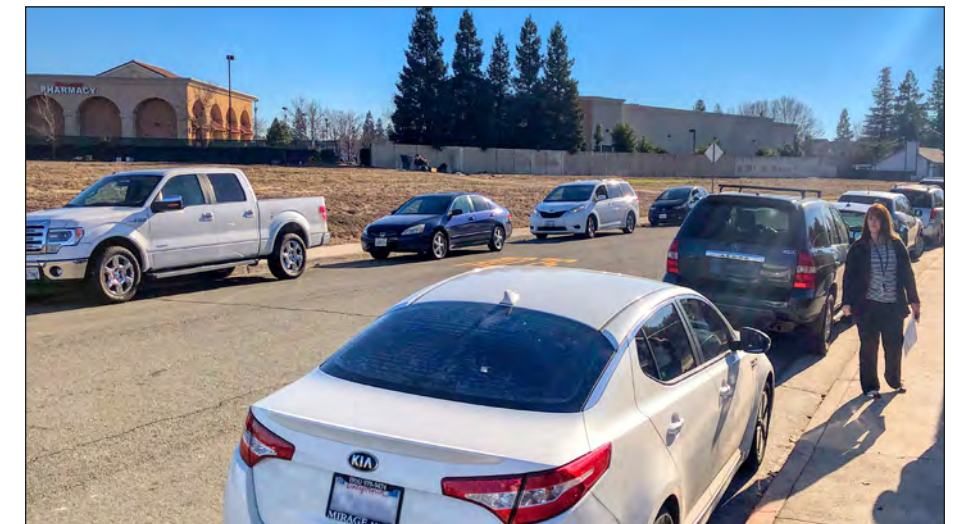
Vehicles parked along both sides of Larchmont Drive, south of Patio Avenue, including within red curb zones.

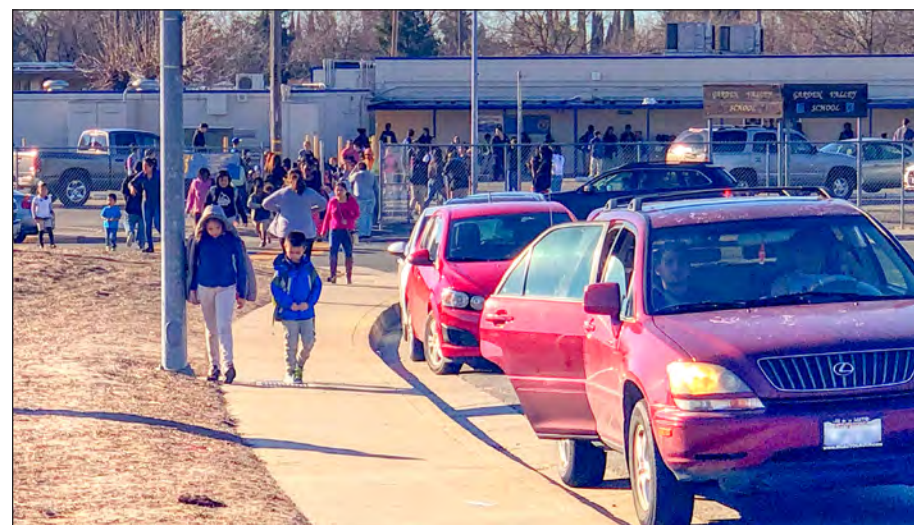
Students and parents walking along the south side of Patio Avenue after school dismissal. The sidewalk is five feet wide.

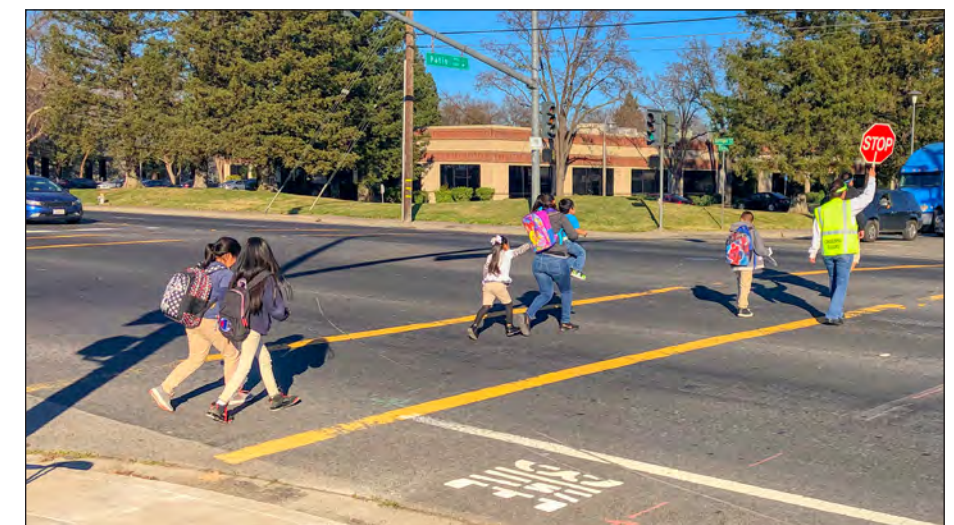
A substantial number of students live on the east side of Northgate Boulevard and cross from Patio Avenue with the help of a crossing guard.
