CITY OF SACRAMENTO VISION ZERO SCHOOL SAFETY STUDY

- **Vision Zero School Safety Study** – This project, which is the focus of this report, documents conditions for students who walk, bike, take transit or private vehicle at 20 schools across Sacramento. The assessments of these conditions reflect the social, built and natural environments that affect the ability and desire of students to walk, bike and take transit to school. This study results in short-, medium- and long-term recommendations for the 20 identified schools to improve safety conditions for children walking or biking to school, and which include signage, pavement marking, traffic calming and operational improvements along roadways within school zones.

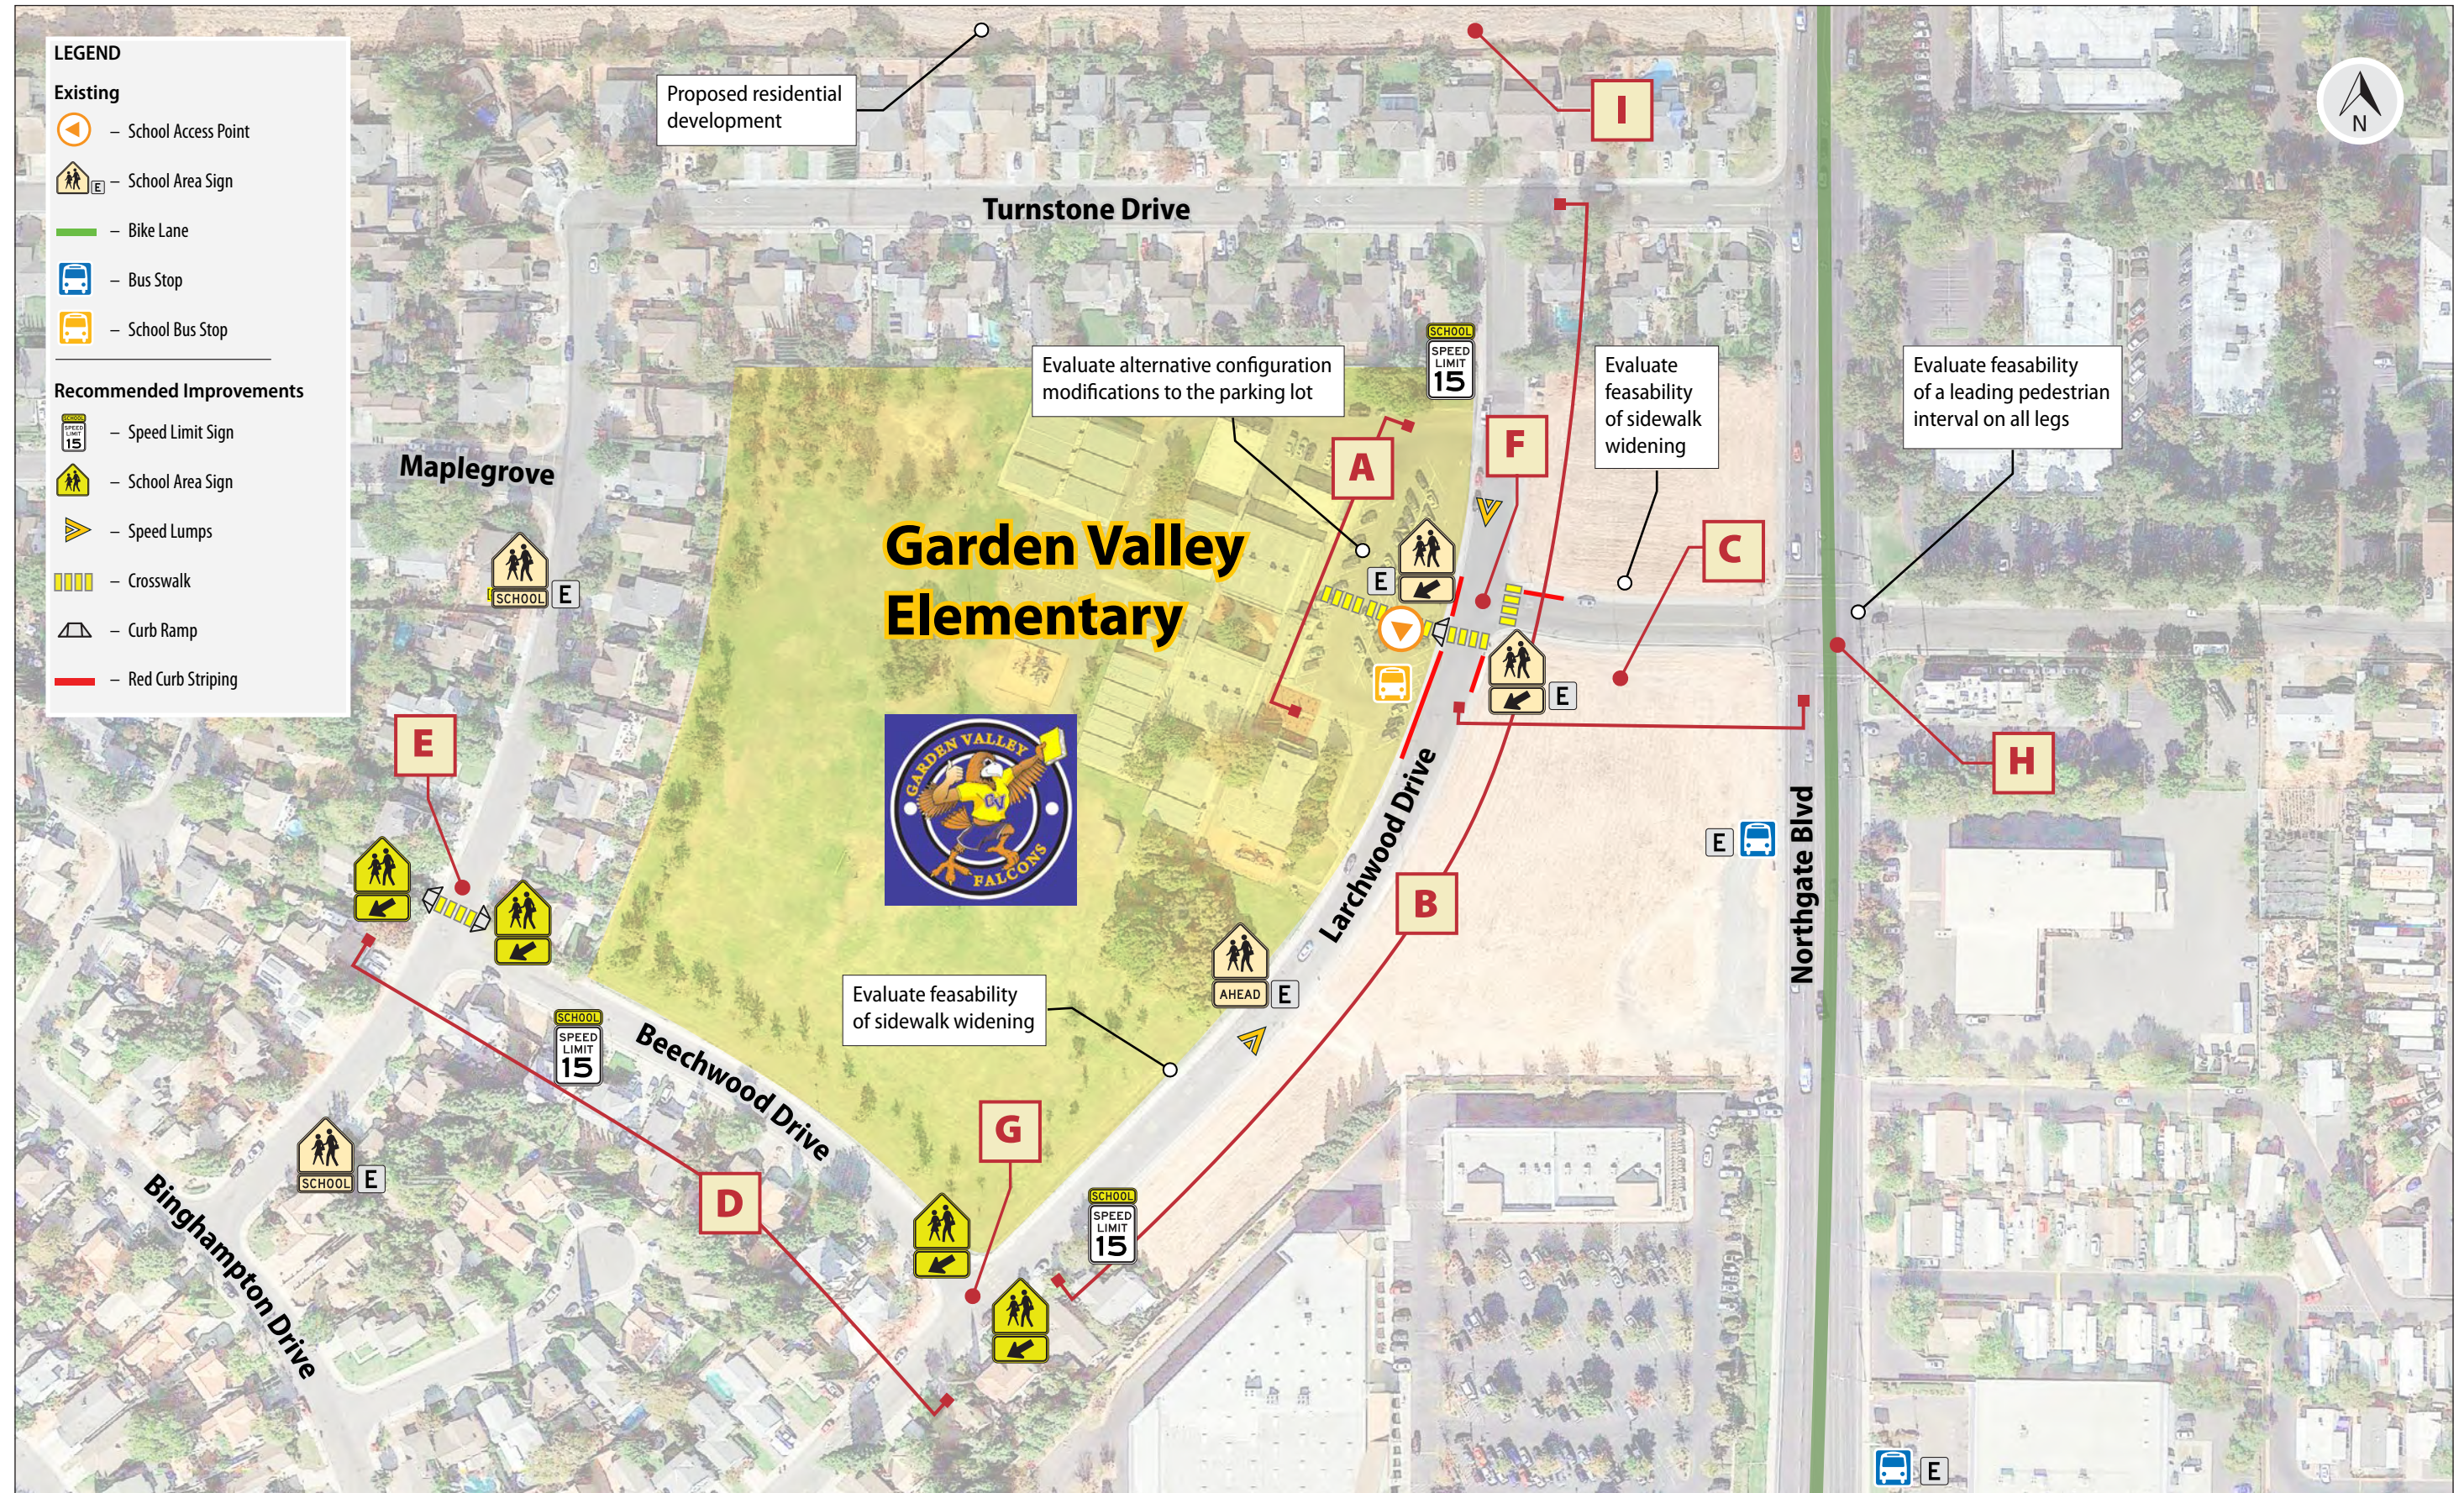
GARDEN VALLEY ELEMENTARY SCHOOL, 3601 LARCHWOOD DRIVE, SACRAMENTO

LOCATION	OBSERVATION	RECOMMENDATIONS	IMPLEMENTATION			RESPONSIBILITY
			Short	Medium	Long	
A School parking lot	A1 Students heavily use lightly-marked crosswalk bisecting school's parking lot.	• Enhance crosswalk with high-visibility markings. Consider raising the crosswalk. – A1	✓			Twin Rivers Unified School District
	A2 Students need to walk above raised curb at end of parking lot's crosswalk where it meets the back of sidewalk at Larchwood Drive.	• Install an ADA-compliant curb ramp – A2		✓		Twin Rivers Unified School District
	A3 Parking lot is inaccessible to vehicles during school commute periods due to inefficient configuration for drop-off and pick-up operations.	• Evaluate alternative configuration modifications to the parking lot to potentially accommodate drop-off and pick-up – A3			✓	Twin Rivers Unified School District
B Larchwood Drive	B1 Some motorists wait to pick up students in yellow curb zones, others park immediately next to marked crosswalks.	• Install red curb at the bus stop with modified R26 (No Parking, Bus Loading Zone) sign – B1	✓			Department of Public Works

LOCATION	OBSERVATION	RECOMMENDATIONS	IMPLEMENTATION			RESPONSIBILITY
			Short	Medium	Long	
D Beechwood Way	D1 Beechwood Way is a qualifying street in the City of Sacramento's school area speed reduction program.	<ul style="list-style-type: none"> As part of city-wide school area speed reduction program, provide 15 MPH school area speed limit signs along Beechwood Way – D1 	✓			Department of Public Works
E Beechwood Way/ Turnstone Drive	E1 Pedestrians use an uncontrolled crosswalk at Turnstone Drive; no curb ramp exists on the north side of the intersection.	<ul style="list-style-type: none"> Install school Assembly B crosswalk signage at the intersection – E1 Install an ADA-compliant curb ramp on the north side of Turnstone Drive– E1 	✓	✓		Department of Public Works Department of Public Works
F Larchwood Drive/ Patio Avenue	F1 High pedestrian volumes, including students and parents, cross the faded uncontrolled crosswalk across Larchwood Drive.	<ul style="list-style-type: none"> Refresh all crosswalk markings at the intersection of Larchwood Drive/Patio Avenue – F1 	✓			Department of Public Works

I Planned development site north of Turnstone Drive and west of Northgate Boulevard	I1 Proposed residential development, if served by Garden Valley Elementary School, may not have convenient walking and cycling route to and from school.	<ul style="list-style-type: none"> Coordinate with Planning Department to identify potential walking and cycling routes (e.g., along Laurelglen Drive, new north-south passageways, Northgate Boulevard) – I1 	✓			Department of Public Works

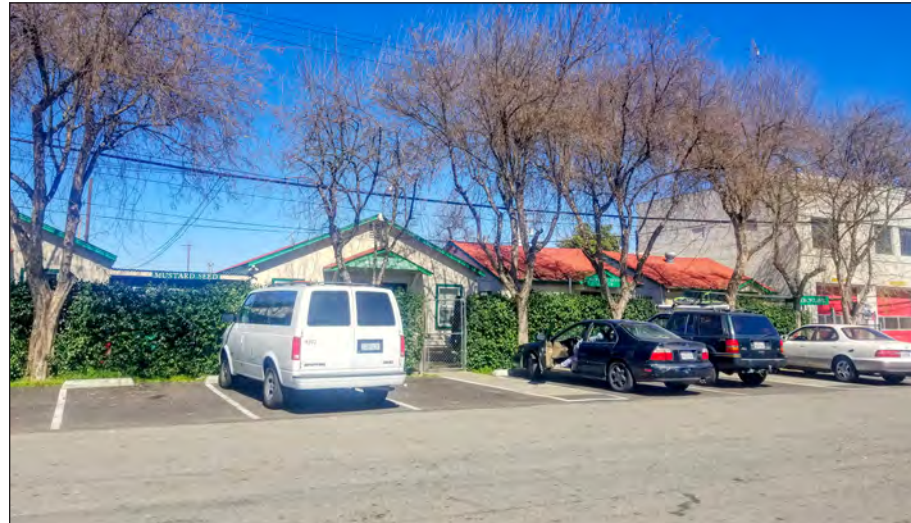
The Mustard Seed School campus is accessed via North C Street. Visitors can access the Loaves and Fishes campus from N 16th Street and NB Street.

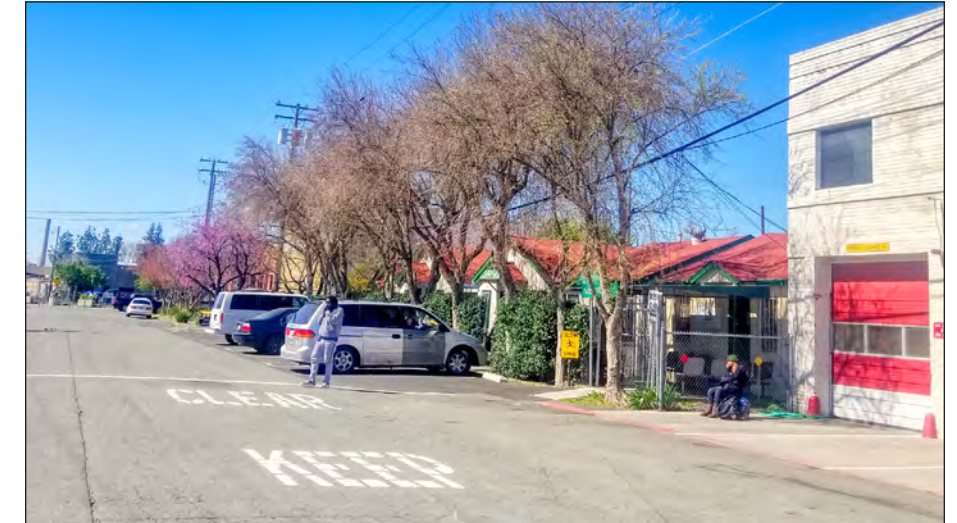
Students were observed being picked up on North C Street. No students were observed walking or bicycling from school.

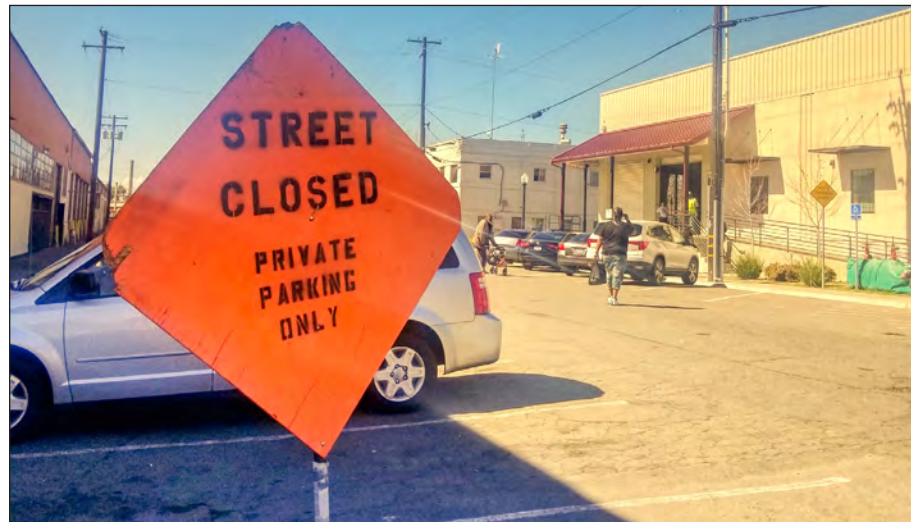
Warning signs deployed by Loaves and Fishes staff discourage general parking and drivers from trying to access N. 12th Street via North C Street.

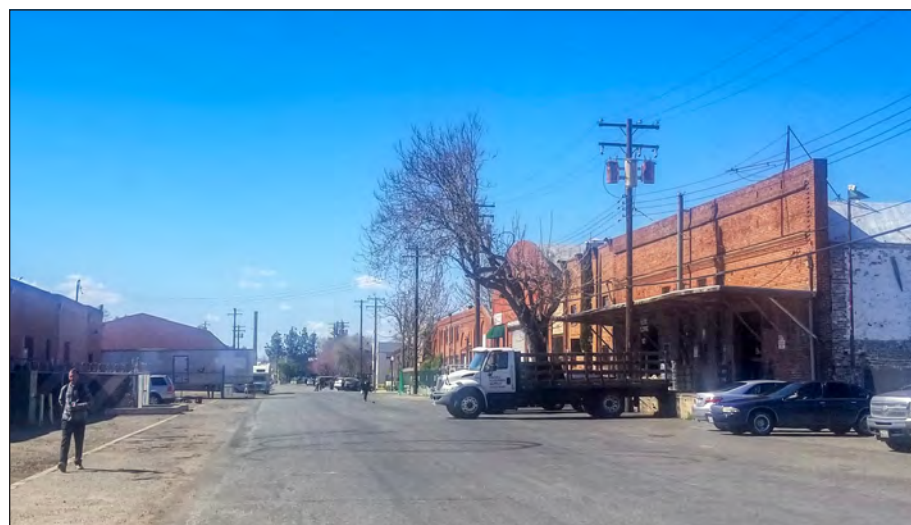
North C Street, Ahern Street and McCormack Avenue border the Loaves and Fishes campus. These streets serve industrial uses and generally lack sidewalks and marked crosswalks.

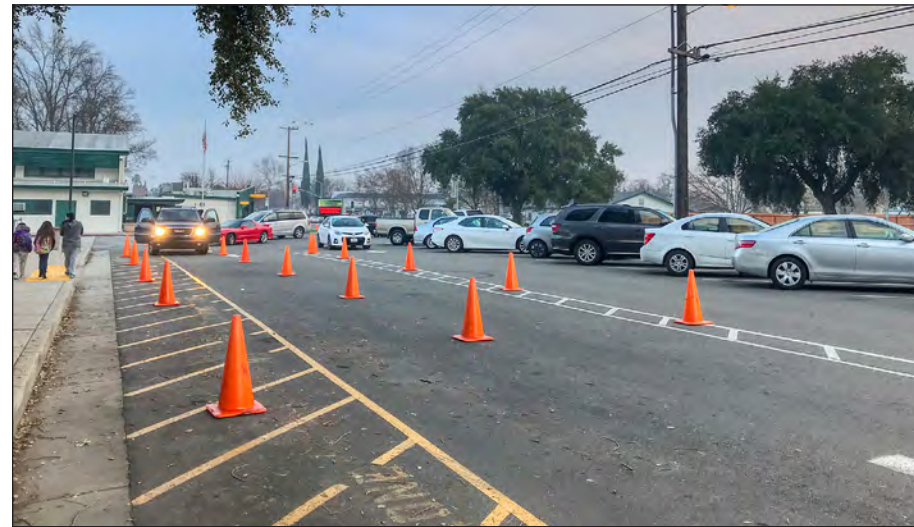
Cones are set out by Smythe Academy staff to guide the morning drop-off process by dividing the parking lot into two lanes.

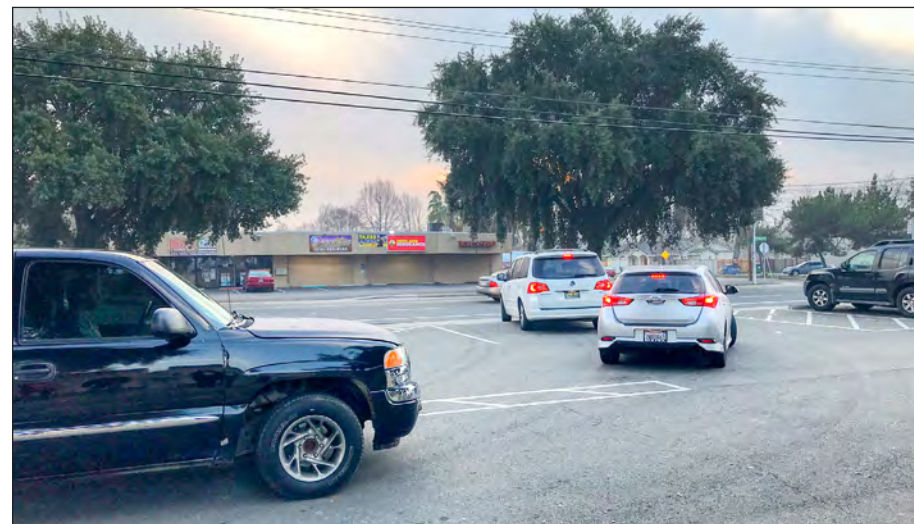
Turns out of the school parking lot, particularly left turns, are challenging due to travel speeds on Northgate Boulevard.

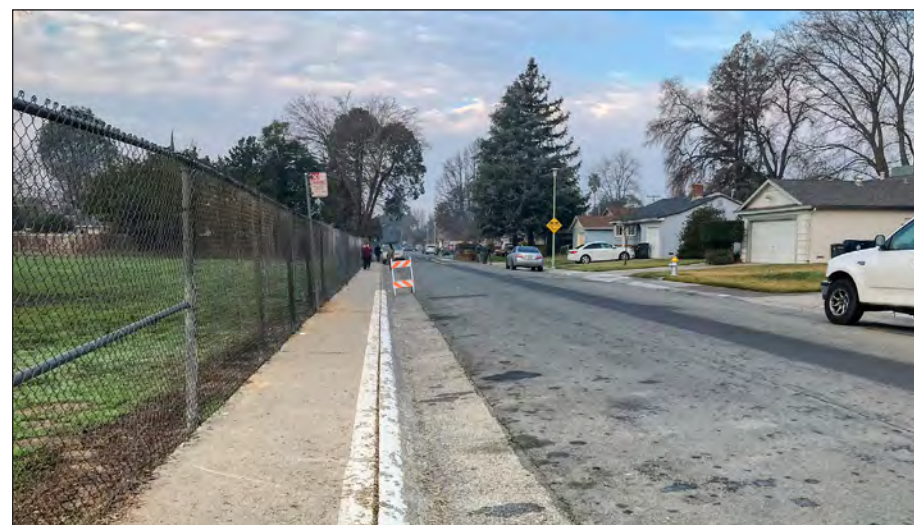
The loading zone on Haggin Avenue is reserved for student drop-offs and pick-ups. The sidewalks are narrow and abut a chain link fence.

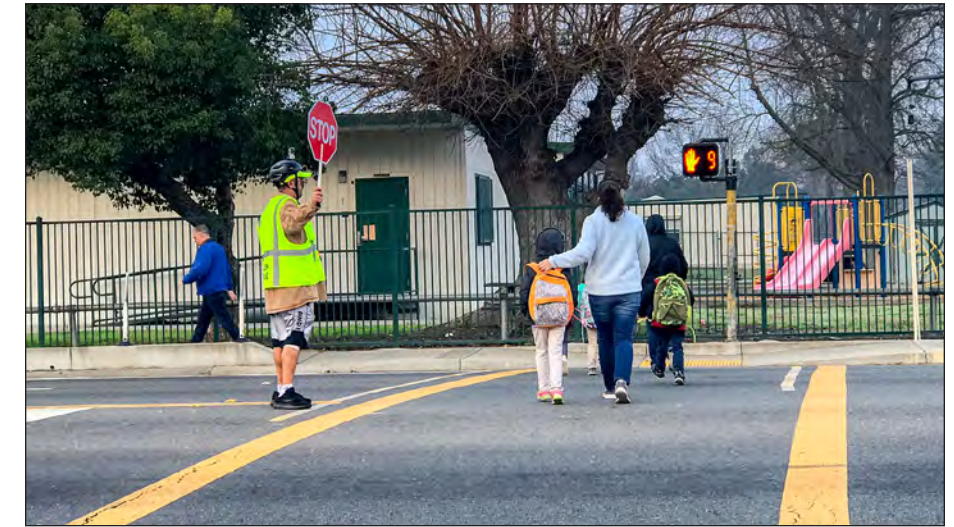
A volunteer crossing guard assists school crossings at the Northgate Boulevard and Haggin Avenue intersection. The nearest marked crossing to the south is 1700 feet (five blocks) away at W. El Camino Avenue.

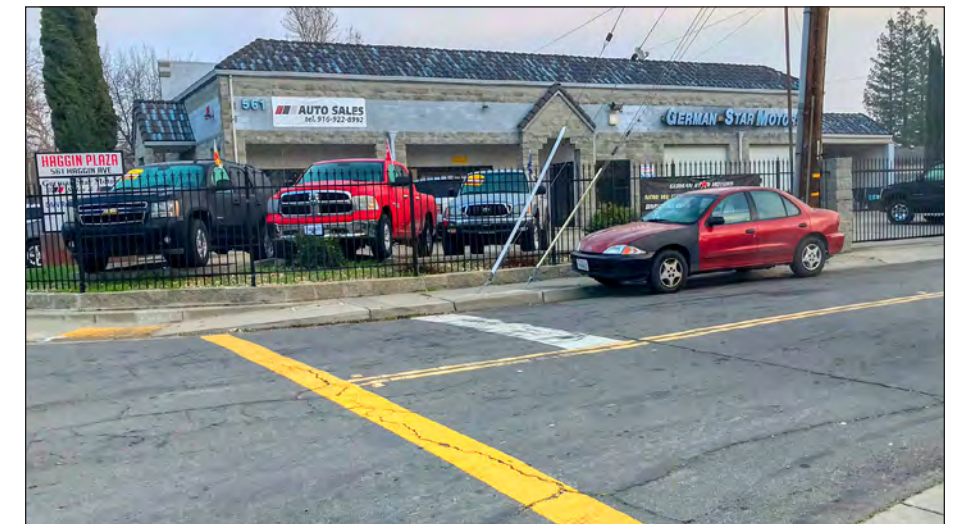
The Haggin Avenue / Northgate Boulevard intersection lacks red curb markings at the corners and vehicles have been reported parking adjacent to the curb ramps.

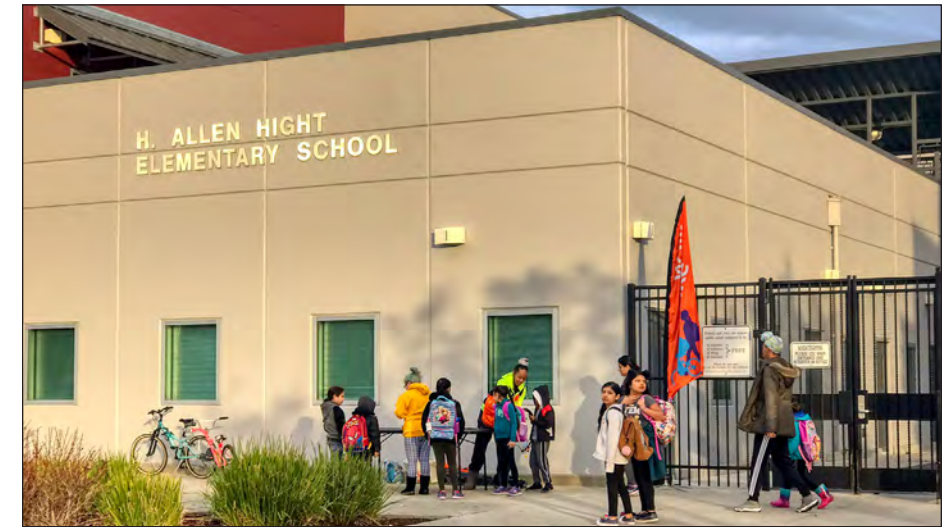
H. Allen Hight has an active Safe Routes to School program. Students who walk and bike to school check-in at the SR2S table before the start of class.

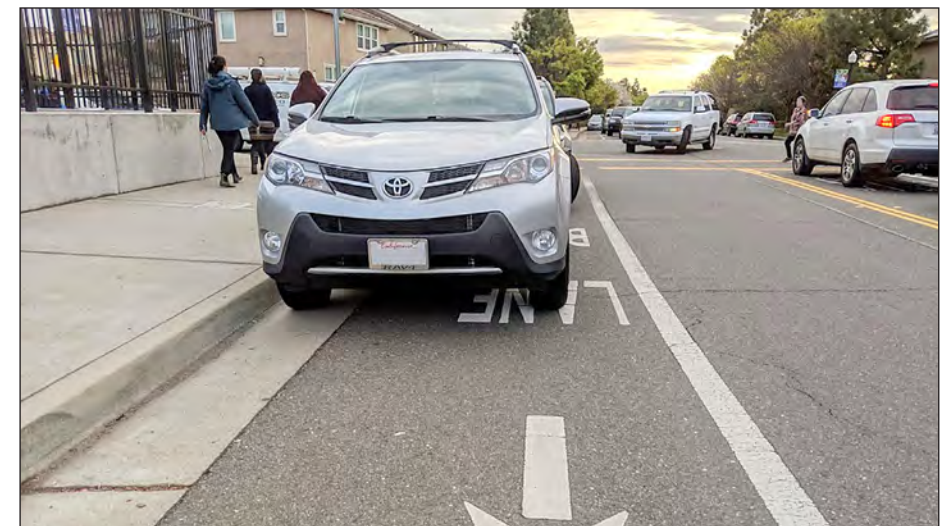
Drivers were observed parking and loading in the bike lane on North Park Drive.

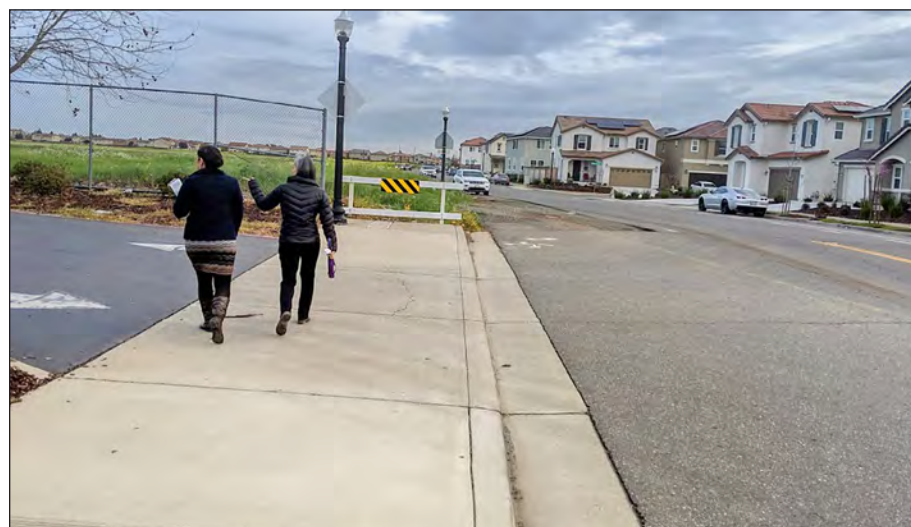
The sidewalk on the west side of Kokomo Drive ends at school limit. The frontage improvements along Kokomo Drive are the responsibility of future development of the adjoining parcel north of the school.

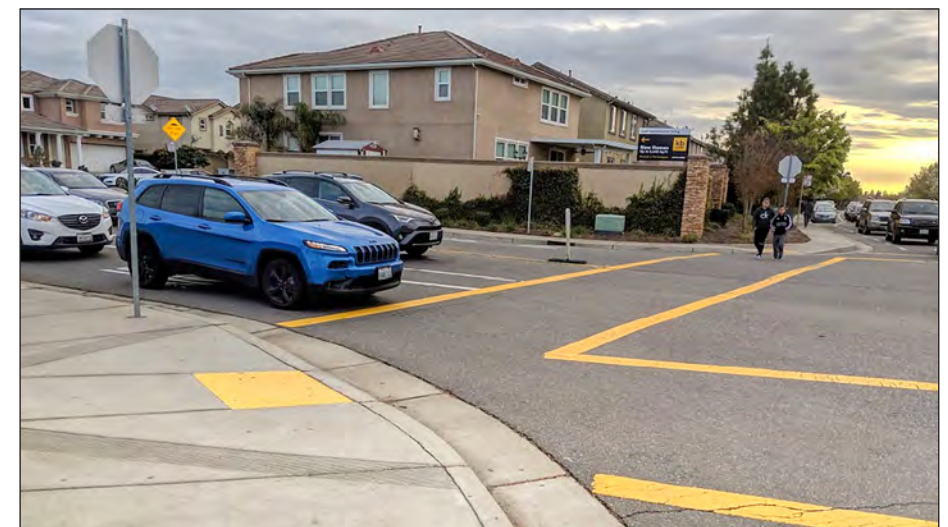
Multi-lane approaches at the all-way stop controlled intersection of North Park Road and Kokomo Drive results in confusion regarding which party has the right-of-way.

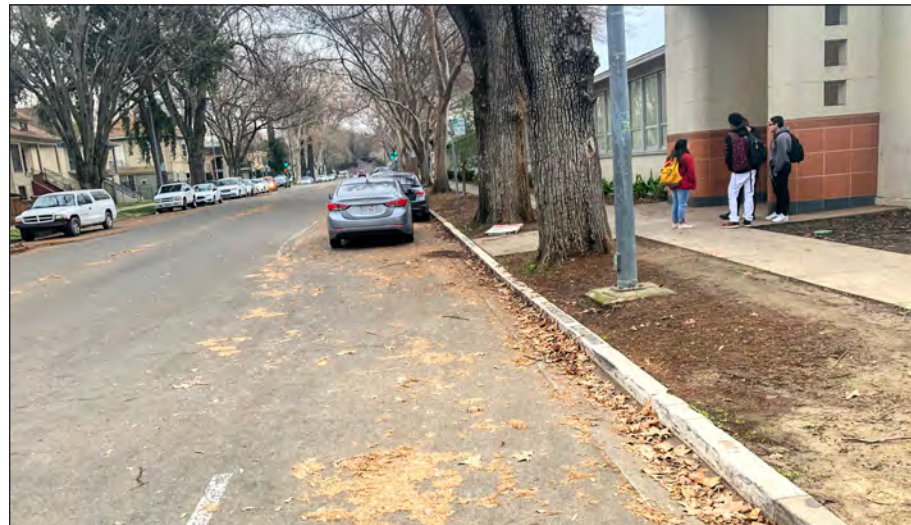
The loading zone at the school entrance on V Street is approximately 40' long and unable to accommodate the volume of unloading/loading vehicles.

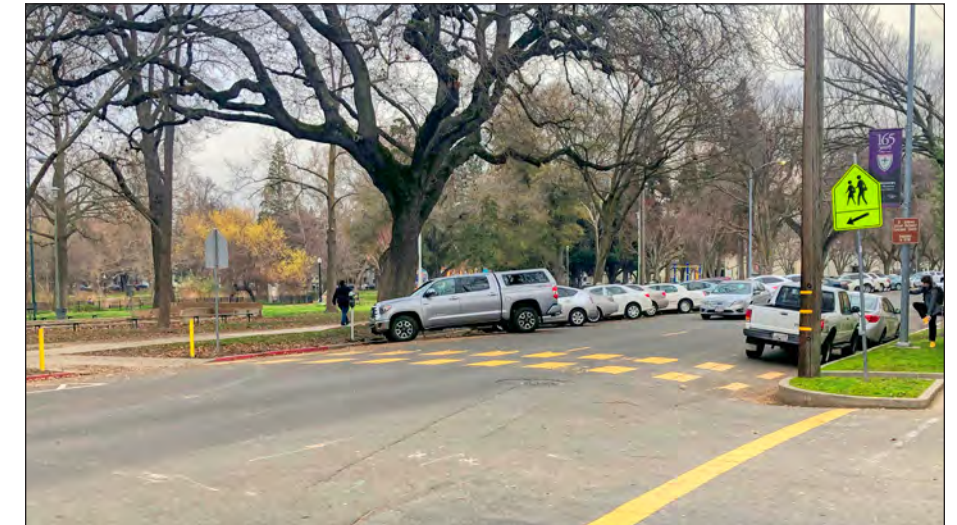
The uncontrolled crosswalk connecting the Met and Southside Park experiences high volumes of pedestrian travel before and after school.

LOCATION	OBSERVATION	RECOMMENDATIONS	IMPLEMENTATION			RESPONSIBILITY
			Short	Medium	Long	
C. V Street and 8th Street Intersection	C1 High pedestrian volumes observed using the uncontrolled marked crosswalk providing access between the Met and Southside Park. Drivers were seen failing to yield to pedestrians at this location.	<ul style="list-style-type: none"> • Install yield markings to increase awareness of uncontrolled crossing – C1, C2 • Install a minimum of 10' of red curb after the crosswalk on the east side of 8th Street to improve sight distance for motorists on V Street – C1, C2 • Consider installation of a Rectangular Rapid Flash Beacon (RRFB), if warranted based on the City's Pedestrian Crossing Guidelines. – C1, C2 • Study whether intersection warrants being converted to All-Way Stop Control – C1, C2 	✓			Department of Public Works
			✓			Department of Public Works
	C2 Motorists making a southbound left turn from V Street have an obstructed view of oncoming southbound traffic due to vehicles parked north of the marked crosswalk on the east side of 8th Street.			✓		Department of Public Works

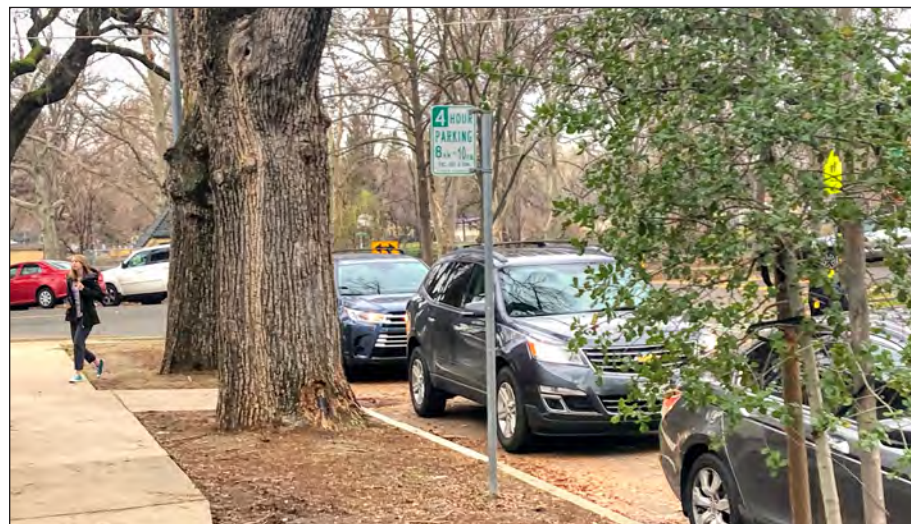
Four-hour parking restriction makes student parking in the vicinity of the school a challenge.

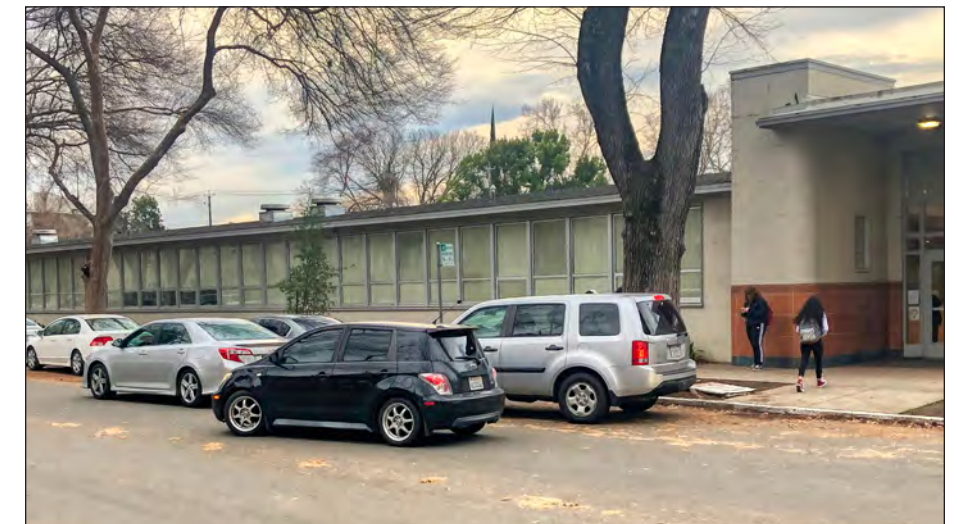
Vehicles double park on V Street due to insufficient loading zone length.

LOCATION	OBSERVATION	RECOMMENDATIONS	IMPLEMENTATION			RESPONSIBILITY
			Short	Medium	Long	
A. V Street	A1 A short loading zone (40') is located directly in front of the school entrance and is the main location for loading and unloading. The length of the existing loading zone is insufficient to accommodate the unloading and loading demand.	<ul style="list-style-type: none"> • Lengthen the loading zone by extending the length of the white curb an additional 40'. Install 20' of red curb on the southeast corner to improve pedestrian sight distance and prevent loading vehicles from blocking the crosswalk – A1 • As part of city-wide school area speed reduction program, provide 15 MPH school area speed limit signs along V Street within 500' of school grounds – A2 • Consider implementing Transportation Demand Management measures to reduce the number of students driving to school to reduce neighborhood parking (e.g., encouraging students to form carpools). Opportunities include encouraging students to form carpools – A3 • Based on the success of the Educational Institution Permit Pilot, consider implementing Educational Institution Permitting along 9th Street and V Street in the vicinity of the school to allow students all-day parking during the school day. If infeasible on these streets, consider implementing a parking program at the W/X Parking Lot – A3 • The Permit program is currently being piloted in three schools citywide - consider extending the pilot program to the Met – A3 	✓			Department of Public Works

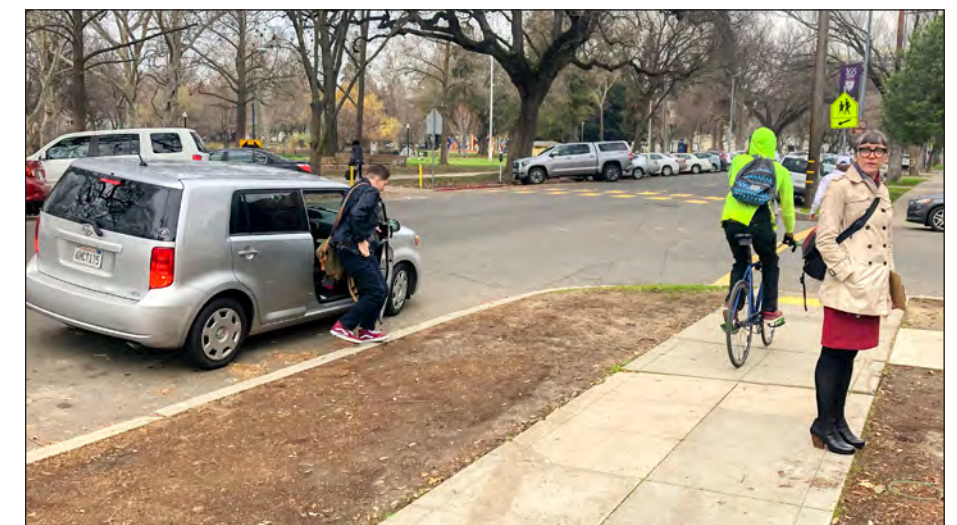
The broken concrete sidewalk on 8th Street presents an accessibility issue..

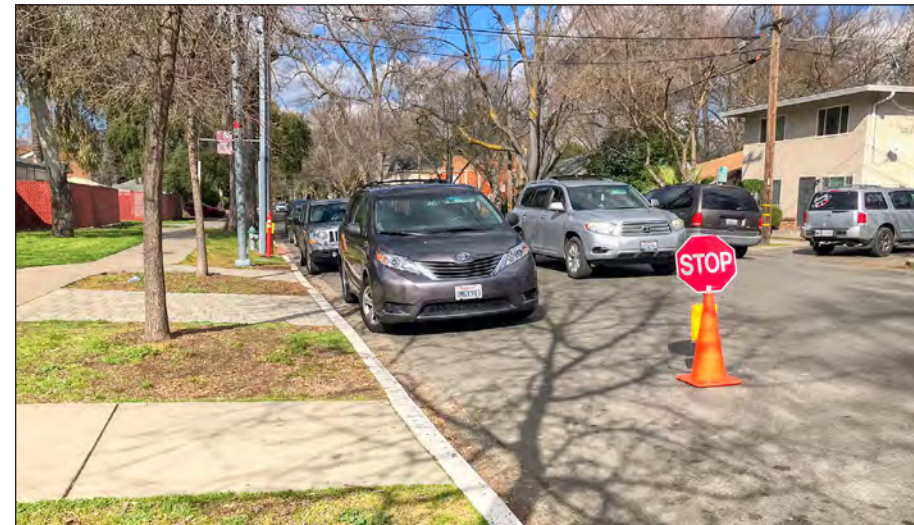
A designated loading zone fronts the school entrance on 12th Street.

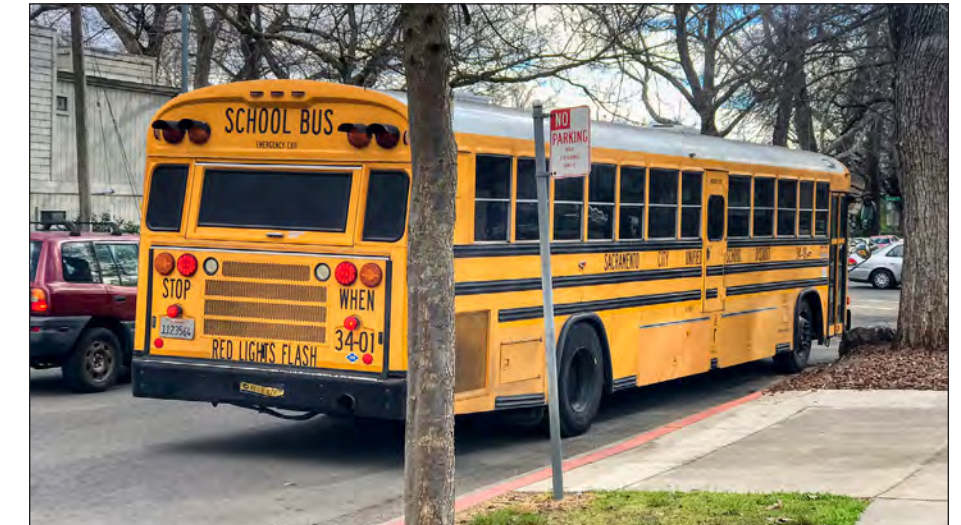
A school bus drops off and picks up in a reserved location, designated by No Parking signs, on 12th Street.

LOCATION	OBSERVATION	RECOMMENDATIONS	IMPLEMENTATION			RESPONSIBILITY
			Short	Medium	Long	
A. 12th Street	A1 Drivers were observed parking in the no parking zone, which is reserved for school-bus loading.	<ul style="list-style-type: none"> • Increase parking enforcement in the no-parking zones during pick-up and drop-off times – A1 	✓			William Land Elementary
	A2 School administrators perceive that speeding occurs along 12th Street. They attribute the speeding to vehicles not affiliated with the school, potentially using 12th Street as a cut-through.	<ul style="list-style-type: none"> • Stripe a right edge line to establish consistent ten-foot vehicle travel lanes and eight-foot parking lanes. Use the extra roadway width to install a five-foot bicycle lane on both sides of the street – A2, A3 	✓			Department of Public Works
	A3 12th Street is a 46' wide roadway without pavement markings or bicycle facilities.	<ul style="list-style-type: none"> • As part of city-wide school area speed reduction program, provide 15 MPH school area speed limit signs along 12th Street – A2 • Work with Sacramento City Unified School District to devise traffic plan routes with school and parents to minimize conflicts with cut-through traffic – A2 	✓	✓		Department of Public Works Department of Public Works

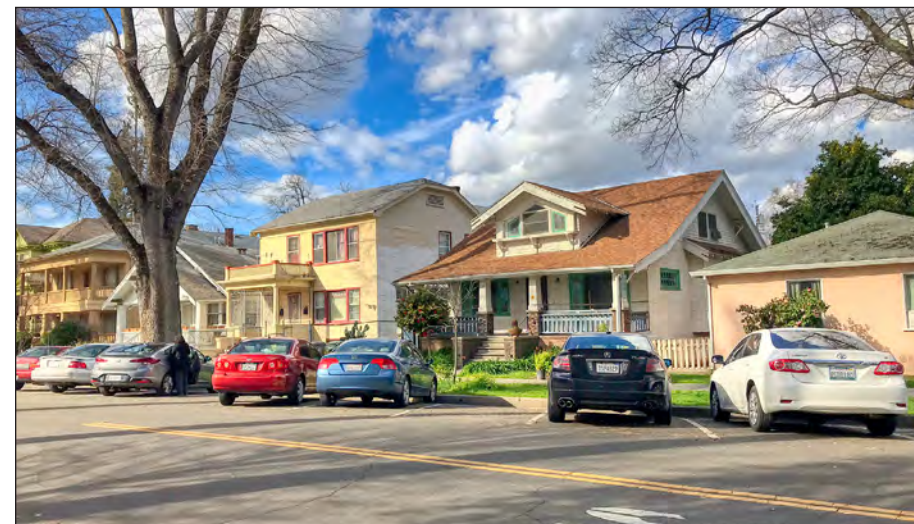
U Street was observed to have unused parking spaces during school hours.

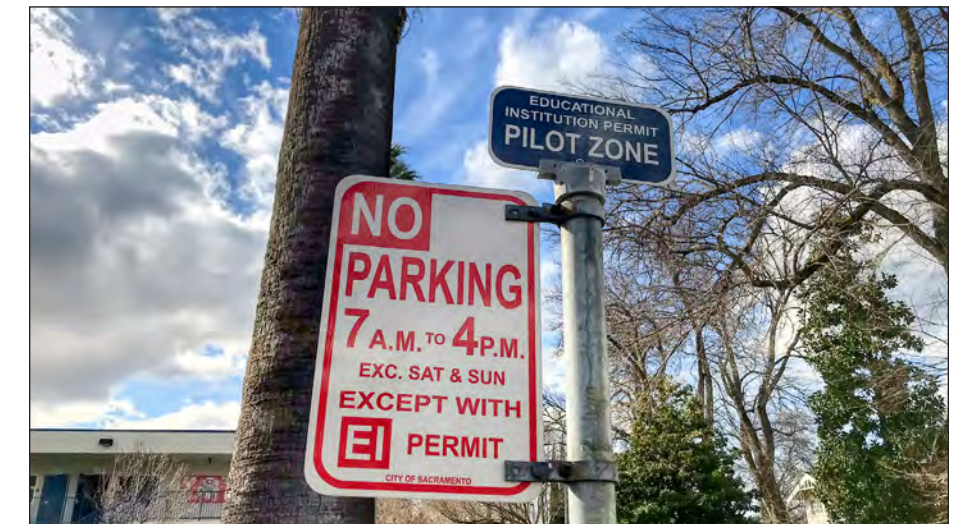
William Land Elementary is one of three Sacramento schools piloting the Educational Institution Permit program. It provides parking permits to teachers & school staff to allow them to park in the neighborhood during school hours.

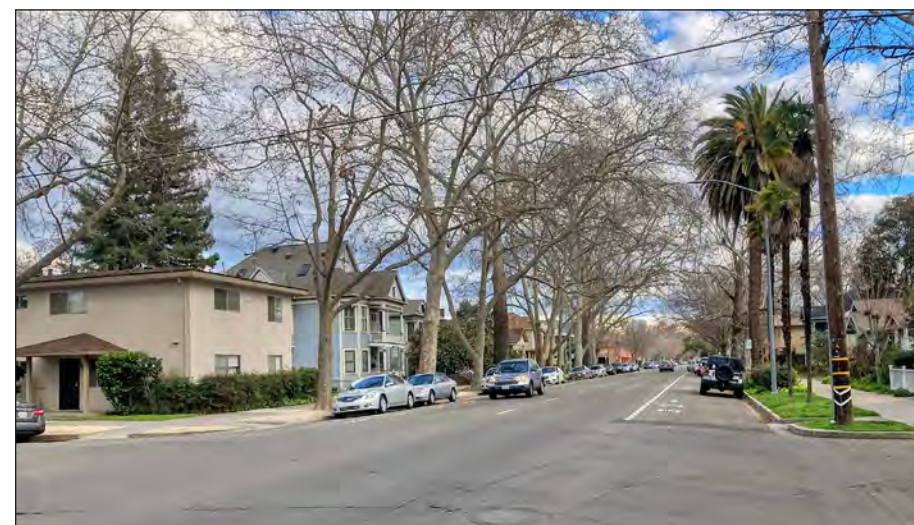
School officials perceived speeding on 10th Street, potentially due to its straight roadway alignment, uninterrupted intersections, and clear sight lines.

C. 10th Street	C1 Vehicles coming off the freeway were observed continue to travel at high speeds on local roads.	<ul style="list-style-type: none"> • Investigate comprehensive traffic calming measures on 10th Street– C1 	✓			Department of Public Works

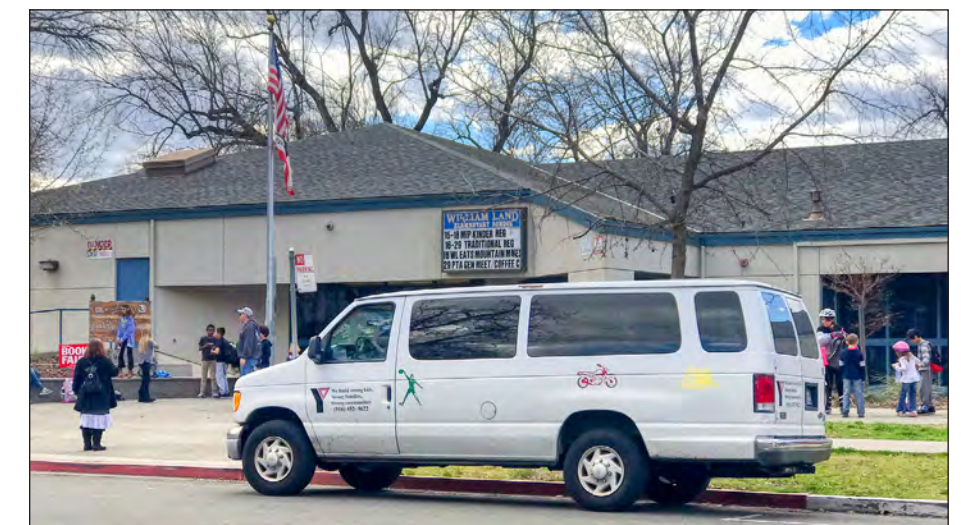
A YMCA bus picks up students on 12th Street for afterschool programming.

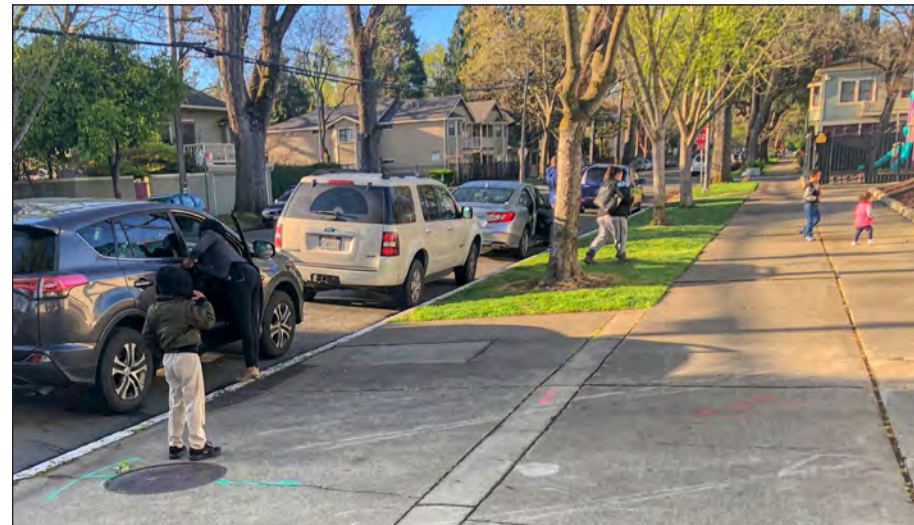
Drop-offs and pick-ups are conducted mostly along 18th Street, directly in front of the school entrance.

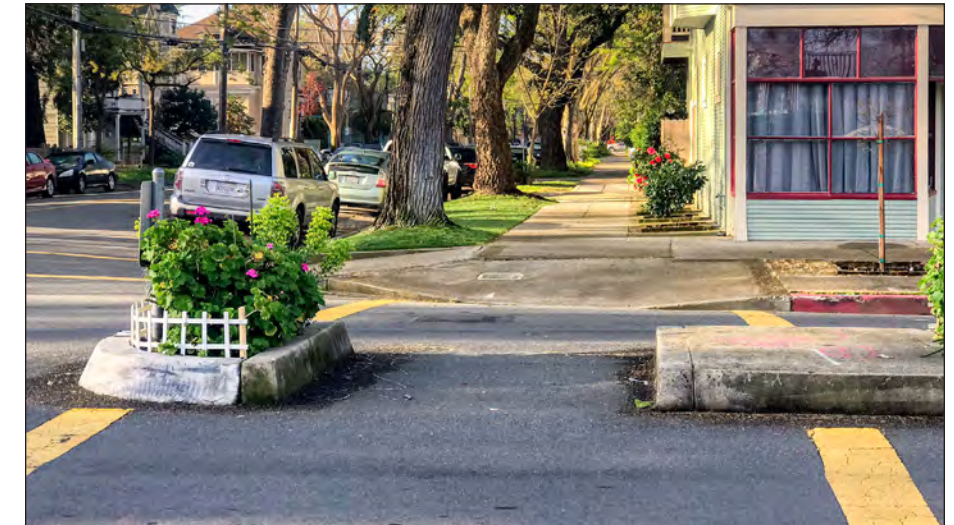
Several curb ramps in the vicinity of the school are missing a detectable surface treatment, i.e., truncated domes.

LOCATION	OBSERVATION	RECOMMENDATIONS	IMPLEMENTATION			RESPONSIBILITY
			Short	Medium	Long	
F. E Street and 18th Street Intersection	F1 Existing curb ramps on the northwest, northeast, and southeast legs of the intersection are lacking truncated domes.	<ul style="list-style-type: none"> Upgrade curb ramps at the northwest, northeast, and southeast legs of the intersection to meet ADA standard by installing truncated domes – F1 		✓		Department of Public Works

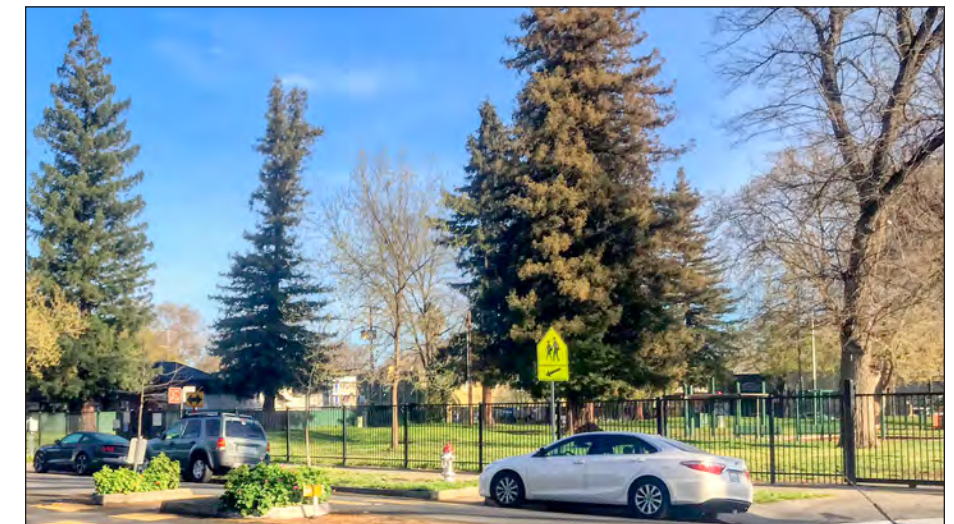
Vehicles were observed double parking along the loading zone on 18th Street.

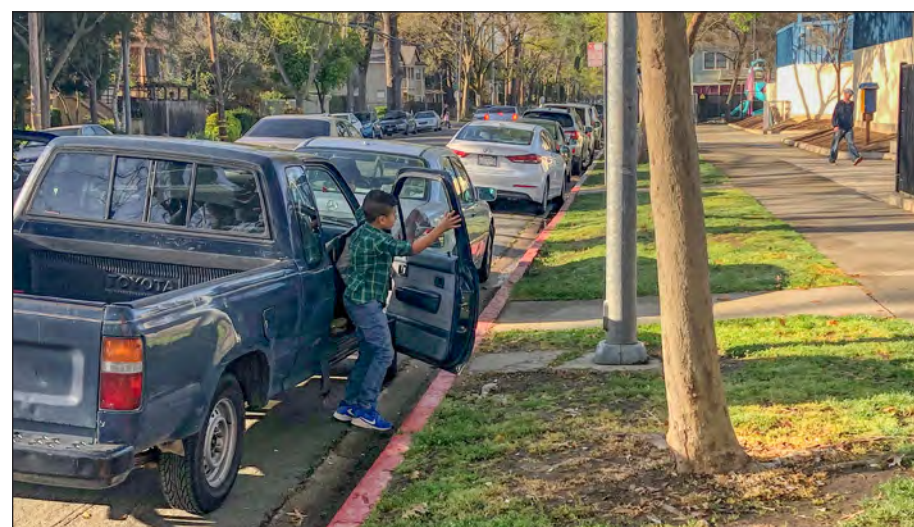
Vehicle parking in front of the crosswalk appears to obstruct pedestrians' visibility to oncoming traffic and vice-versa.

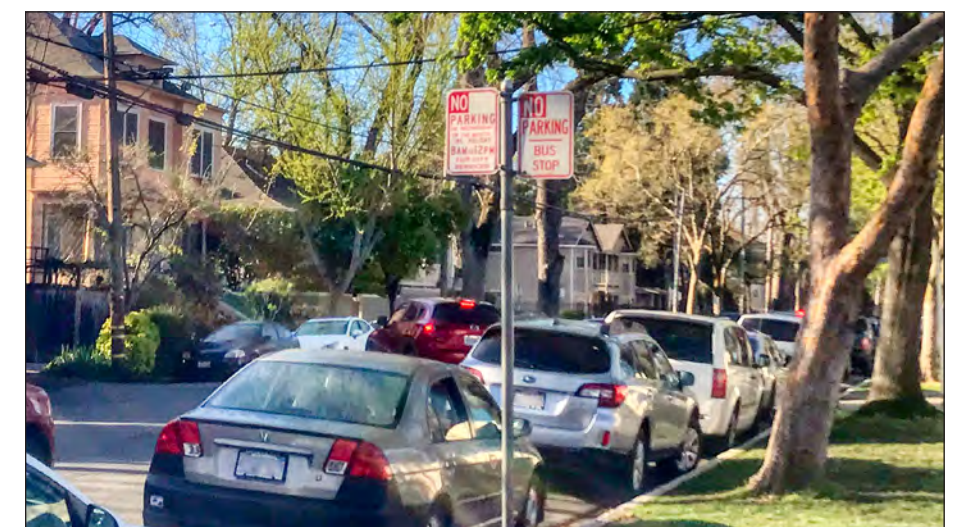
Several vehicles were observed parked or dropping-off in the school bus zone.

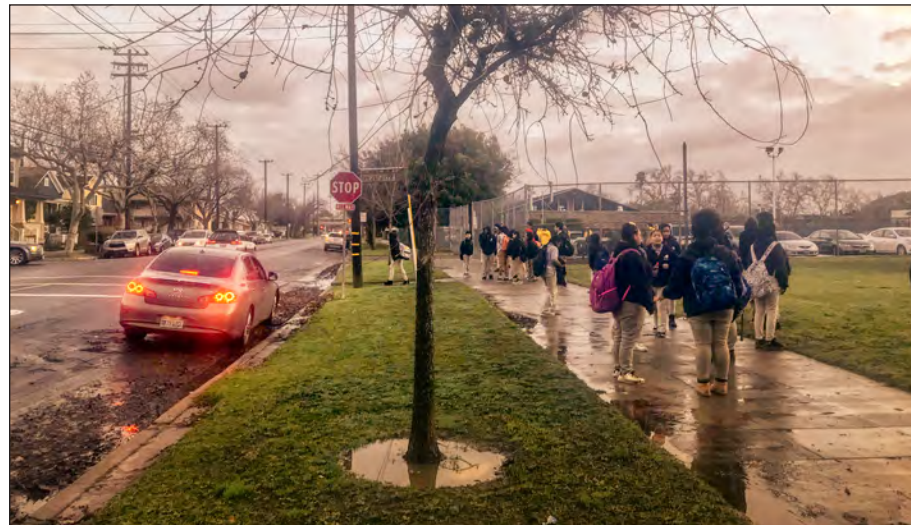
Students gather on 34th Street as they wait for the school gate to open. Note wet landscaped area between roadway curb and sidewalk.

A3 Grass strip along east side of 34th Street results in muddy drop-off's for students during inclement weather.	<ul style="list-style-type: none"> • As part of city-wide school area speed reduction program, provide 15 MPH school area speed limit signs along 34th Street within 500' of school grounds – A2 	✓			Department of Public Works
		<ul style="list-style-type: none"> • Install a right edge-line on the east side of 34th Street to narrow vehicular travel lane and designate drop-off / pick-up zone – A1, A2 	✓			Department of Public Works
		<ul style="list-style-type: none"> • Replace existing grass landscaping with decomposed granite strip – A3 		✓		Department of Public Works

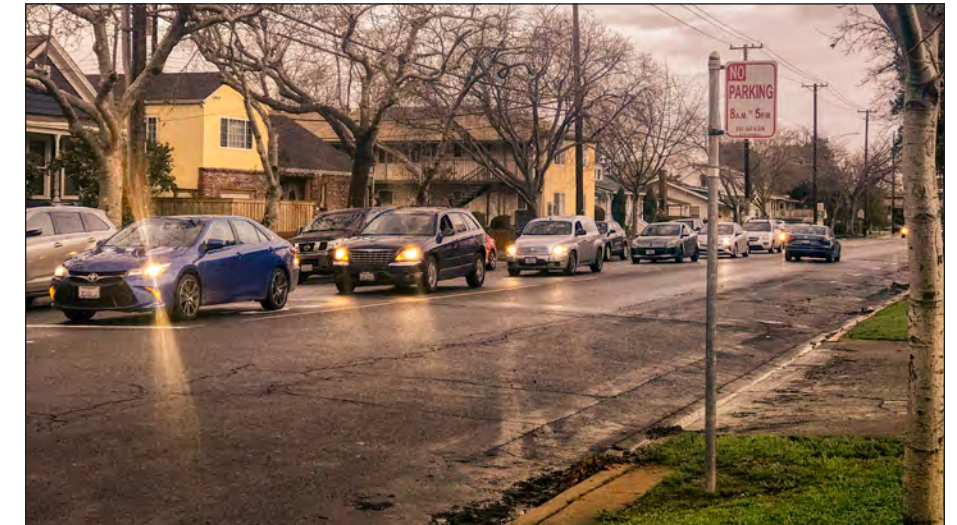
Morning commute traffic queuing along 34th Street.
