CITY OF SACRAMENTO VISION ZERO SCHOOL SAFETY STUDY

- **Vision Zero School Safety Study** – This project, which is the focus of this report, documents conditions for students who walk, bike, take transit or private vehicle at 20 schools across Sacramento. The assessments of these conditions reflect the social, built and natural environments that affect the ability and desire of students to walk, bike and take transit to school. This study results in short-, medium- and long-term recommendations for the 20 identified schools to improve safety conditions for children walking or biking to school, and which include signage, pavement marking, traffic calming and operational improvements along roadways within school zones.

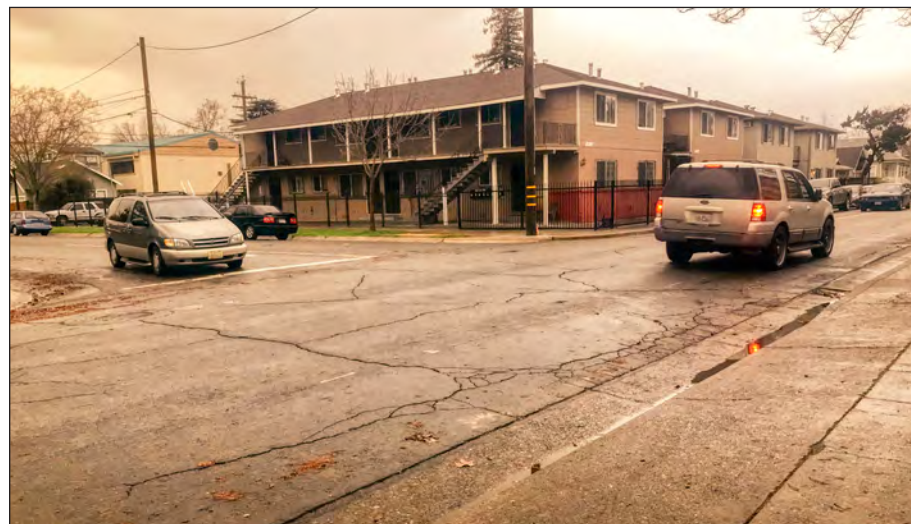
Offset driveway at the intersection of Y Street and 36th Street requires awkward vehicular movements and confusing routing for pedestrians crossing the street.

H 36th Street and Y Street Intersection	H1 Students were observed crossing outside of marked crosswalks from the residential area on the south side of Y Street to the school parking lot. H2 The offset intersection makes it difficult to recognize the right of way for vehicles turning out of the 36th Street and driveway approaches. H3 The offset intersection requires vehicles traveling between the school driveway on the north side of Y Street and 36th Street to travel in a zig-zag path. This complex movement is complicated by the large number of vehicles traveling down Y Street.	<ul style="list-style-type: none"> Evaluate appropriateness for a new marked crossing with ADA compliant curb ramps and appropriate driveway clearances across Y St.– H1 Consider driveway relocation to the west to create standard four-legged intersection. Short term possibilities may include a stop sign on the school driveway and/or changing the school circulation to consist of one "in" driveway and one "out" driveway – H2, H3 	✓		✓	Department of Public Works Department of Public Works / Sacramento Charter High School

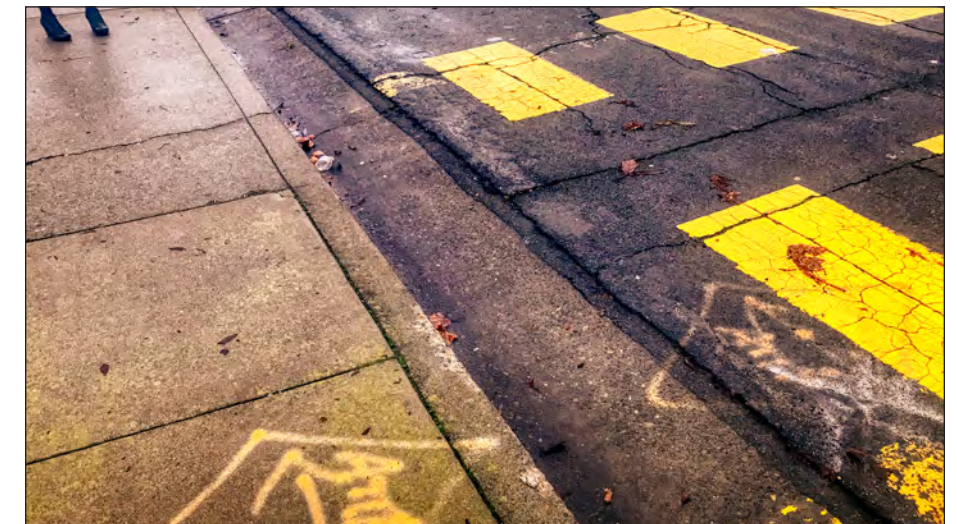
Several crosswalks along Y Street lack curb ramps.

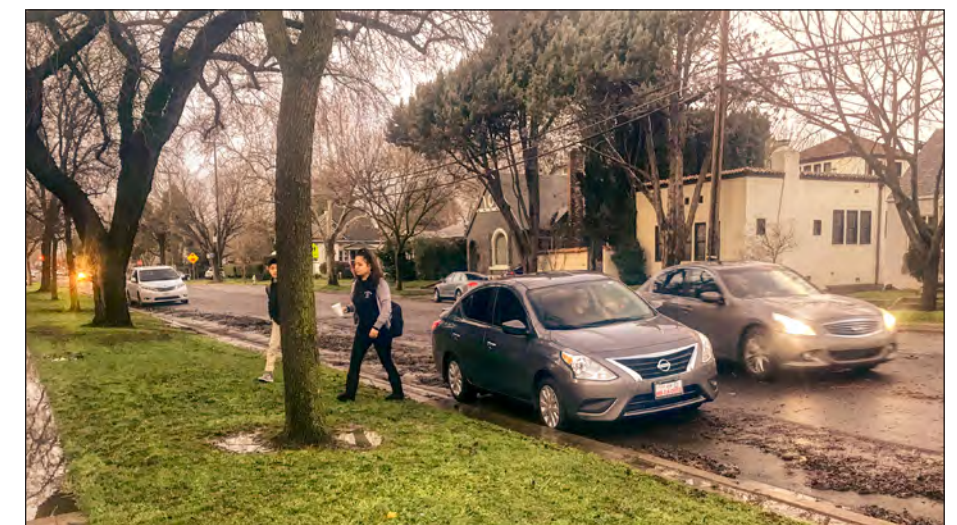
Drivers conduct drop-offs at midblock locations along 34th Street. Students must cross the grass to reach the sidewalk.

LOCATION	OBSERVATION	RECOMMENDATIONS	IMPLEMENTATION			RESPONSIBILITY
			Short	Medium	Long	
A. 34th Street	A1 Sacramento Charter High does not have an official drop-off and pick-up procedure enforced by the school. Drop-off's and crossings occur at unmarked midblock locations and result in abrupt stops in the middle of the roadway.	<ul style="list-style-type: none"> • Implement and enforce a school regulated drop-off and pick-up procedure. Make the procedure guidelines available to parents and students via online messaging and/or printed hand-outs – A1 	✓			Sacramento Charter High School
	A2 School administrators reported speeding on 34th Street.	<ul style="list-style-type: none"> • Consider a No Parking Passenger Loading Zone timed around pick-up and drop-off times along the east side of 34th Street between V Street and W Street. If necessary, this recommendation may be extended until Y Street – A1 	✓			Department of Public Works

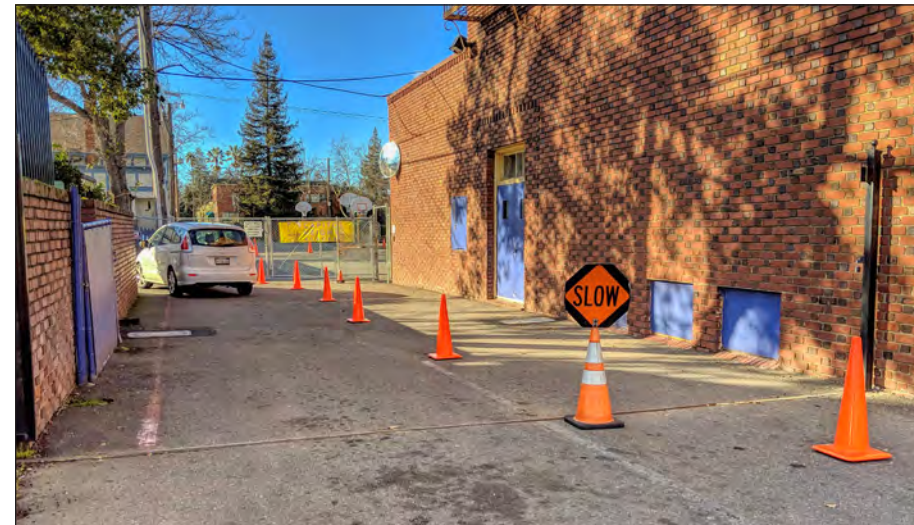
Cones are set out by Aspire staff to guide vehicles onto campus for student pick-up.

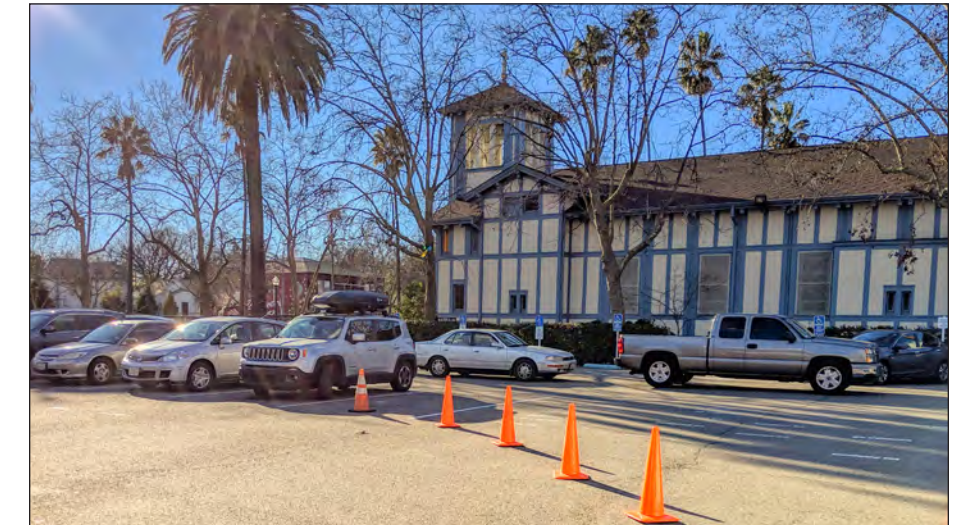
The parking lot behind the school where vehicles queue before student pick-up on the playground.

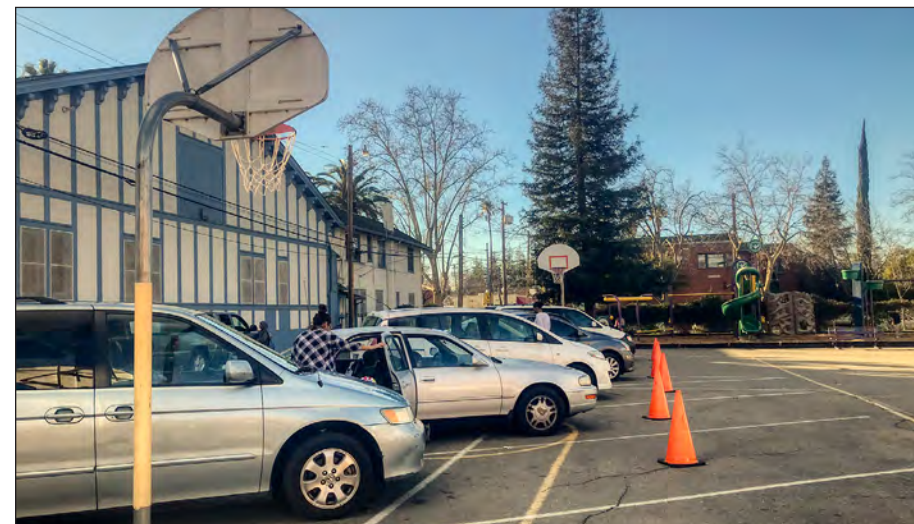
On-campus pick-up is organized by school staff and takes place on the school playground.

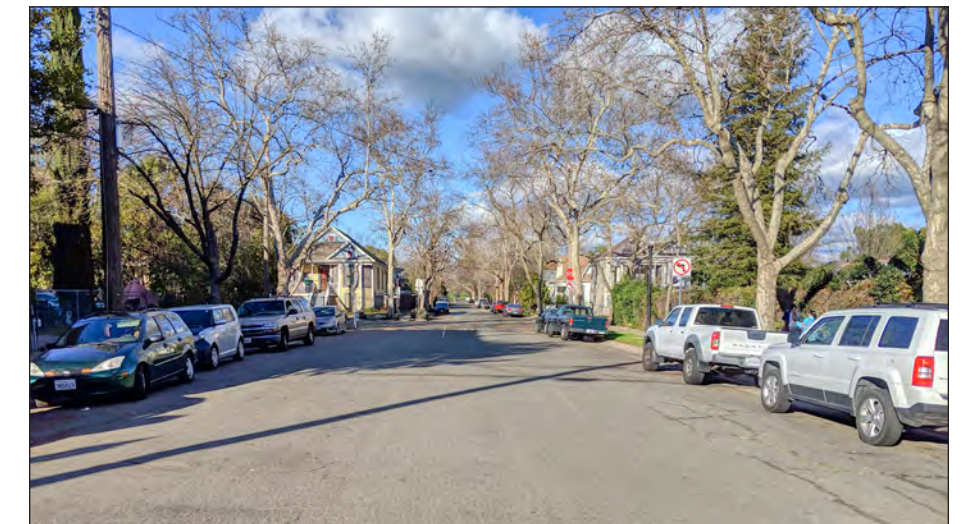
33rd Street is a 45-foot wide roadway with on-street parking on both sides.

LOCATION	OBSERVATION	RECOMMENDATIONS	IMPLEMENTATION			RESPONSIBILITY
			Short	Medium	Long	
A. 33rd Street	A1 School administrators perceive that speeding occurs on 33rd Street.	<ul style="list-style-type: none"> • As part of city-wide school area speed reduction program, provide 15 MPH school area speed limit signs along 33rd Street – A1 • Parking services to enforce parking along 33rd Street – A2 • Study feasibility of constructing a raised curb and/or railing at the school driveway to reduce likelihood of students darting into traffic. Consider whether such a feature may interfere with existing swinging gate – A4 	✓			Department of Public Works
	A2 Vehicles were observed double parking along 33rd Street.		✓			Department of Public Works
	A3 School administrators reported vehicle cut-through traffic using 33rd Street to reach Broadway.			✓		Aspire Capitol Heights Academy
	A4 School access door leads directly into driveway at the south end of the campus building on the west side of 33rd Street. Drive aisle is delineated with cones.

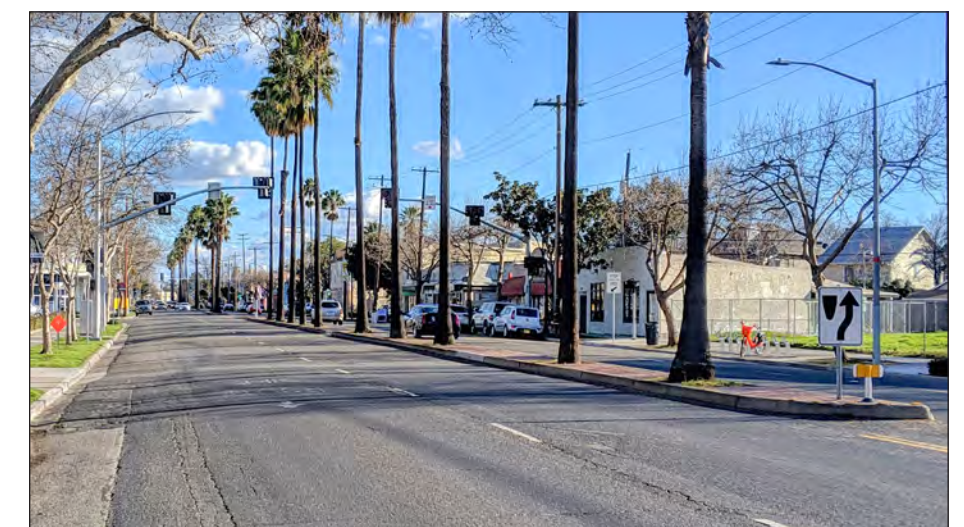
Broadway is a 65-foot wide arterial roadway. School administrators reported high speeds along Broadway

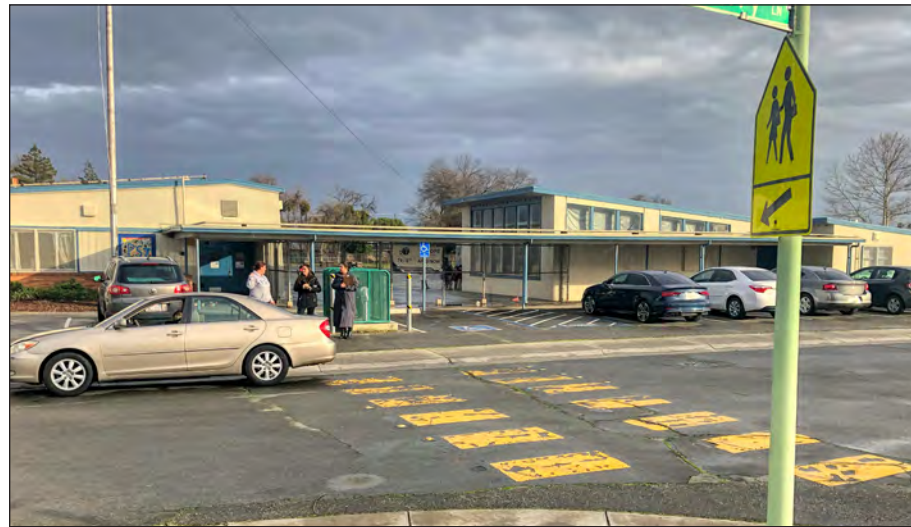
Crosswalk marking across Strawberry Lane at 27th Street is worn and should be refreshed.

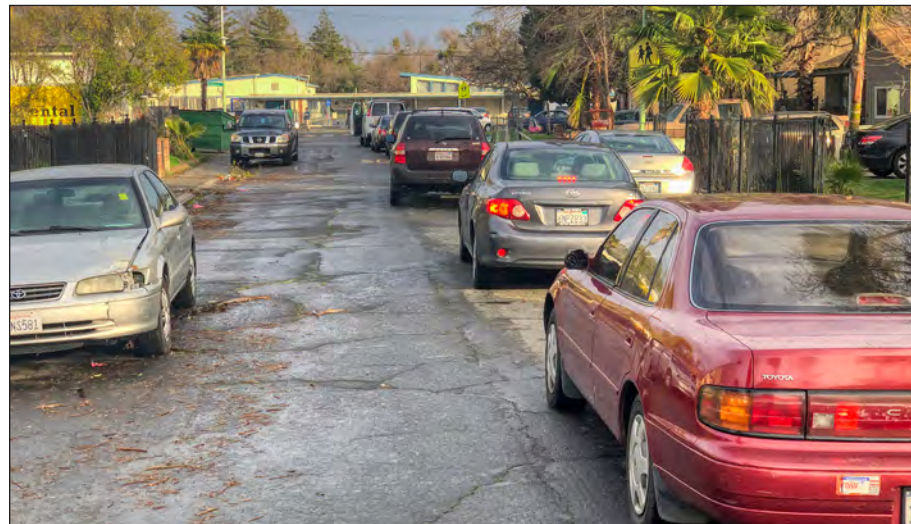
Vehicles waiting to access Strawberry Lane loading zone queue on 27th Avenue.

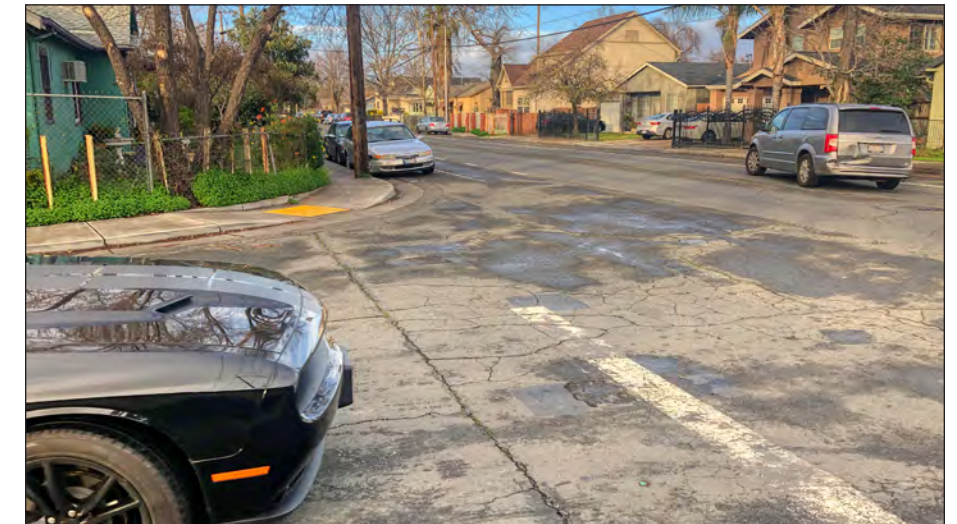
Parking on Martin Luther King Jr Boulevard obstructs sight lines for vehicles approaching from eastbound 26th Street.

C. Martin Luther King Jr. Boulevard	C1 Motorist behavior was described to consist of “erratic” and “high speeds” by audit attendees. Attendees noted that motorists using MLK Jr. Boulevard are often unaware of the presence of a school.	<ul style="list-style-type: none"> • Evaluate appropriateness for a new marked crossing with ADA standard curb ramps and appropriate driveway clearances across Martin Luther King Jr. Boulevard at 26th Avenue. Consider installation of Rectangular Rapid Flash Beacon (RRFB) at the potential crosswalk, if warranted based on the City’s Pedestrian Crossing Guidelines – C1, C2 	✓			Department of Public Works
	C2 Students were observed crossing MLK Jr. Boulevard at unmarked midblock locations. Bus stops used by students are located on MLK Jr. Boulevard. Accessing the northbound stop requires crossing MLK Boulevard.

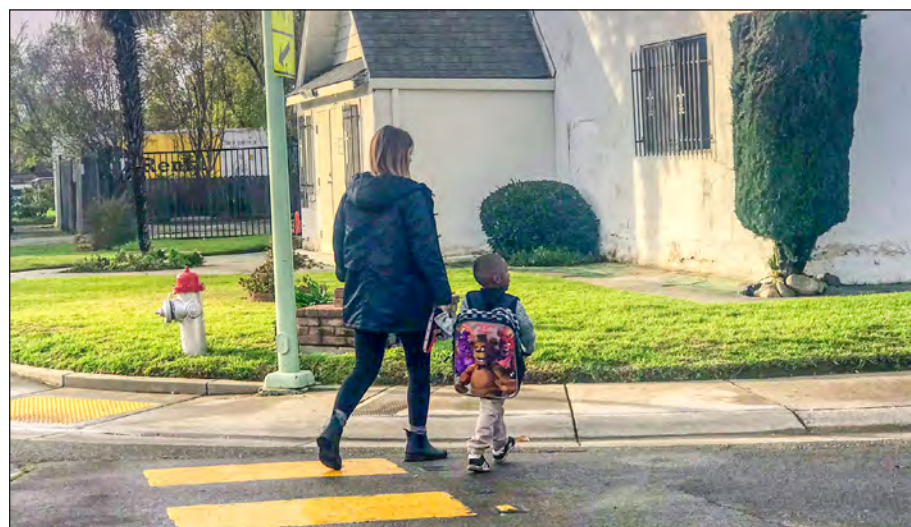
School staff assists afterschool pick-up by walking students to their rides waiting on Strawberry Lane.

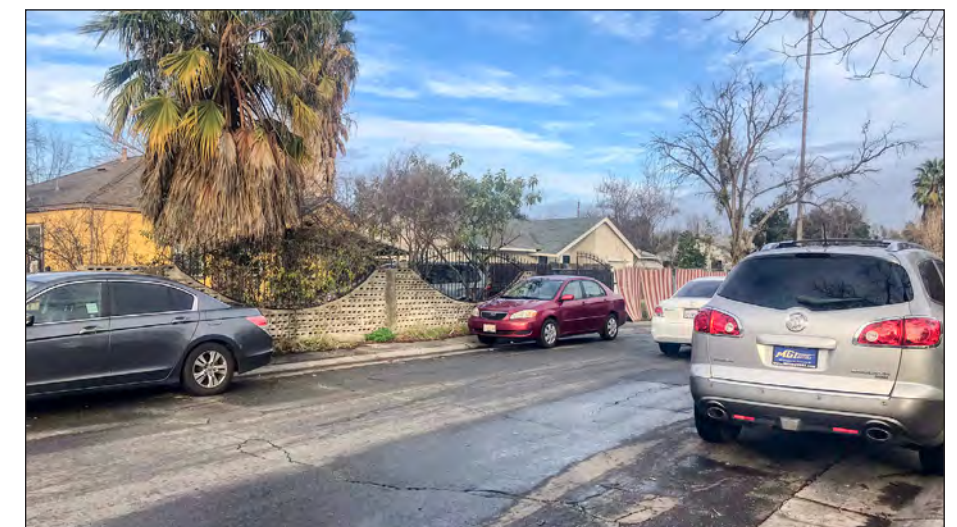
Vehicles parking on both sides of 26th Avenue leave approximately 12' for vehicle travel.

B. 26th Avenue	B1 School administrators reported speeding on 26th Avenue. Vehicles were observed traveling around other vehicles, both parked or moving.	<ul style="list-style-type: none"> • Install speed lumps on 26th Avenue, if warranted based on the City’s Speed Lump Program guidelines – B1 		✓		Department of Public Works

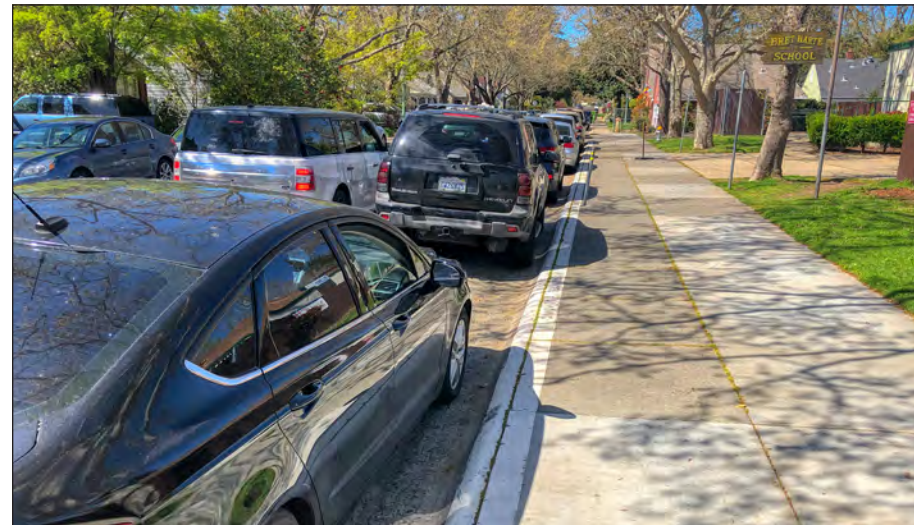
School representatives report that parked vehicles along 8th Street are a combination of residential vehicles and school staff vehicles, and remain parked in the loading zone through the course of the day.

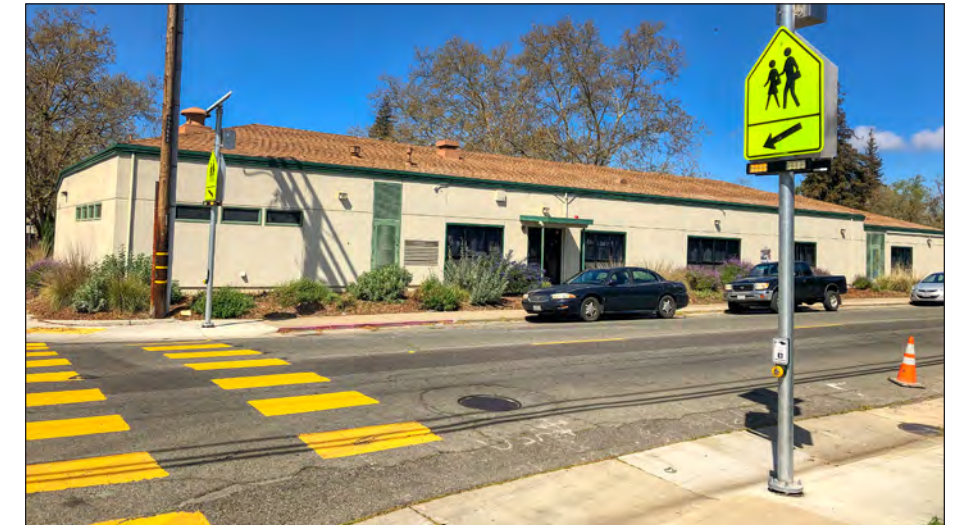
There is a crosswalk with rectangular rapid flashing beacon at the intersection of Franklin Boulevard and 9th Avenue adjacent to the school.

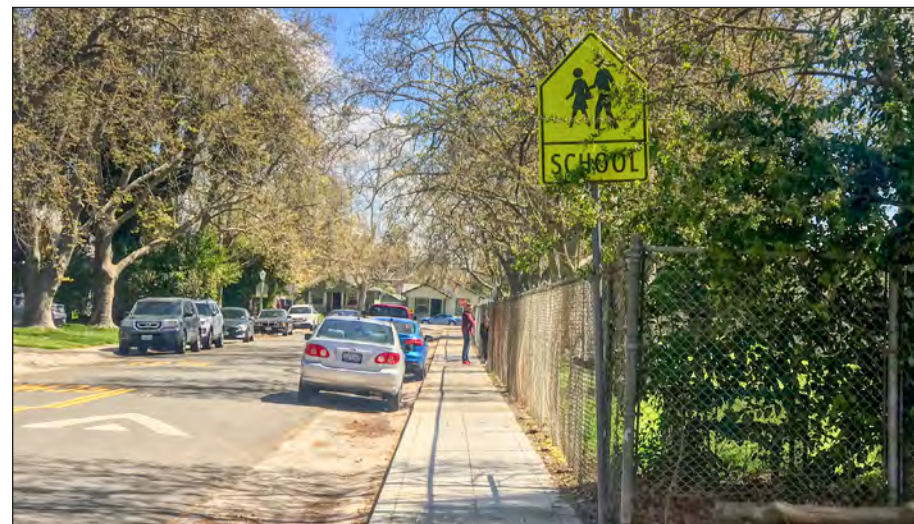
Existing school warning assembly on 7th Avenue is obstructed by overgrown landscaping.

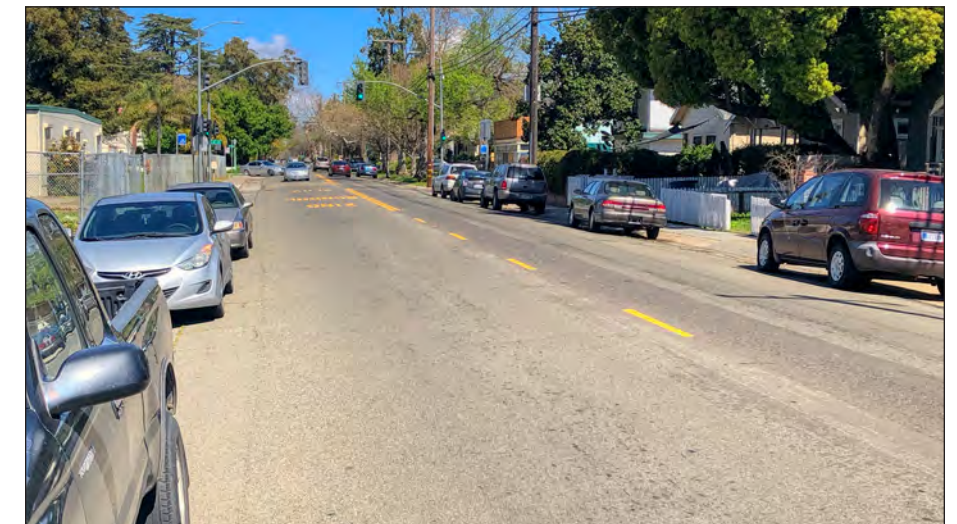
Franklin Boulevard runs adjacent to the school and is a highly trafficked and wide arterial street. School representatives perceive speeding along the street.

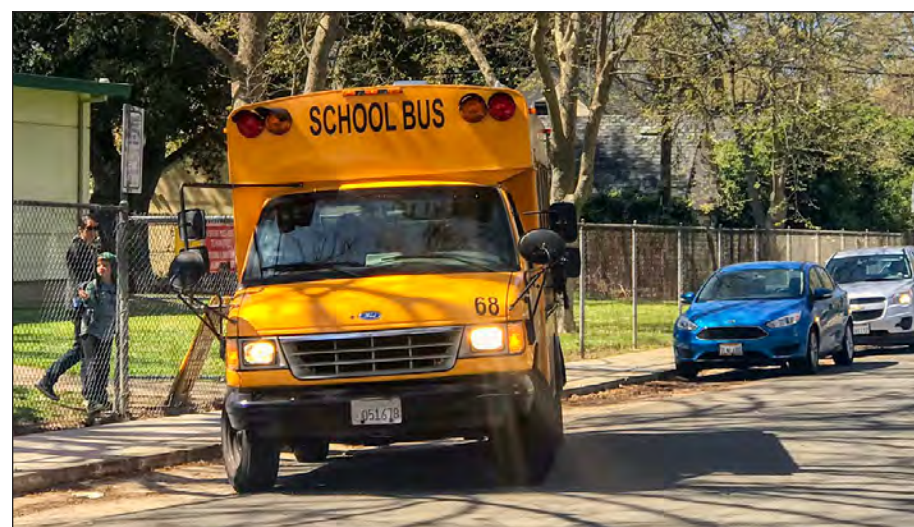
A school bus picks up students at the back-school entrance on 7th Avenue.

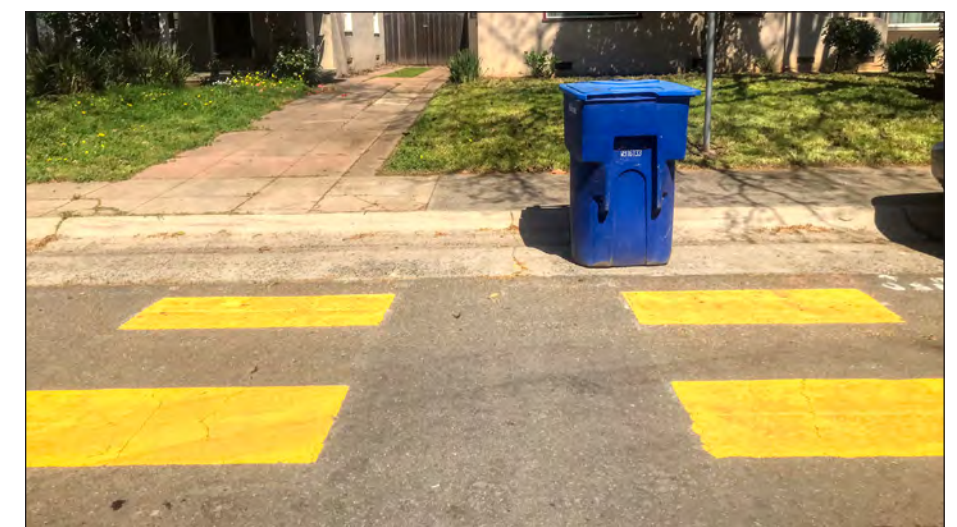
The existing crosswalk at 7th Avenue and Cutter Way lacks ADA-accessible curb ramps.

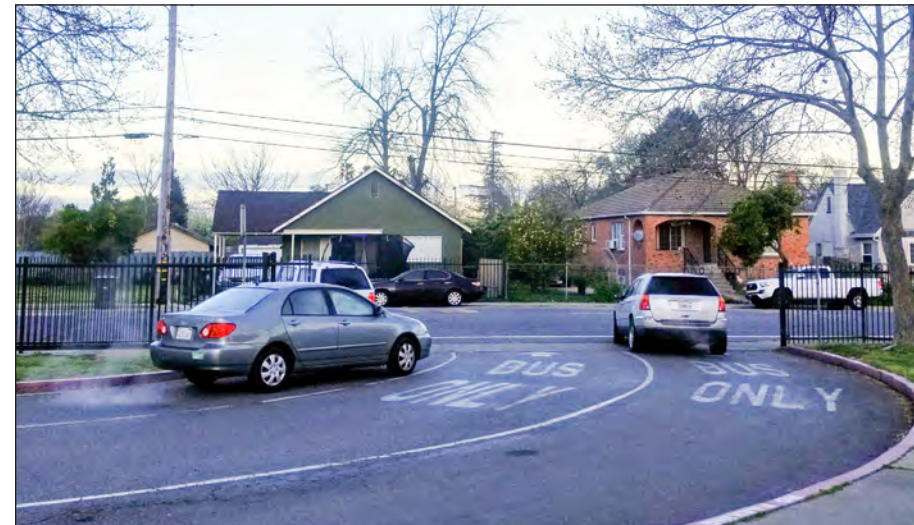
Some parents drop students off in the designated school bus loading zone.

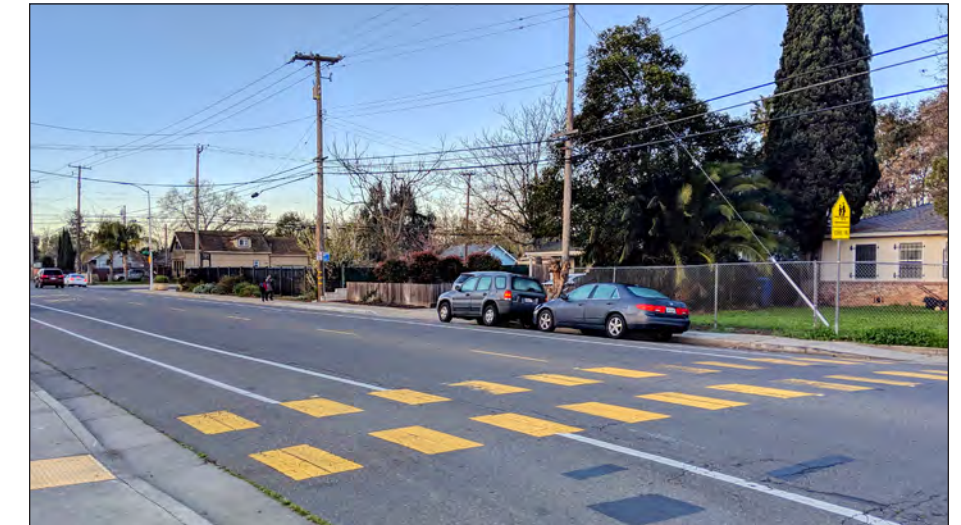
The school crosswalk across Martin Luther King Jr. Boulevard is marked with high-visibility crosswalk markings and a school crosswalk warning sign.

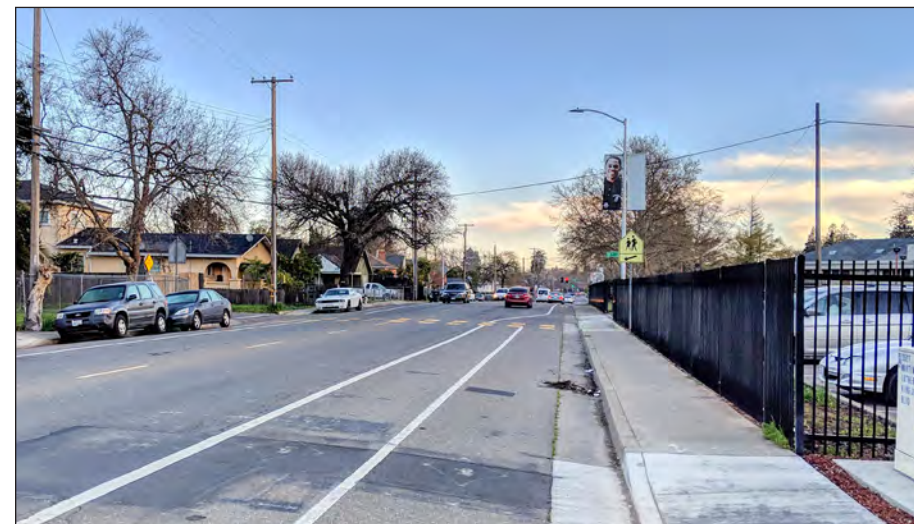
On-street parking is prohibited on Martin Luther King Jr. Boulevard in front of the school. The area is used as a loading zone during pick-up and drop-off times.

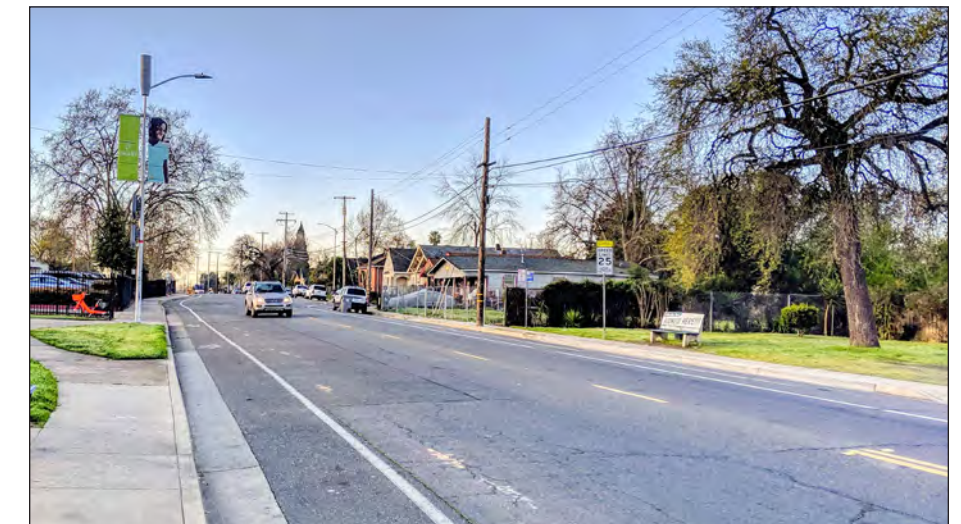
The northbound vehicle lanes in front of the school are between 16 and 20 feet wide.

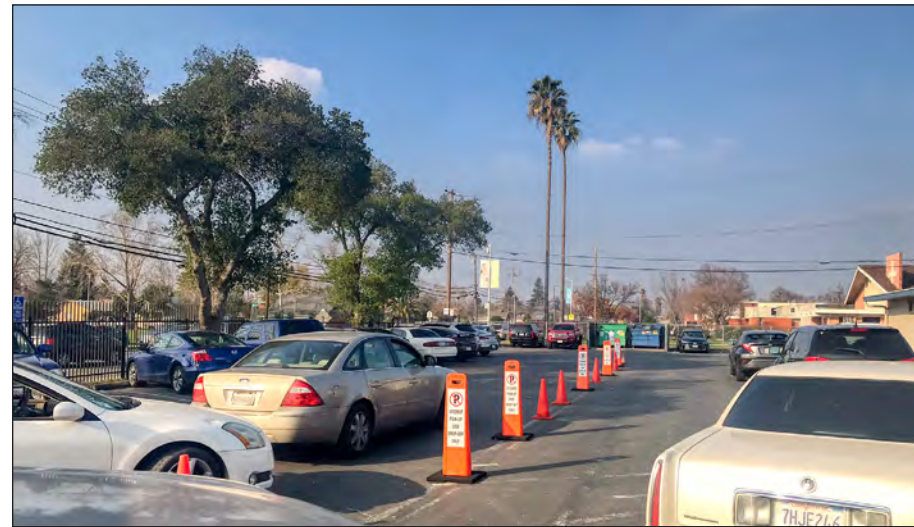
Cones are set out by the Oak Ridge staff to designate the loading loop procedure.

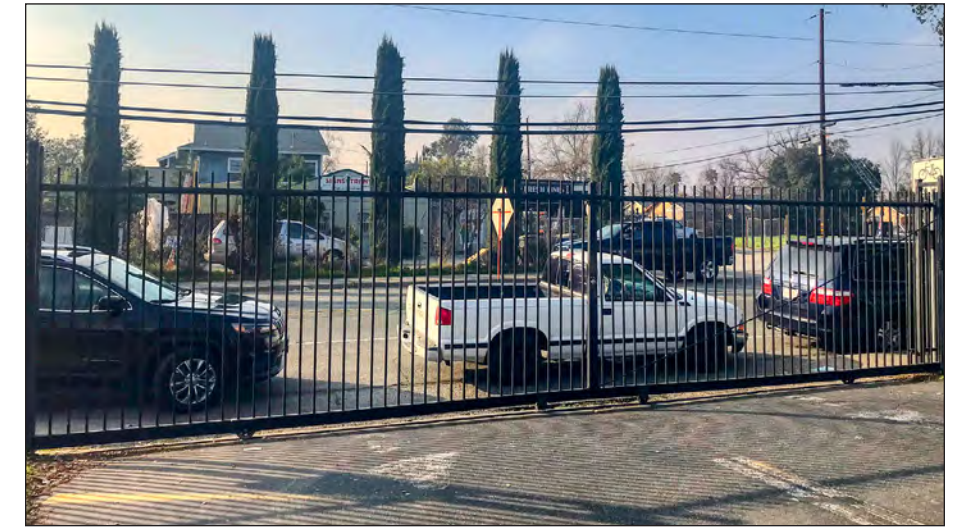
Driveway entrance gate closes 15 minutes before the release bell. Vehicles arriving after the gates close use Martin Luther King Jr Boulevard for pick-up.

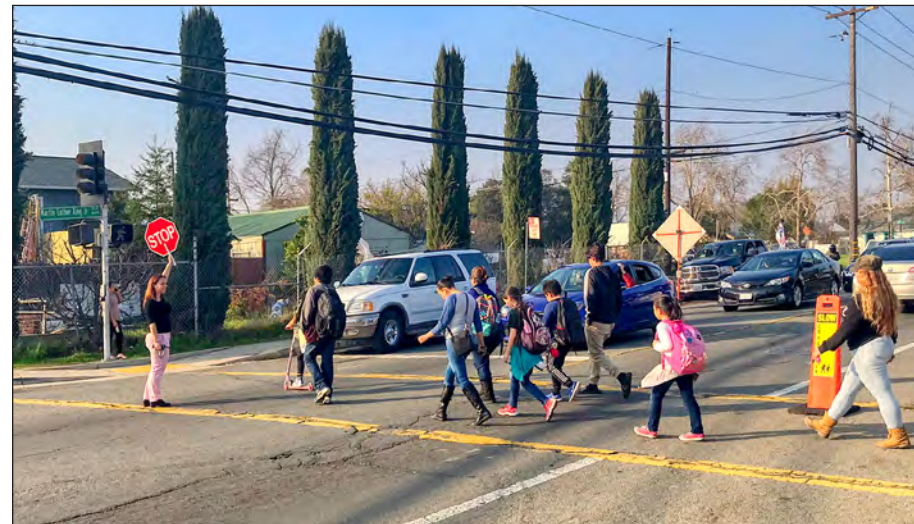
A volunteer crossing guard assists school crossings at the Martin Luther King Jr Boulevard and 21st Street intersection.

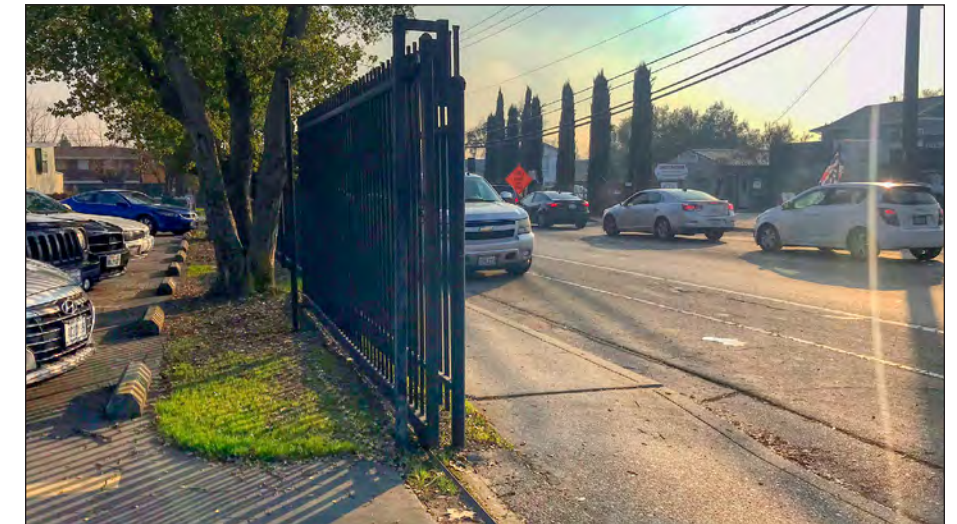
There is limited visibility for vehicles turning left out of the school driveway onto Martin Luther King Jr Boulevard.

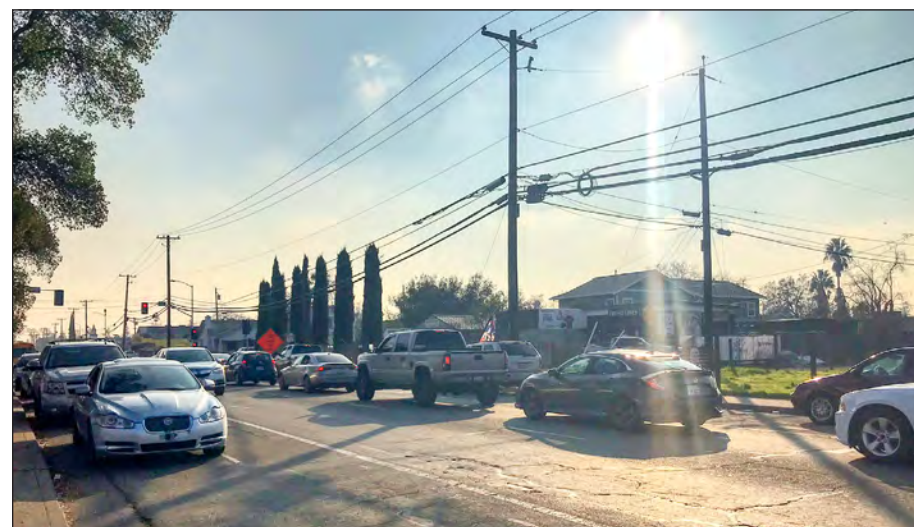
Two schools operating on similar bell schedules and located within 500' feet of each other cause congestion on Martin Luther King Jr Boulevard during morning and afternoon peak periods.

A4 Christian Brothers High School is adjacent to Oak Ridge. Similar bell times cause a high volume of school-related congestion on Martin Luther King Jr. Boulevard.

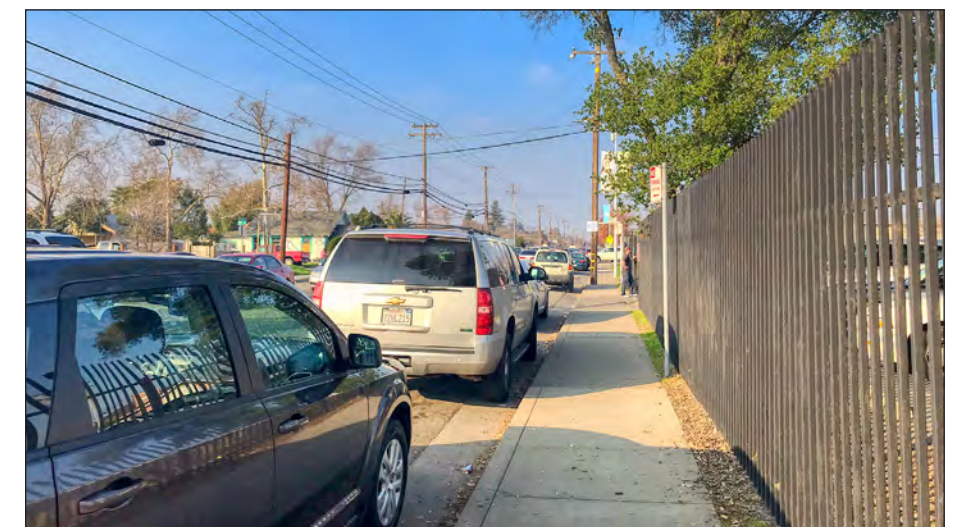
Drivers use the no parking zone on Martin Luther King Jr Boulevard as a loading zone during afternoon pick-up.

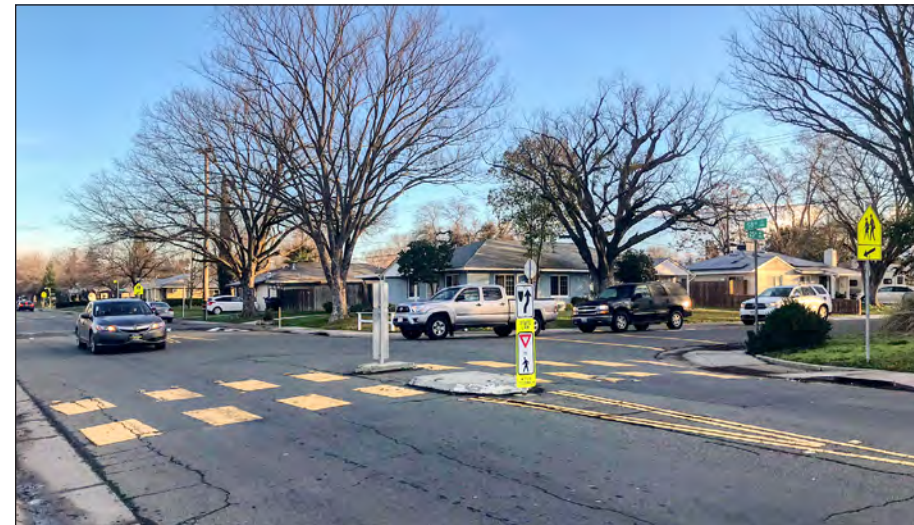
Existing uncontrolled crosswalk in front of West Campus entrance.

B. 58th Street and 25th Street Intersection	B1 Walk audit attendees observed a steady stream of students using the uncontrolled crosswalk at the school's entrance during the morning drop off period. School administrators noted the same pattern during the afterschool period. Drivers were seen failing to yield to pedestrians at the crosswalk.	<ul style="list-style-type: none"> • Continuous pedestrian flow could be mitigated with provision of a crossing guard. A more organized flow of students due to the enforcement of a crossing guard could help increase yield compliance – B1 	✓			West Campus High School / Sacramento City Unified School District

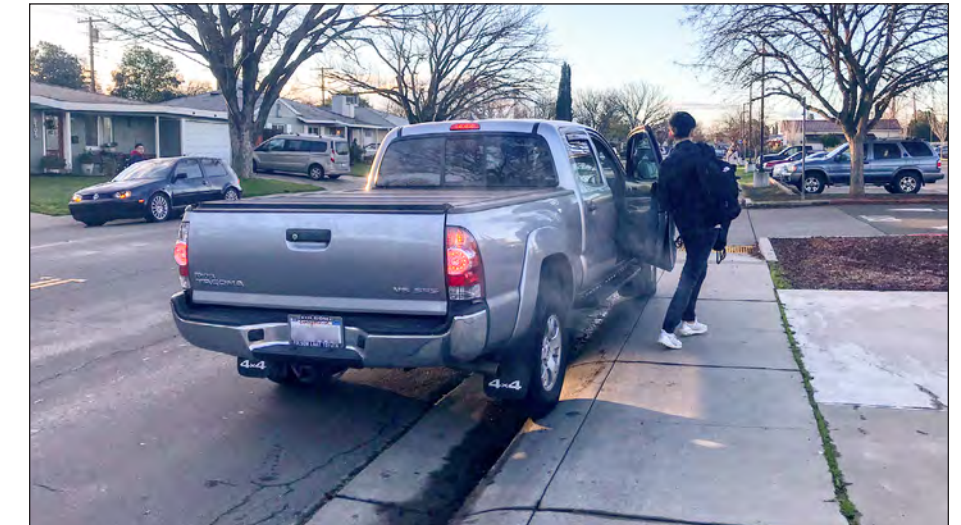
Vehicles conducting curbside drop-off's in 58th Street occasionally obstruct visibility for vehicles exiting the school driveway.

LOCATION	OBSERVATION	RECOMMENDATIONS	IMPLEMENTATION			RESPONSIBILITY
			Short	Medium	Long	
A. 58th Street	A1 School administrators reported occasional speeding on 58th Street.	<ul style="list-style-type: none"> • As part of city-wide school area speed reduction program, provide 15 MPH school area speed limit signs along 58th Street within 500' of school grounds – A1 • Consider speed lumps on 58th Street south of 25th Avenue - A1 • Work with West Campus High School to provide targeted enforcement by staff to discourage improper drop-offs – A2, A3 	✓			Department of Public Works
	A2 Vehicles were observed stopping in the middle of the street and/or in the middle of the crosswalks to drop off their students.		✓			West Campus High School
	A3 Drop-offs in the crosswalk in front of the school entrance obstructs visibility for vehicles exiting the school driveway.		✓			Department of Public Works

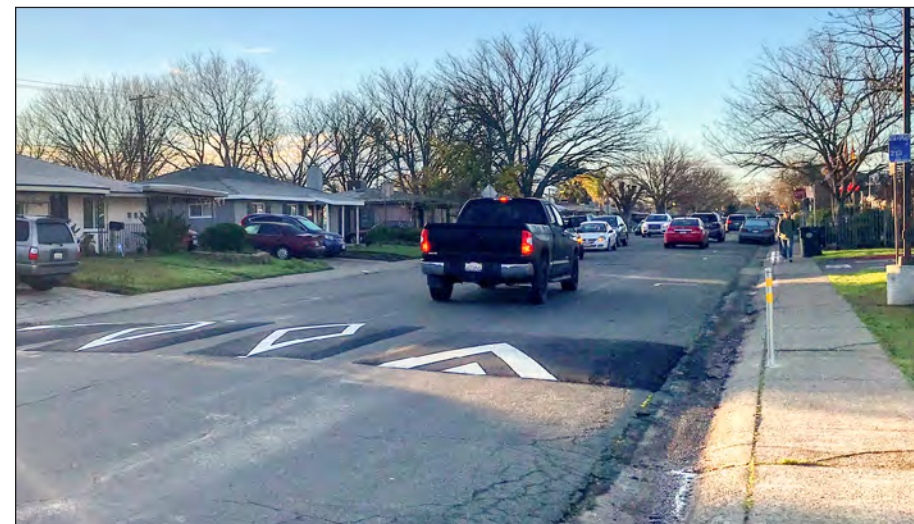
Existing speed lumps on 58th Street.

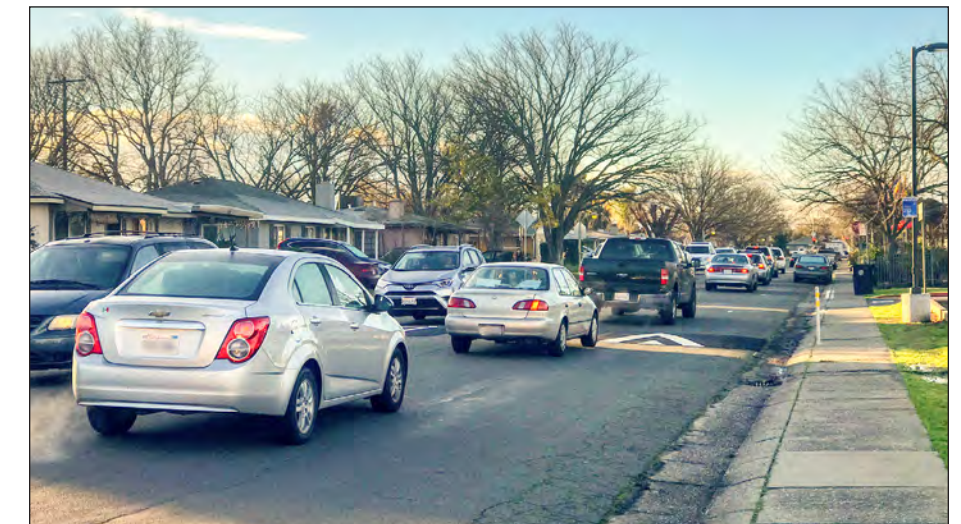
58th Street experiences significant high school, elementary school, and residential traffic during the morning peak period.

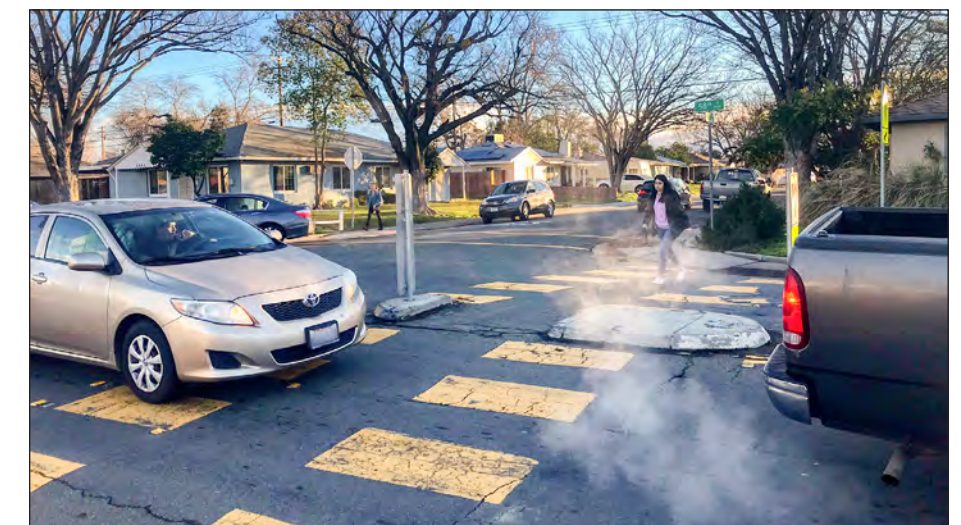
Vehicles use red no parking zone as a curbside drop-off location.

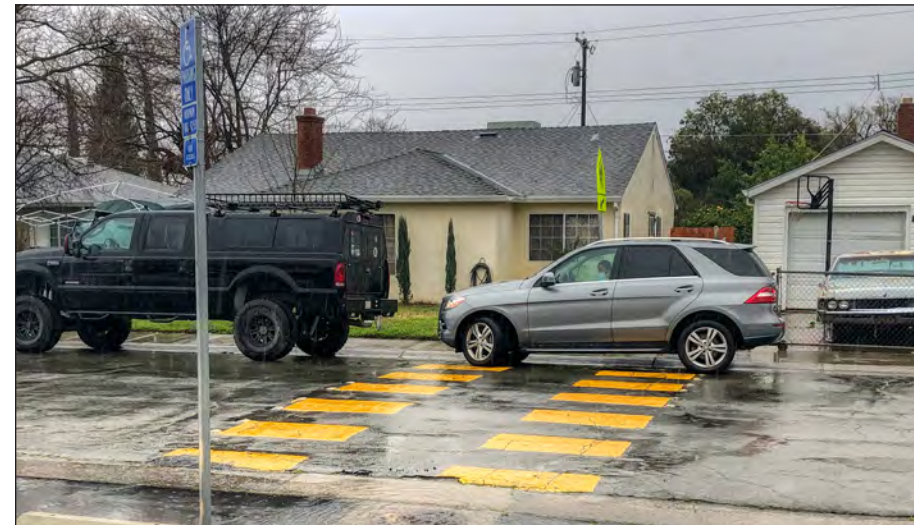
Drivers block the marked crosswalk while queuing on Lowell Street.

LOCATION	OBSERVATION	RECOMMENDATIONS	IMPLEMENTATION			RESPONSIBILITY
			Short	Medium	Long	
A. Lowell Street	A1 Lowell Street experiences heavy congestion during the afternoon pick-up period. Congestion combined with the high amount of on-street residential parking results in segments of the street operating as a one-way street in the southbound direction.	<ul style="list-style-type: none"> • Consider installing a no parking zone on the west side of Lowell during drop-off and pick-up periods to reduce congestion and allow for two-way vehicle traffic * – A1 	✓			Department of Public Works
	A2 Drivers were seen failing to yield to pedestrians at the uncontrolled midblock crosswalk.	<ul style="list-style-type: none"> • Consider upgrading midblock crosswalk into a raised crossing to increase pedestrian visibility, if warranted based on the City’s Pedestrian Crossing Guidelines. Further study is needed, along with potential removal or relocation of the existing speed hump – A2 		✓		Department of Public Works

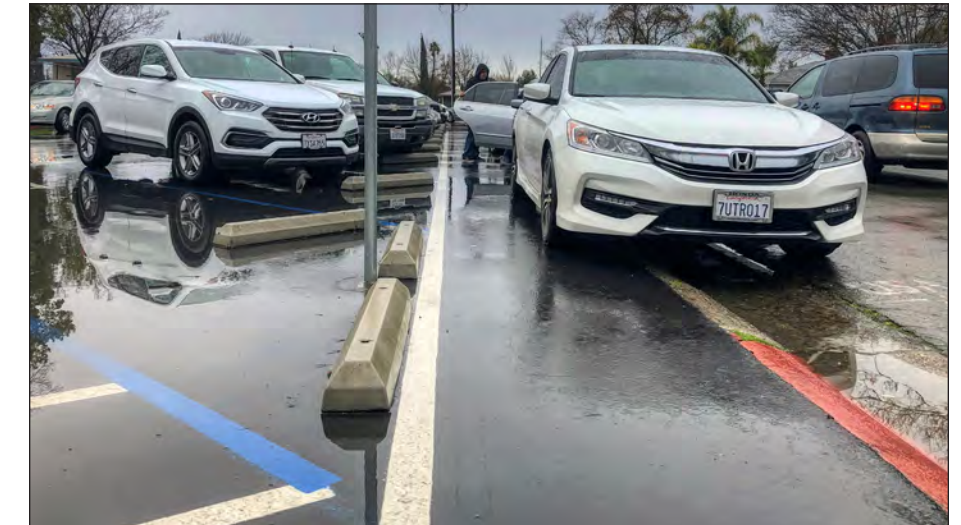
Vehicles park on the sidewalk that leads to the sidewalk on Lowell Street.

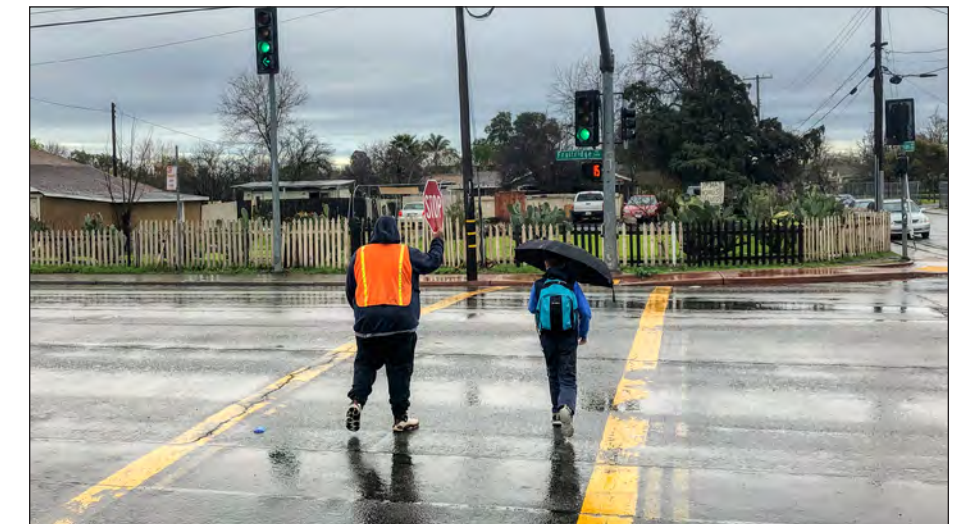
A volunteer crossing guard assists school crossings at the intersection of Fruitridge Road and Lowell Street/Wallace Avenue.

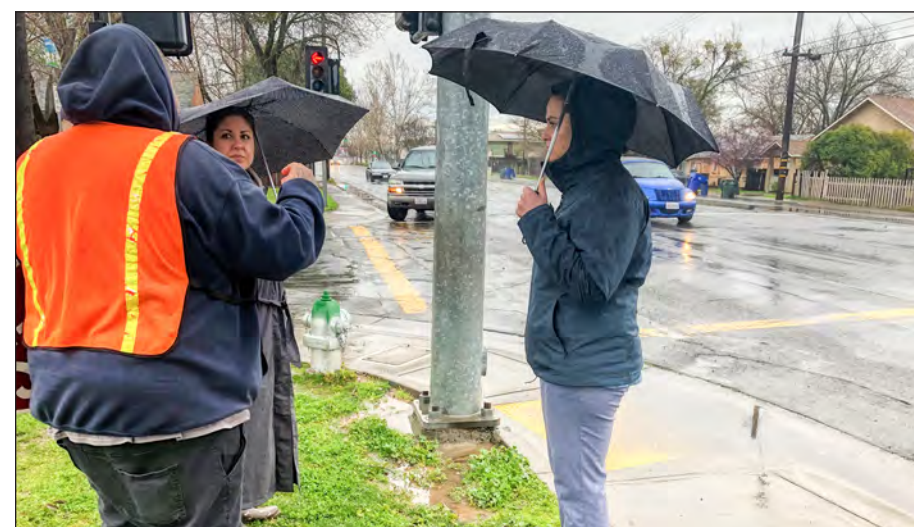
Pedestrian waiting space at the northwest corner of the Fruitridge/Lowell/Wallace intersection is limited.

LOCATION	OBSERVATION	RECOMMENDATIONS	IMPLEMENTATION			RESPONSIBILITY
			Short	Medium	Long	
C. Fruitridge Road and Lowell Street/ Wallace Avenue Intersection	C1 Drivers were seen not yielding to pedestrians when making right turns from northbound Wallace Avenue onto eastbound Fruitridge Road. C2 There is limited curb space on the northwest corner for pedestrians waiting to use the crosswalks.	• Consider prohibiting right turns on red from Wallace Street – C1	✓			Department of Public Works

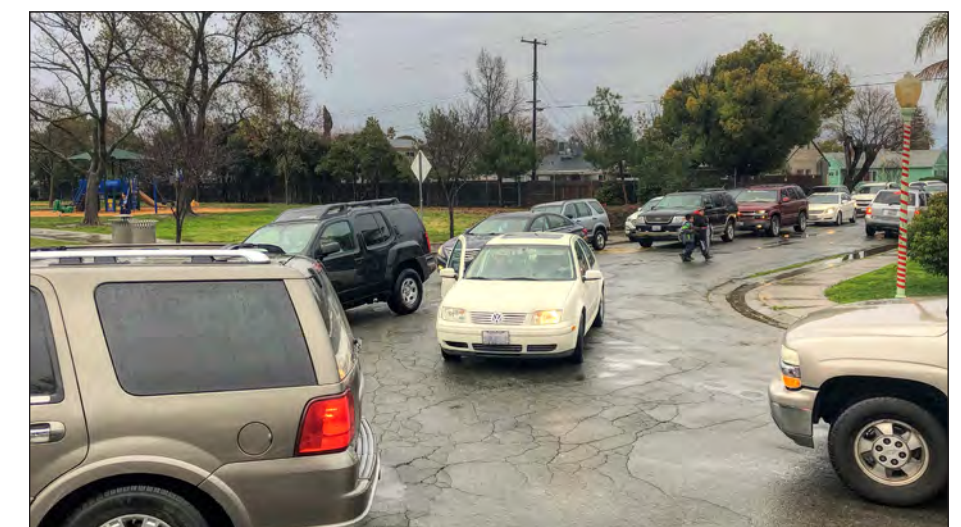
The bend in Lowell Street at the loading loop entrance creates a potential conflict zone for vehicles.
