CITY OF SACRAMENTO VISION ZERO SCHOOL SAFETY STUDY

- **Vision Zero School Safety Study** – This project, which is the focus of this report, documents conditions for students who walk, bike, take transit or private vehicle at 20 schools across Sacramento. The assessments of these conditions reflect the social, built and natural environments that affect the ability and desire of students to walk, bike and take transit to school. This study results in short-, medium- and long-term recommendations for the 20 identified schools to improve safety conditions for children walking or biking to school, and which include signage, pavement marking, traffic calming and operational improvements along roadways within school zones.

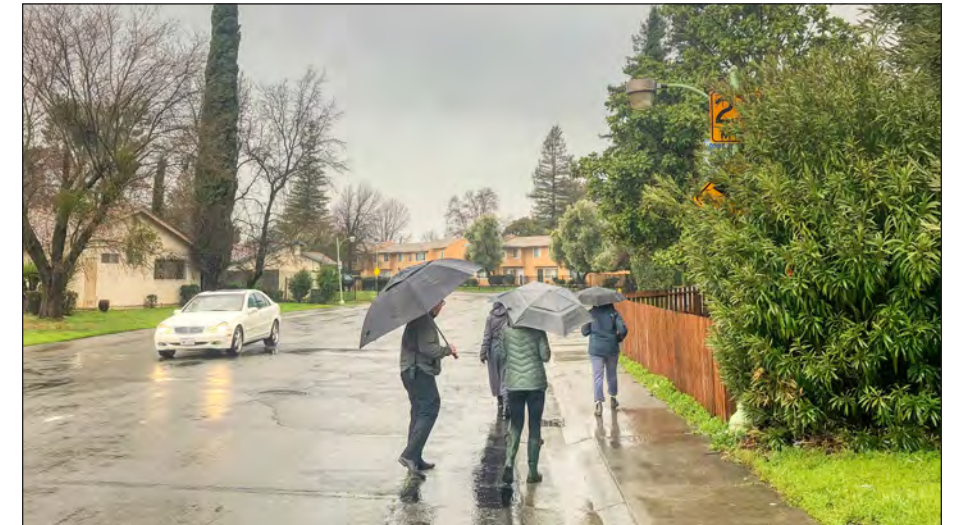
Overgrown vegetation along Bamford Drive blocks school-area signs.

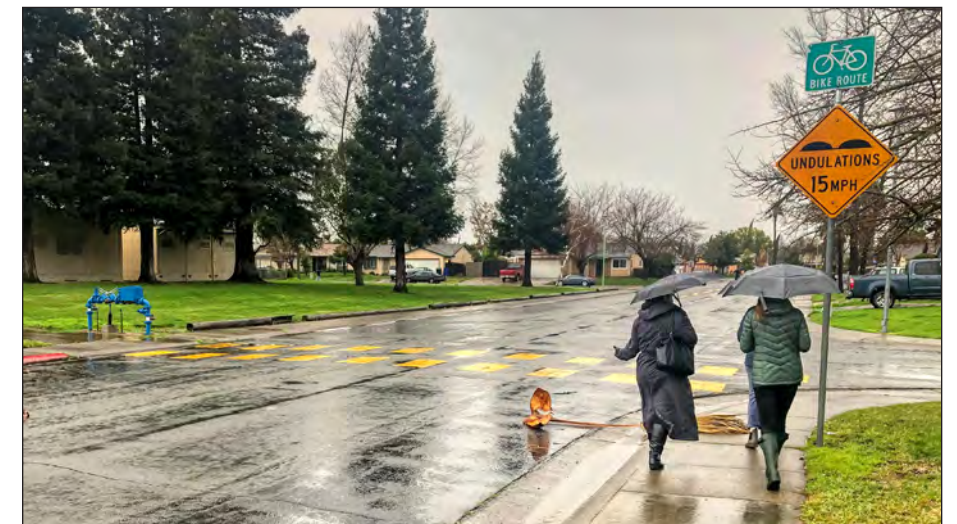
The uncontrolled crossing at Bamford Drive and Panos Court lacks school-area crosswalk signs and ADA-compliant curb ramps.

LOCATION	OBSERVATION	RECOMMENDATIONS	IMPLEMENTATION			RESPONSIBILITY
			Short	Medium	Long	
D. Bamford Drive and Panos Court Intersection	D1 The uncontrolled crossing at this location lacks school crosswalk signs.	<ul style="list-style-type: none"> Install School Assembly B signs at the uncontrolled crossing on Bamford Street per California MUTCD – D1 Per CA MUTCD, prohibit parking within 20' of the crosswalk by painting red curb on both the east and west sides of the crosswalk - D2 Upgrade curb ramps at the northeast and southeast corners to be Case C curb ramps built to ADA standards – D3 	✓			Department of Public Works
	D2 Parking is allowed on both sides of the crosswalk.		✓			Department of Public Works
	D3 Existing curb ramps at the northeast and southeast corners of the intersection do not meet ADA standards.			✓		Department of Public Works

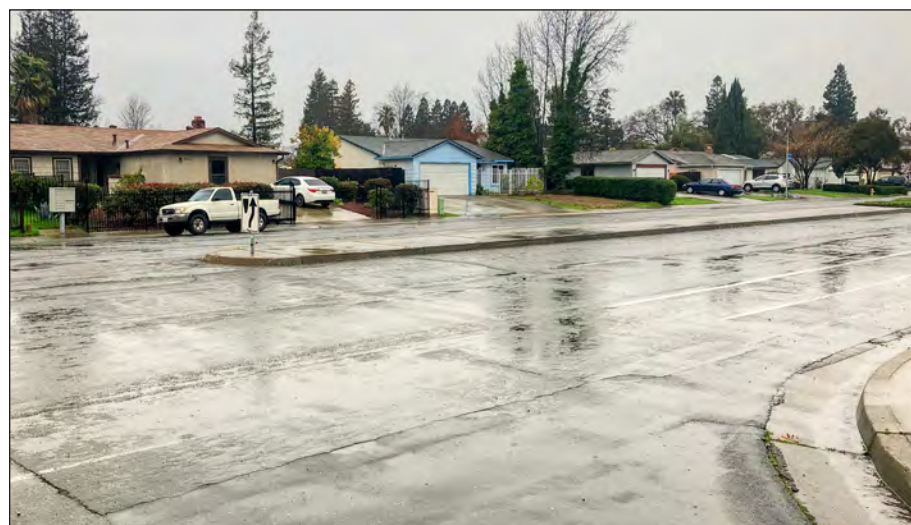
Bamford Drive at Center Parkway lacks a marked crosswalk across Center Parkway.

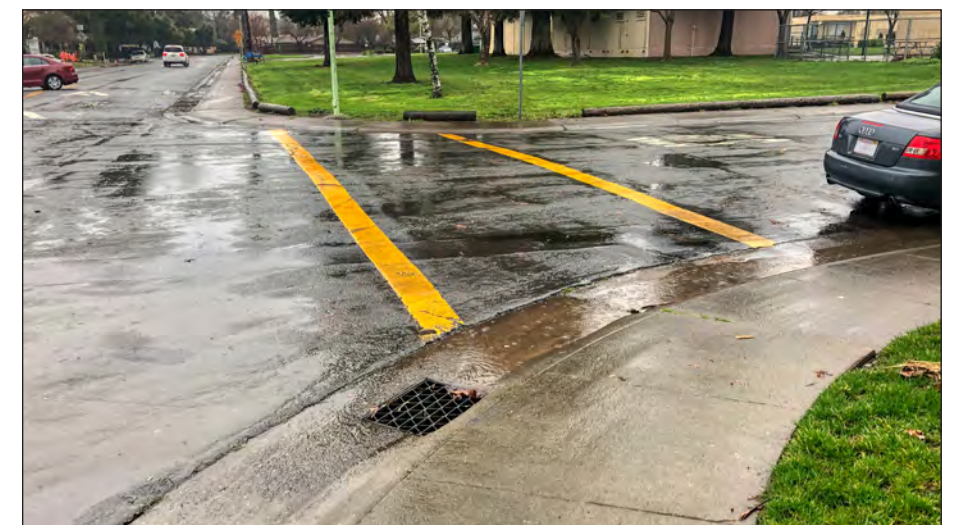
Many crosswalks near the two schools lack ADA-compliant curb ramps (shown: Grandstaff Dr and Bamford Dr)

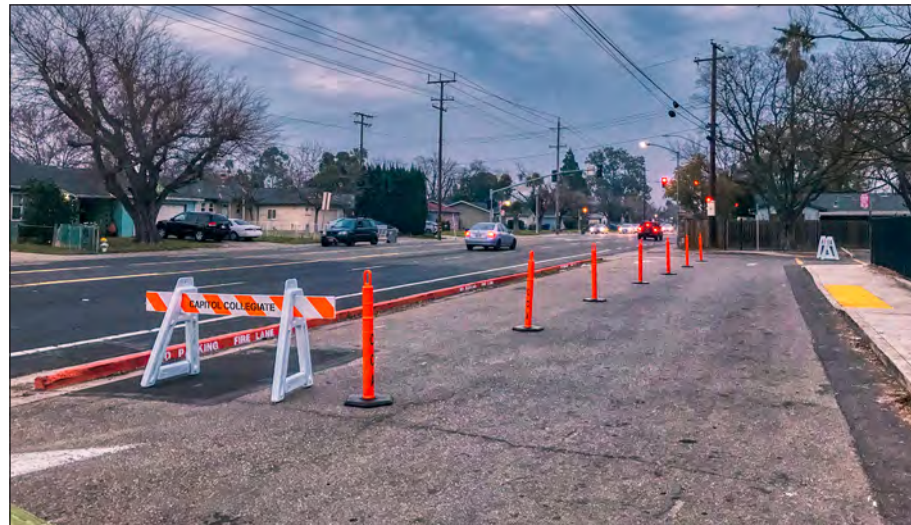
School staff sets up cones to guide drivers in the on-campus loading zone off Meadowview Road during the morning drop-off period. The front loading loop is used for K-2nd grade students.

LOCATION	OBSERVATION	RECOMMENDATIONS	IMPLEMENTATION			RESPONSIBILITY
			Short	Medium	Long	
A. School Loading Zone	A1 Motorists attempting to turn left out of the parking lot loop cause back up through the loop, resulting in further back-ups into the two-way left-turn lane.	<ul style="list-style-type: none"> • Increase school enforcement of prohibiting left turns onto westbound Meadowview during drop-off and pick-up times. Install a “No Left Turns from 7 - 9 am and 2 - 4 pm” sign – A1 	✓			Capitol Collegiate Academy

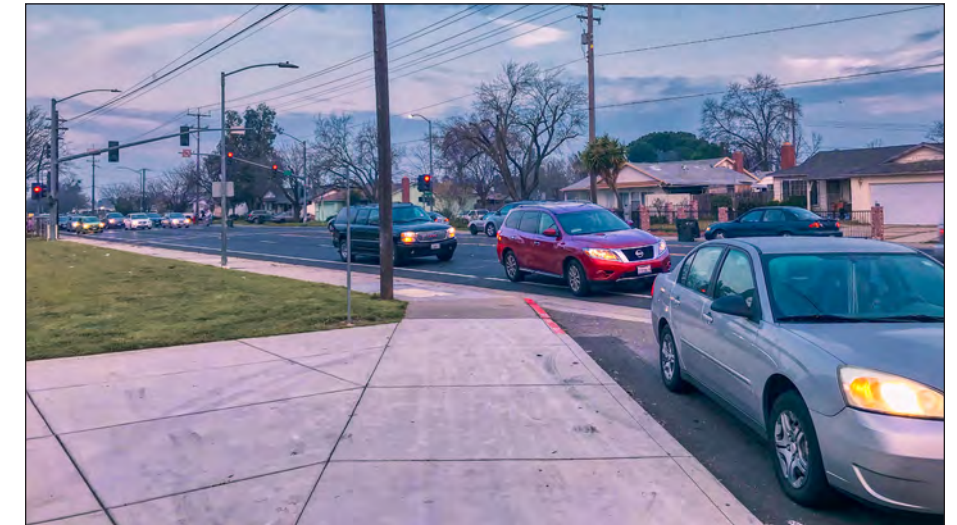
Eastbound vehicle traffic queuing into the drop-off zone backs up onto Meadowview Road.

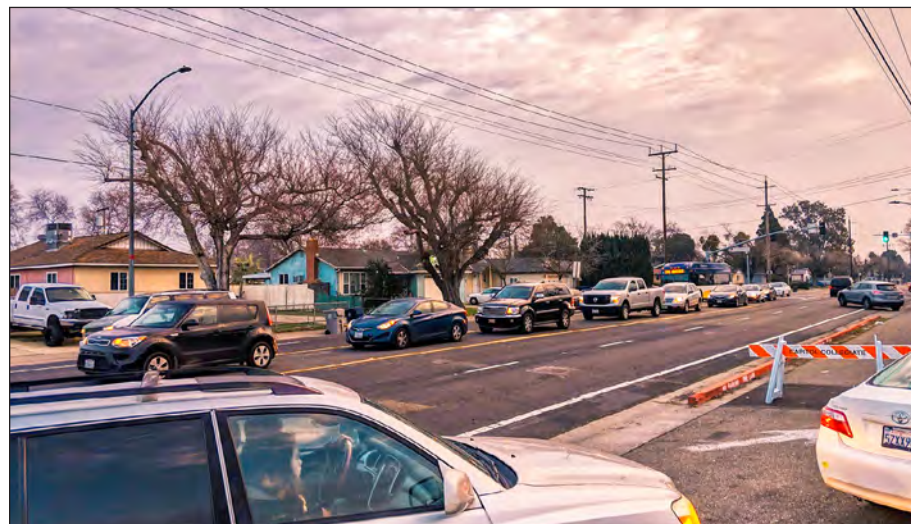
The continuous two-way left-turn lane along Meadowview Road backs up with westbound traffic attempting to turn into school driveway.

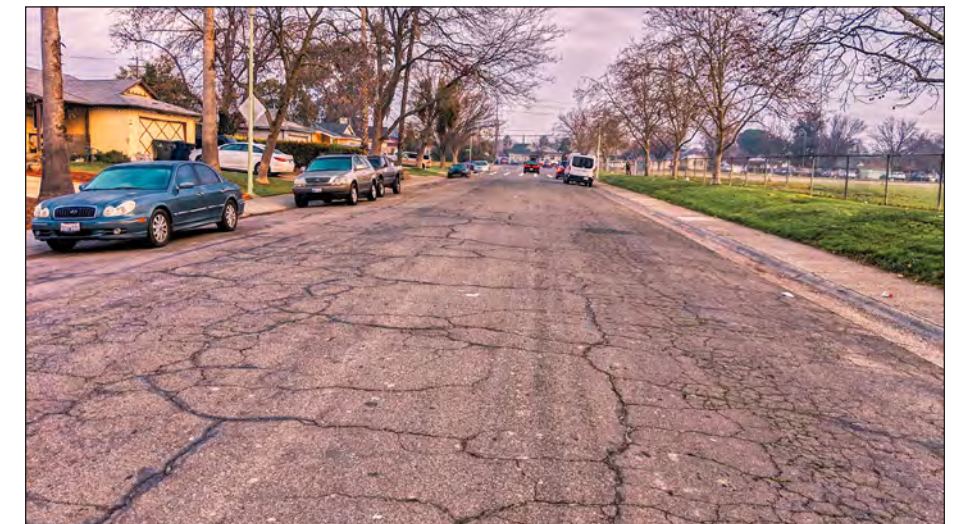
19th Street is a 36-foot wide roadway with on-street parking on both sides.

C. 19th Street	<p>C1 Vehicles were observed double parking along 19th Street, particularly during the afternoon pick-up period.</p> <p>C2 Vehicles were observed speeding between existing undulations.</p> <p>C3 Students use the undulations as a midblock crossing; 19th Street otherwise lacks midblock crossings.</p>	<ul style="list-style-type: none"> • Consider signing the east side of 19th Street, adjacent to the school grounds, as a 15 minute parking zone during pick-up and drop-off times * – C1 • Install school zone signing and striping per MUTCD Standards to increase awareness of the school-related street use – C2 • Provide targeted police enforcement focused on speeding – C2 • Consider upgrading existing undulations to speed lumps, per City’s Speed Lump Program – C2 • Consider replacing undulations with raised pedestrian crosswalk, if warranted based on the City’s Pedestrian Crossing Guidelines – C3 	<p>✓</p> <p>✓</p> <p>✓</p>	<p></p> <p>✓</p> <p>✓</p>		<p>Department of Public Works</p> <p>Department of Public Works</p> <p>Police Department</p> <p>Department of Public Works</p> <p>Department of Public Works</p>

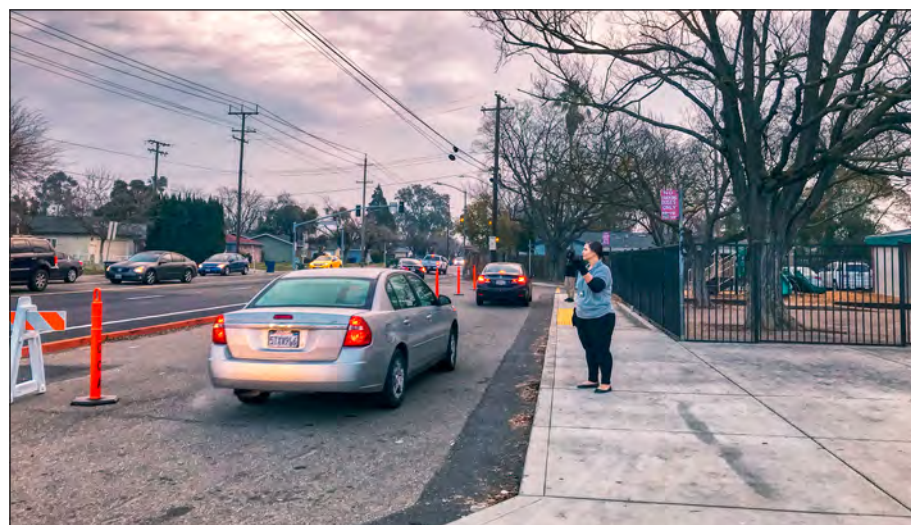
School staff is stationed at the loading loop to assist with the drop-off procedure and keep vehicles moving.

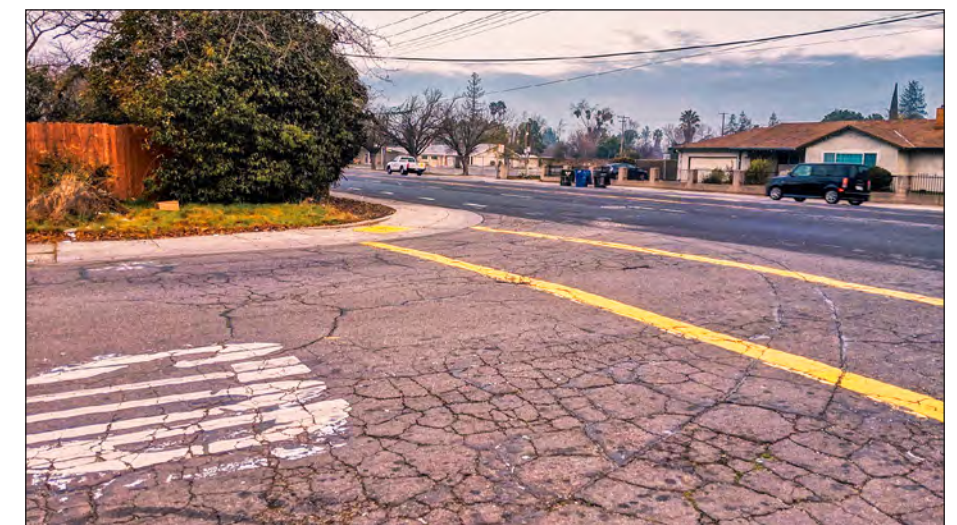
Northbound left turns at 19th Street and Meadowview Road can be challenging due to wall to the west blocking northbound sightline of oncoming eastbound traffic.

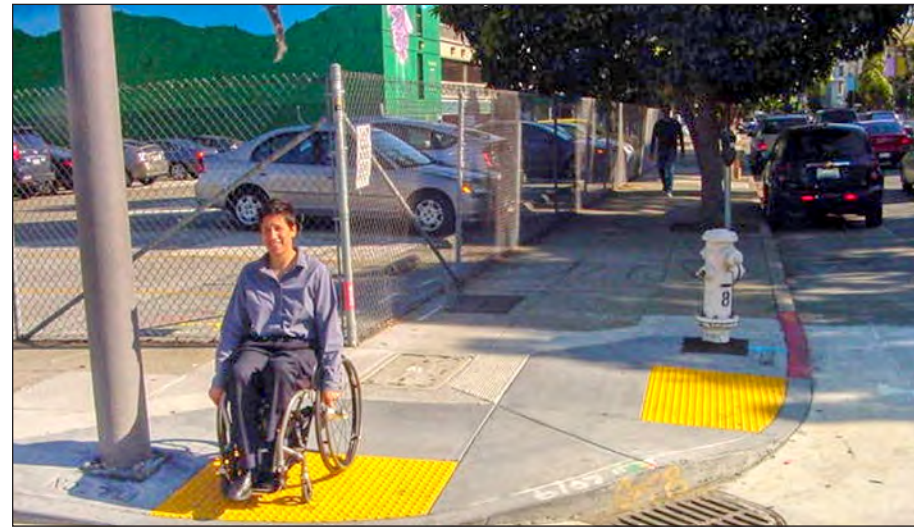
Curb Ramps

Curb ramps allow people in wheelchairs, with strollers, and with vision impairments to cross the street safely. Directional (dual) curb ramps should be used whenever possible. Diagonal curb ramps cause wheeled users to enter the intersection at an angle misaligned from the crosswalk, which places them at greater exposure and risk to vehicle traffic.

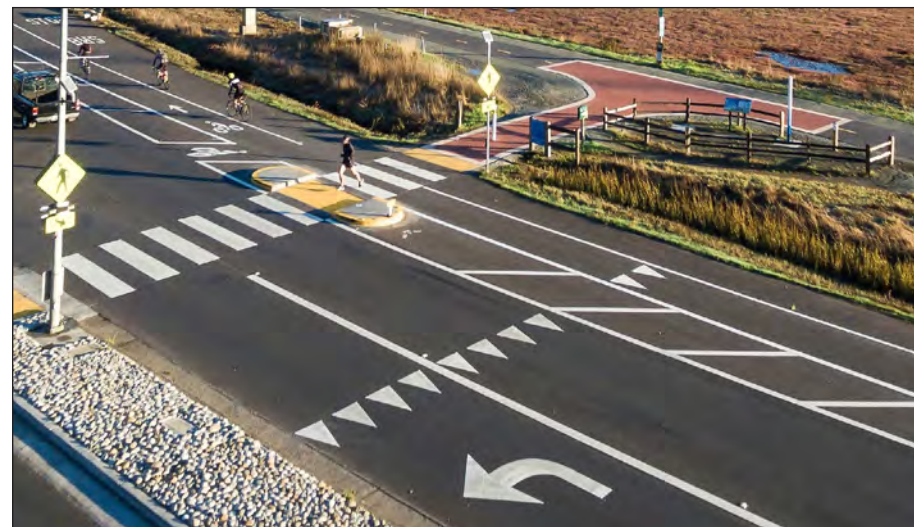
Striping

Painting narrower travel lanes, edge lines, yield markings, roadway centerlines, and passenger loading zones can all improve roadway safety depending on its use. For example, striping improvements can encourage slower vehicular speeds and more predictable vehicular movements and enhance the visibility of crosswalks, bicycle lanes and other safety measures.

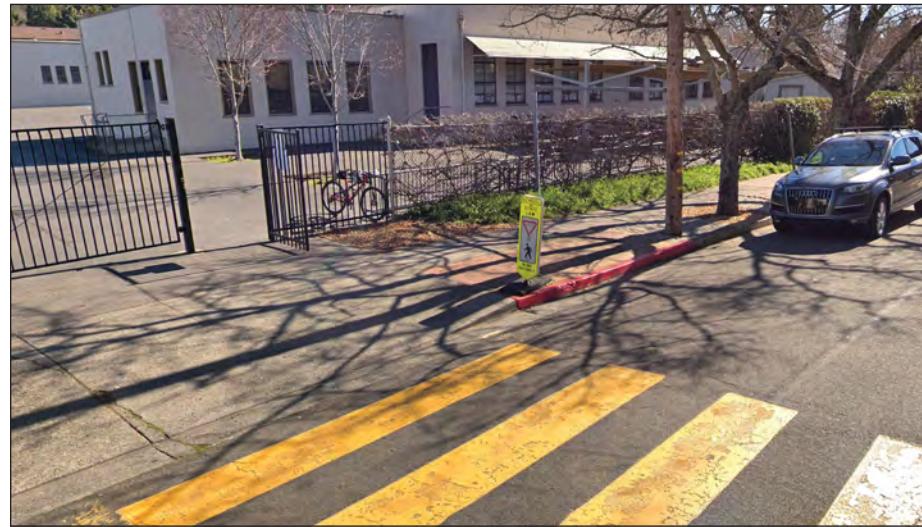
Visibility Improvements

The practice of prohibiting parking with red curb striping on the approach to intersections and crosswalks where parked vehicles would obstruct the visibility of people entering a crosswalk is referred to as “Daylighting.” Other visibility improvements include the maintenance of trees and shrubbery, and modifications to fences that may obstruct sightlines at intersections.

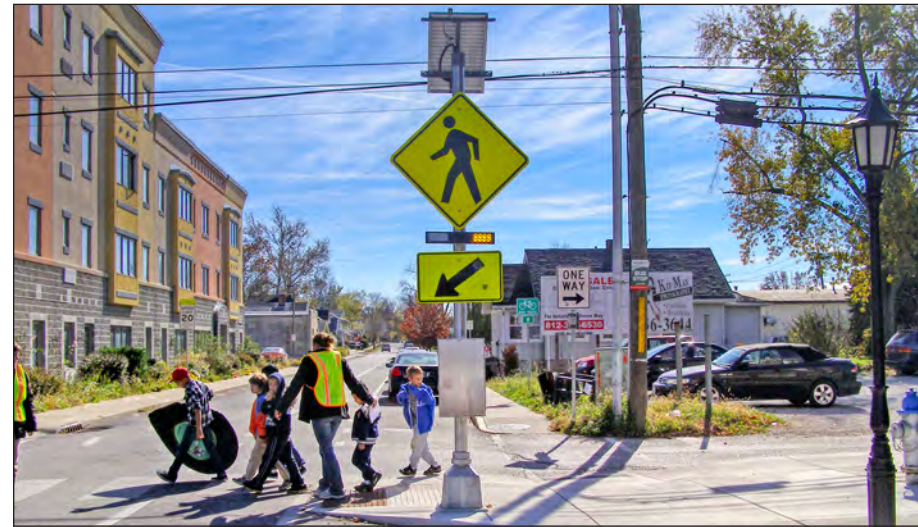
Rectangular Rapid Flashing Beacon

Rectangular rapid-flashing beacons (RRFBs) are user-actuated LEDs that supplement warning signs at uncontrolled crossings. They can be activated by a push-button or by a pedestrian detection system. RRFBs help alert oncoming drivers of pedestrians in the crosswalk and have been shown to increase yield compliance at uncontrolled crossings.

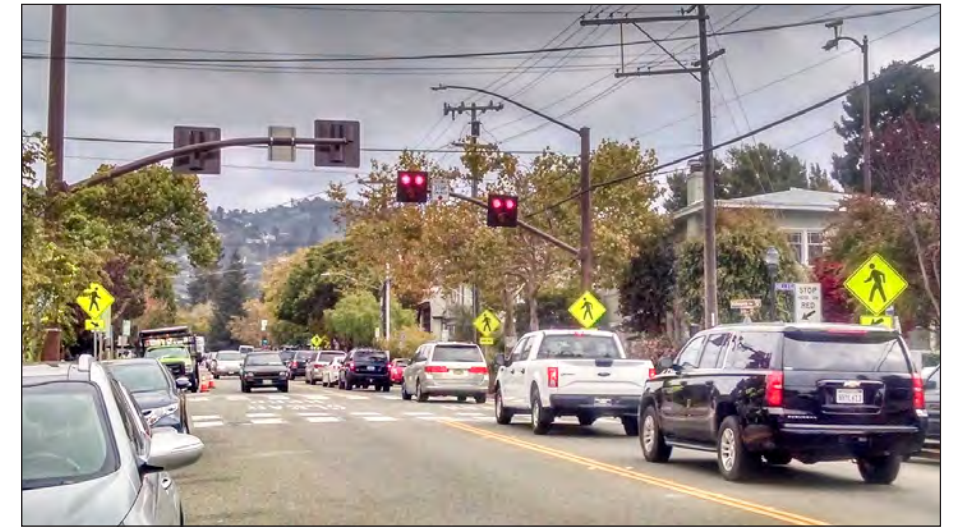
Pedestrian Hybrid Beacon

Pedestrian hybrid beacons are used to control traffic when conditions require more than warning signs but do not justify a full traffic signal. They are installed at intersections with a history of traffic collisions involving pedestrians and in areas with high pedestrian volumes.

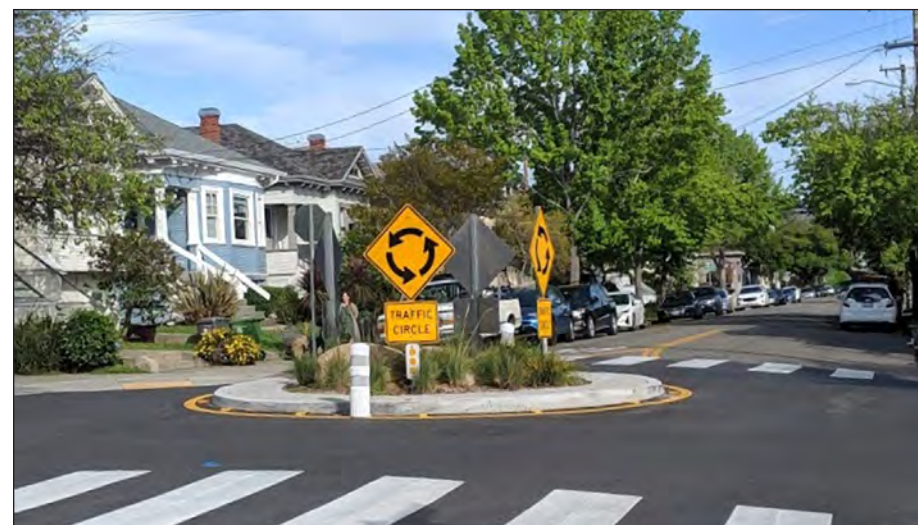
Mini-roundabouts / Neighborhood Traffic Circles

Mini-roundabouts, also known as neighborhood traffic circles, are raised circular islands with wayfinding signs and optional landscaping, designed to lower speeds at minor stop-controlled intersections. These devices offer most of the benefits of conventional roundabouts, including reduced speeds and numbers of collisions, but in the context of residential streets.

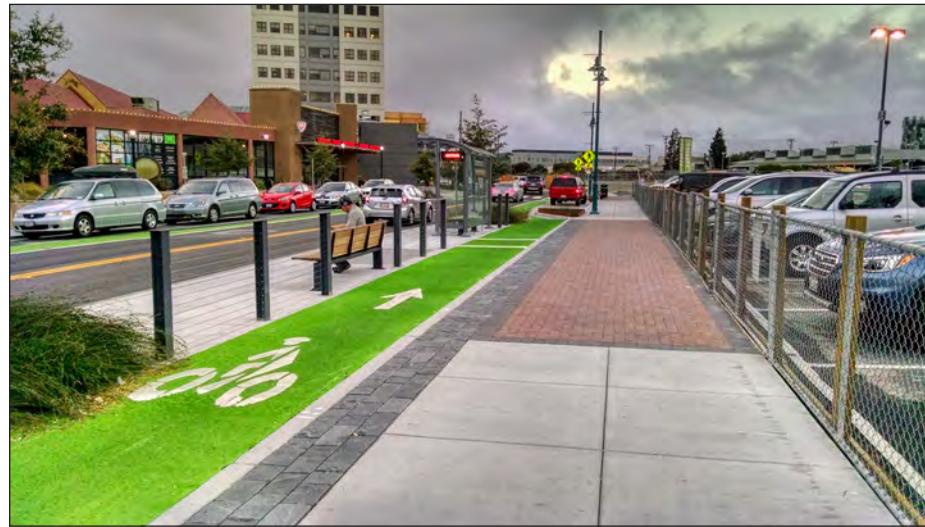
Bike Lanes

Designated bicycle lanes separate cyclists from vehicle traffic by striping or a physical barrier (usually bollards, landscaping, or parked cars). These facilities can increase safety by decreasing opportunities for collisions with over-taking vehicles and by clearly identifying where on the roadway drivers may expect to see cyclists.

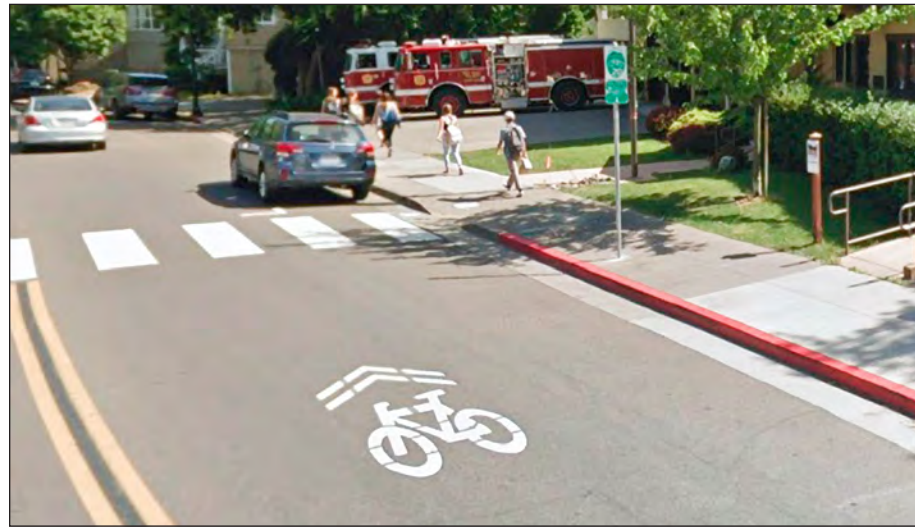
Shared-lane markings, better known as “Sharrows,” help to clarify to all road users where bicyclists are expected to ride and are useful to assist cyclists in wayfinding. Additionally, sharrows assist bicyclists with lateral positioning in a shared travel lane. Sharrows are not a facility type and should not be substituted for bike lanes where warranted.

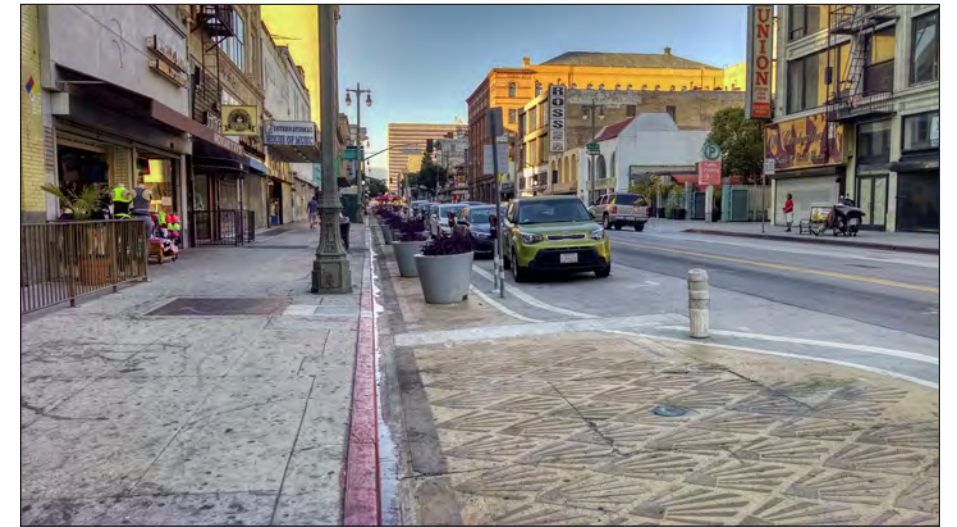
Gateway Treatment

Gateway treatments are intended to alert drivers that they are entering a slower area which may include a school zone. This treatment may include signage, entry portals, speed tables, raised crossings, and curb extensions, and may include some amount of roadway narrowing at the mouth of an intersection.

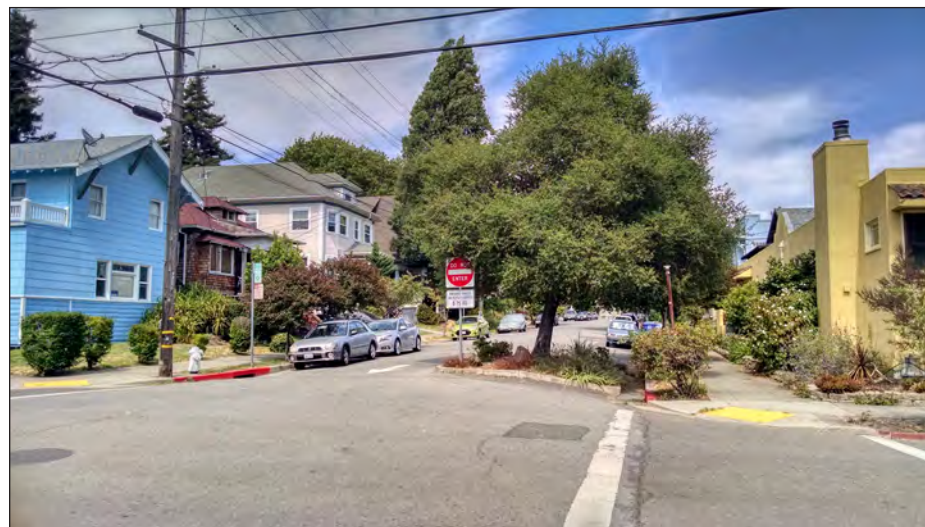
Partial Street Closure

Partial street closures reduce through vehicle traffic while preserving emergency vehicle access. They can be constructed with simple materials such as plastic bollards or made permanent with trees or shrubbery. They improve safety by reducing the attractiveness of the street as a through-route and reduce the Level of Traffic Stress (LTS) for people bicycling.

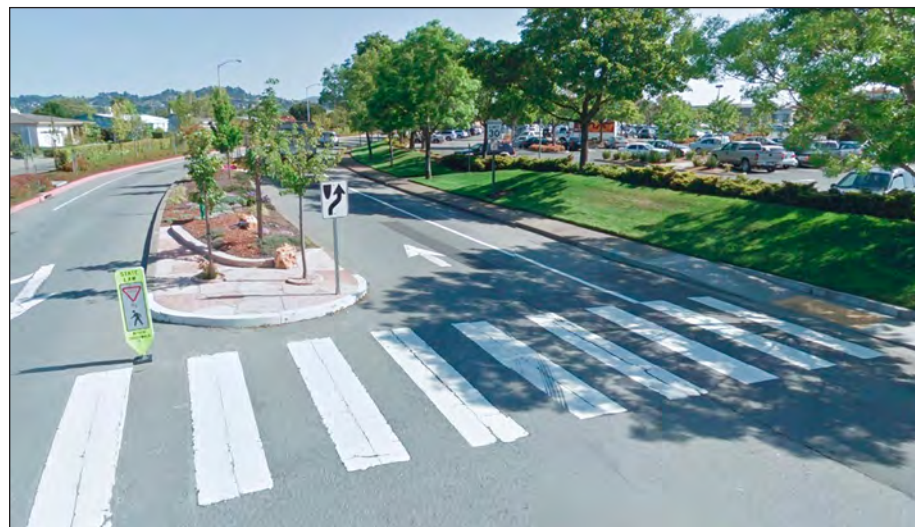
Raised Median

Raised medians are a solid concrete feature in the center of the roadway, often including a planting strip. They reduce the frequency of all crash types and eliminate illegal U-turns on streets with long center two-way turn lanes.

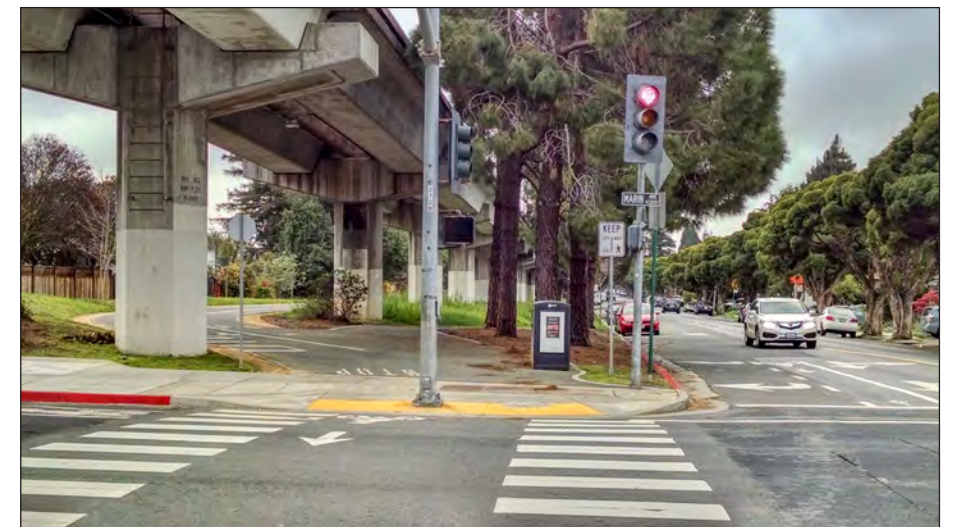
Traffic Signal (New)

A traffic signal can reduce the incidence of specific crash types and may interrupt extremely heavy flows to permit the crossing of minor movements that could not otherwise move safely through an intersection. However, traffic signals generally increase injury collisions overall (compared to all-way stop control), so their installation should always be carefully considered.

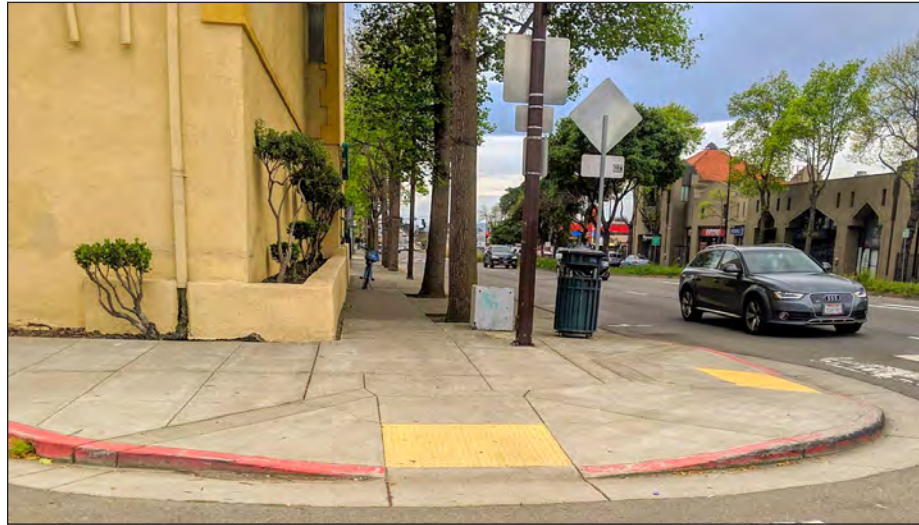
Bulb-outs and Corner Curb Reconstructions

Curb extensions, also called bulb-outs, extend the sidewalk into the parking lane or shoulder to narrow the roadway and provide additional pedestrian space at corners. Bulb-outs increase pedestrian visibility by creating a waiting area in front of parked vehicles and decrease pedestrian exposure to vehicles by reducing crosswalk length. They also reduce vehicle turn speeds.

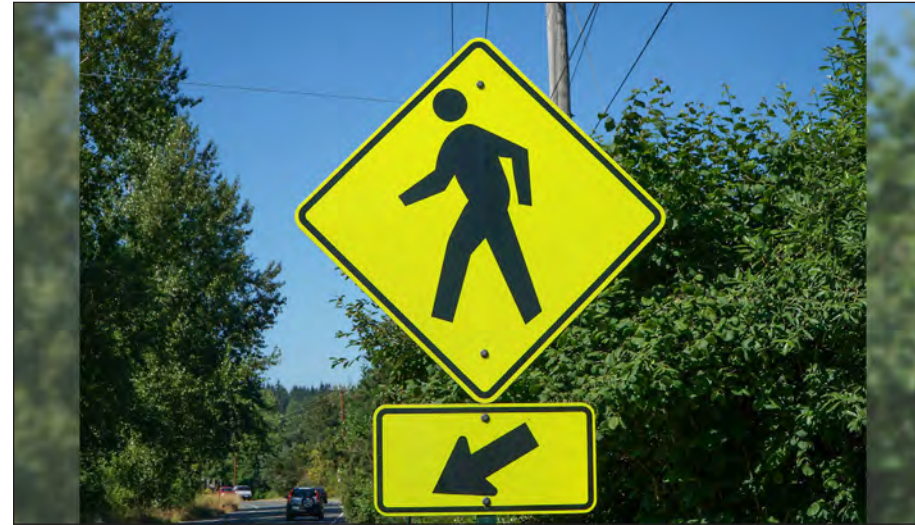
Signage

Signs such as “Yield Here to Pedestrians” or “Stop Here for Pedestrians” that can be placed at the roadway surface level in advance of the crosswalk, on posts, or overhead. “No Parking 8am-9am and 3pm-4pm” can be placed in passenger loading zones. “Bicyclists May Use Full Lane” can be placed in locations where designated bicycle lanes are not warranted.

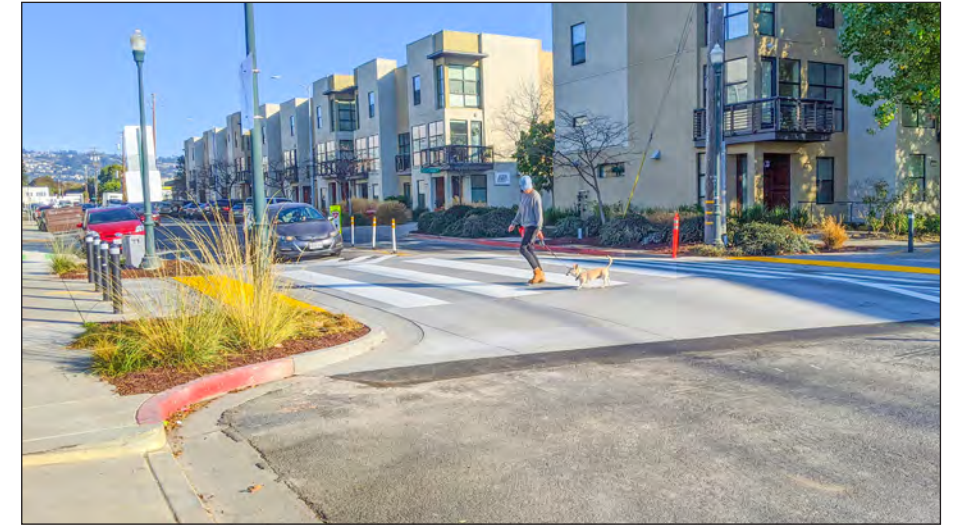
Traffic Calming

Traffic calming uses physical design and other measures to reduce speeding and other unsafe behaviors of drivers while encouraging safer, more responsible driving. Some examples of traffic calming include speed feedback signs, which relay vehicular speeds to drivers and flash when speeds exceed the limit. Physical measures to calm traffic can include rumble strips in the roadway, raised crosswalks, and speed lumps.
